## **Repair mortars for historic masonry Effects of the binder choice on durability**

Groot, Caspar

**Published in**  
Heron

# Repair mortars for historic masonry; Effects of the binder choice on durability

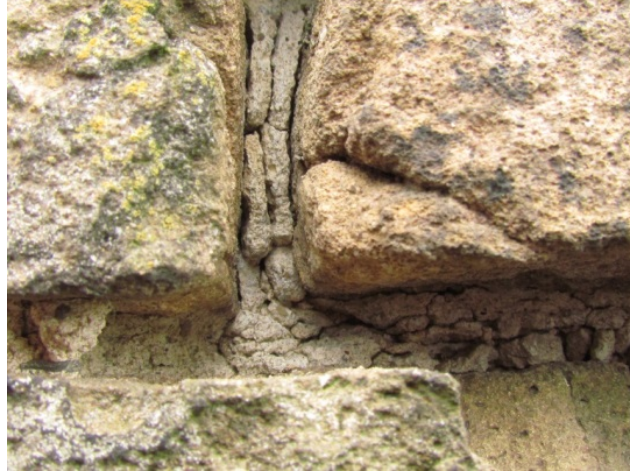
*Figure 3. Frost damage of lime-based bedding mortar caused by a high degree of saturation  
(in West wall of Ruin De Nijenbeek, the Netherlands)*

Freeze-thaw cycles are in colder parts of the world a major reason for damage in historic masonry (figure 3). Obviously, if a mortar does not contain moisture no freeze-thaw damage is to be expected. Damage only takes place if, as a result of the presence of moisture, a high crystallisation pressure (expansion) can develop, causing higher tensile stresses than the mortar tensile strength. In terms of materials properties this means that for a mortar the degree of saturation, the total pore volume, the pore size and distribution, freezing rate and the mortar tensile strength all contribute to freeze-thaw durability (Hall and Hoff 2002).

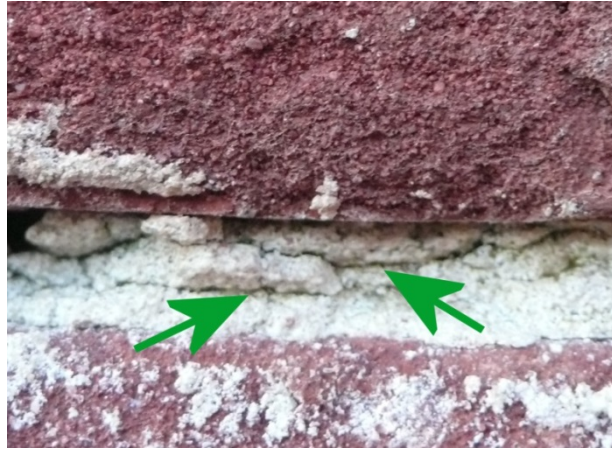
*Figure 4. Frost damage in an uncarbonated air lime mortar due to an application of the mortar too late in the season (Brussels, Belgium)*

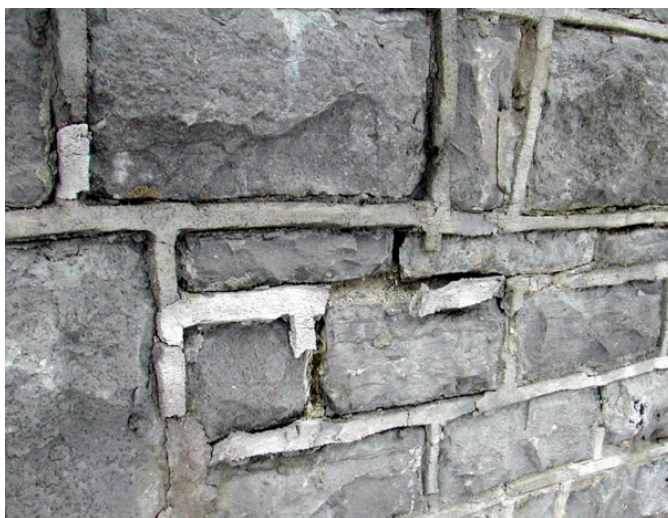
*Figure 5. Push out of a dense repointing mortar caused by frost damage to the bedding mortar. Combination of problems: strong dense mortar (restricts drying, shrinkage cracks allow ingress of moisture); depth of the repointing insufficient (wrong on-site practice). Free-standing garden wall, Ottawa, Canada. (P. Maurenbrecher)*

fill up of the joint. Curing by wetting for a shorter or longer period of time depending on the type of binder used. Practice has learnt that a high percentage of durability problems can be attributed to inadequate on-site practices (figure 5).

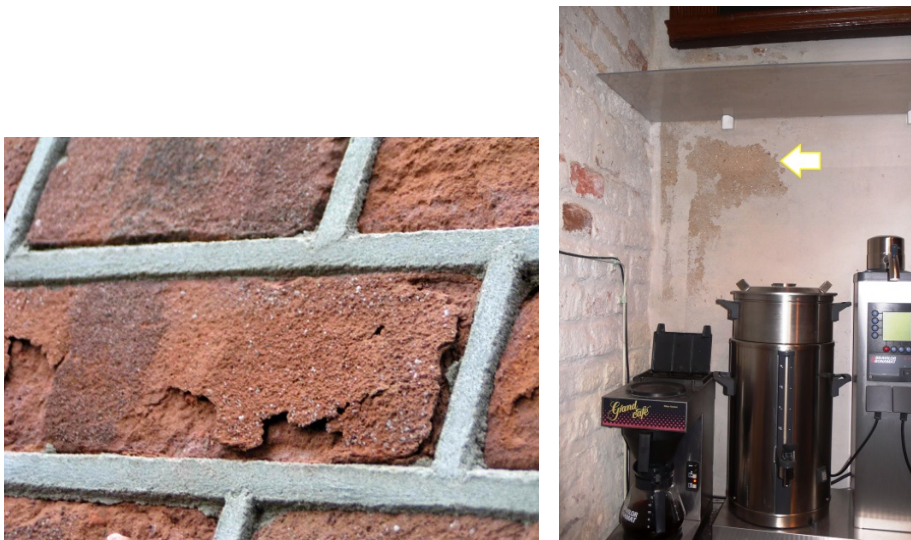
*Figure 7. Left: Spalling of brick caused by salt crystallisation (Netherlands). The brickwork had been treated with a water repellent: concentration of salts and crystallisation-dissolution cycling under the water repellent layer. Right: Sanding of surface layer of plaster caused by salts.*

The drying front may be situated within or at an exterior face of the wall. Crystallisation will cause the serious damage of spalling (cryptoflorescence) when it takes place within the wall; at an exterior face the less serious damage of sanding (see figure 7) will occur.

The examples in figure 7 illustrate the effects of the position of the drying front to the damage. A treatment with a water repellents applied to the exterior face of wall (figure 7,

left) results in a drying front within the wall. The reason is that liquid moisture transport from within the wall to the exterior has to transform into vapour transport at the transition zone of untreated material or water repellent layer. This means that deposition of salts will occur at the transition zone, within the wall, resulting in cryptoflorescence (see as well Ioannou and Hoff 2008, Falchi et al. 2016). If the porosity of the substrate does not deviate too much of that of the repair material (and no application of a water repellent) deposit and crystallization of salt solution will take place at the outer face of the wall (figure 7, right), causing minor damage (sanding).

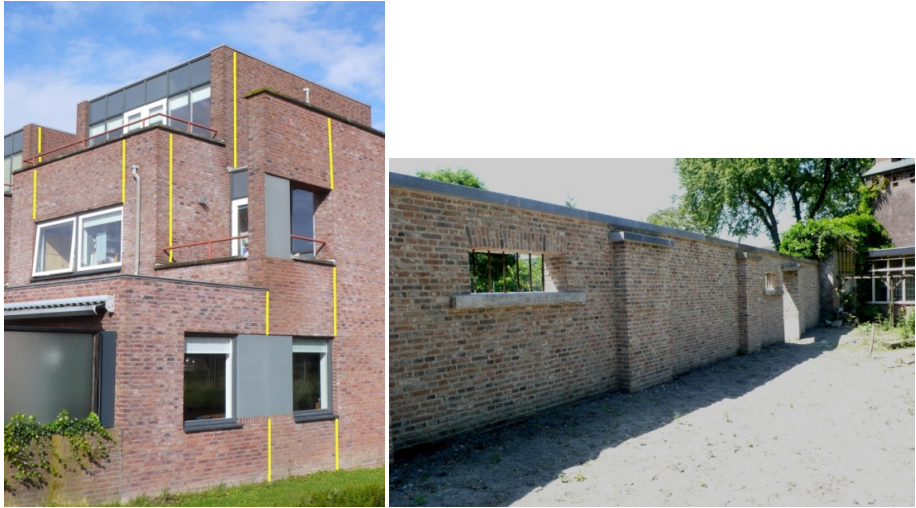
Figure 9. Left: many expansion joints in modern cement mortar masonry (see the yellow lines). Right: in this wall built with a natural hydraulic lime (NHL 3,5) only one expansion joint was applied at the top of the door opening at the rear of the wall.

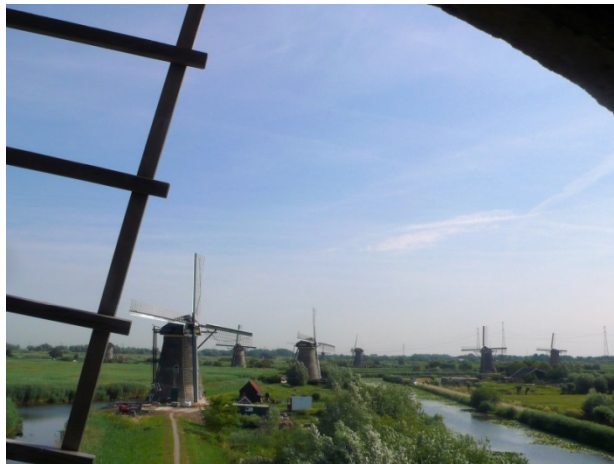
*Figure 12. Water mills built in 1738 at Kinderdijk, the Netherlands. They are almost identical in design, but built by different contractors. Striking are the differences in quality of these mills. From the beginning several of them are suffering from serious rain penetration problems.*

*Others show no problems at all.*

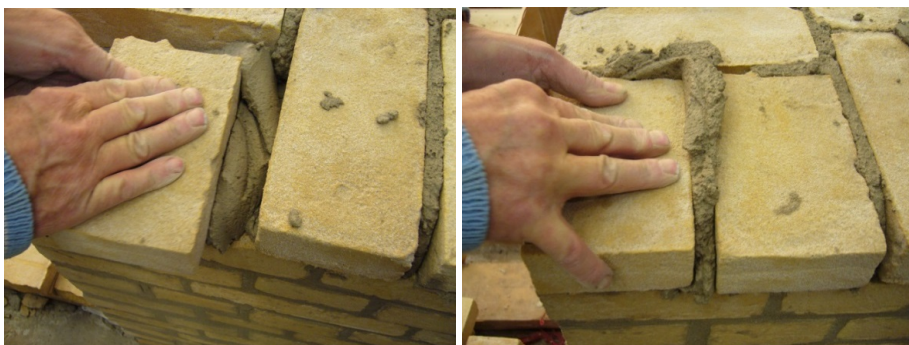
*Figure 13. A basic requirement for water tightness is that during execution no voids are left; to avoid this every brick should be fully surrounded by mortar. This is only possible if the brick laying is done carefully brick-by-brick.*

Proof for this interpretation was found in a field study (Groot and Gunneweg 2005) where examples were analyzed of well-made historic brickwork constructed with high absorption bricks (Initial rate of absorption (IRA)  $> 3 \text{ kg}/(\text{m}^2 \cdot \text{min})$ ) and high porous lime mortars without any leakage problem (the most unfavourable mortar-brick combination with regard to leakage potential). In case of a presence of pores  $> 100 \mu\text{m}$  and cavities originating from wrong brick laying technique, leakage at defined spots may be expected. The reason is that pores coarser than  $100 \mu\text{m}$  contribute to the water permeability through gravity or wind driven water ingress (see Thomson et al. 2004). Hence, leakage may in these cases be attributed to networks of fine cracks, wide cracks throughout the wall, voids in the interior of the masonry (voids, apart from being water reservoirs in the wall, may also promote leaching of soluble material, such as calcium hydroxide). Generally, the porosity of the mortar is finer than of the bricks in low-strength fired clay brick masonry. This means that the mortar may act as a barrier to water transport in masonry. (For more extensive information what may happen as result of moisture transport from mortar to brick see Groot 93 and Brocken 98). Tests with various mortar-brick masonry combinations showed that the barrier effect of air lime mortars is rather low, and the more hydraulic the mortar the higher the barrier effect.
