## **Molybdate as corrosion inhibitor for hot dip galvanised steel scribed to the substrate A study based on global and localised electrochemical approaches**

Corrosion Science

# **Molybdate as corrosion inhibitor for hot dip galvanised steel scribed to the substrate: a study based on global and localised electrochemical approaches**

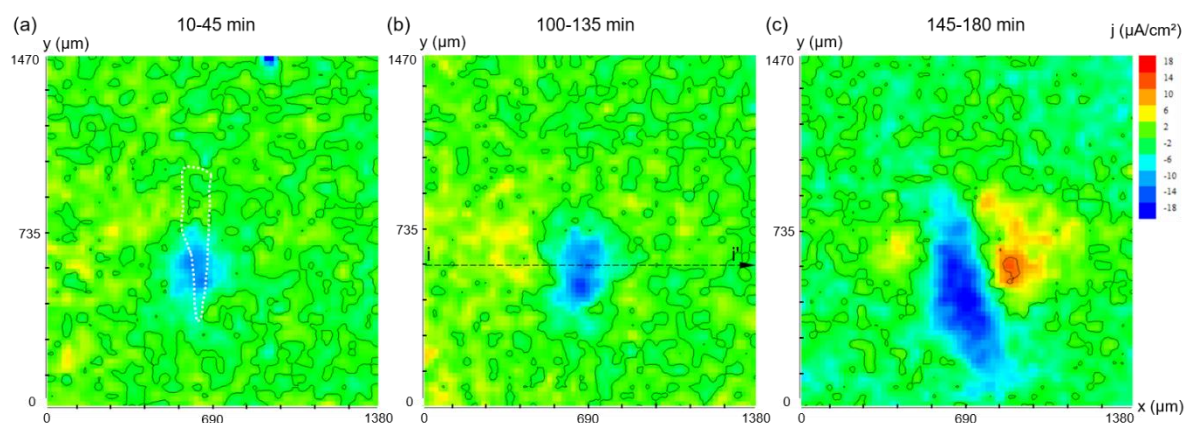
Fig. 13. Current density ( $\mu\text{A}/\text{cm}^2$ ) maps obtained by SVET on severely scratched HDG ( $\sim 18$   $\mu\text{m}$ -depth defect) exposed to  $0.05$  M NaCl +  $5$  mM  $\text{Na}_2\text{MoO}_4$  solution after (a) 10-45 min, (b) 100-135 min and (c) 145-180 min of immersion. The  $j$  scale is the same for all maps. The scratched zone is represented by white dots in (a). The 'i-i' line in (b) indicates the direction used for constructing  $j_z$  line profiles.

At the beginning of immersion, only minor cathodic activity emerged from the scratch region (Fig. 13(a)). Next, as shown in Fig. 13(b), the cathodic response from the same location became relatively more pronounced, while an anodic process with low intensity spread out around the defect. By the end of the test (Fig. 13(c)), a larger area seemed to support cathodic activity, and anodic reactions appeared more concentrated closer to the scratched zone.

The presence of Cl was not detected on the exposed surface, suggesting the protective behaviour of the molybdate film concerning chloride-induced corrosion attack (and eventual formation of insoluble zinc chloride hydroxides). The mismatch between the distributions of Fe and O is also worth mentioning: this fact suggested that dissolution of the steel substrate did not take place. This is an essential point because inhibitive species of Zn might eventually extinguish its sacrificial character and in turn, drive corrosion of steel [2,17]. Nevertheless, the patchy and heterogeneous character of the molybdate film was not ideal for extended protection [4] – which might explain the increase of corrosion activities eventually depicted after 3 h of immersion (Fig. 13(c)).
