Eemdijk full-scale field test programme: ground dike and sheet pile dike failure test

Programme d'essai terrain à taille réelle Eemdijk: essais de déformation et de rupture pour une digue standard en terre et une digue renforcée avec palplanches

ABSTRACT: Dikes in the Netherlands have traditionally been constructed with soil. Climate change and subsidence requires heightening and or reinforcing these existing dikes. Traditional reinforcements demand additional space, which in some cases conflicts with existing buildings. Applying sheet pile walls in dikes allows for strengthening while minimizing the increase in footprint. However, a validated design approach that complies with relevant regulations lacks. To enable the validation of a proposed design approach, a full-scale field test programme (Eemdijkproef) was performed near the town of Eemdijk, The Netherlands. It consisted of a step wise approach: 1) sheet pile pullover tests, 2) ground dike stability test, 3) sheet pile dike stability test. All tests were loaded until failure occurred. The two similar test dikes were constructed at full scale (5m high, 25m wide, 60m long). In one dike an 18m long sheet pile wall was installe

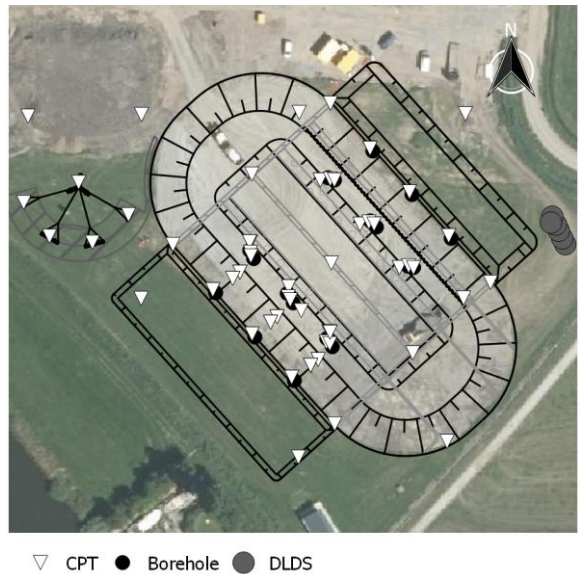
Figure 1 shows the FST site with the sheet pile dike at the NE-side and the ground dike at the SW-side. The POT is located at the W-side. Furthermore the soil investigation points are

presented with the Deltares Large Diameter Samples (DLDS) at the E-side.

Figure 1 Topview FST site with soil investigation points.
