# Eemdijk full-scale field test programme: ground dike and sheet pile dike failure test

## Programme d'essai terrain à taille réelle Eemdijk: essais de déformation et de rupture pour une digue standard en terre et une digue renforcée avec palplanches

**ABSTRACT:** Dikes in the Netherlands have traditionally been constructed with soil. Climate change and subsidence requires heightening and or reinforcing these existing dikes. Traditional reinforcements demand additional space, which in some cases conflicts with existing buildings. Applying sheet pile walls in dikes allows for strengthening while minimizing the increase in footprint. However, a validated design approach that complies with relevant regulations lacks. To enable the validation of a proposed design approach, a full-scale field test programme (Eemdijkproef) was performed near the town of Eemdijk, The Netherlands. It consisted of a step wise approach: 1) sheet pile pullover tests, 2) ground dike stability test, 3) sheet pile dike stability test. All tests were loaded until failure occurred. The two similar test dikes were constructed at full scale (5m high, 25m wide, 60m long). In one dike an 18m long sheet pile wall was

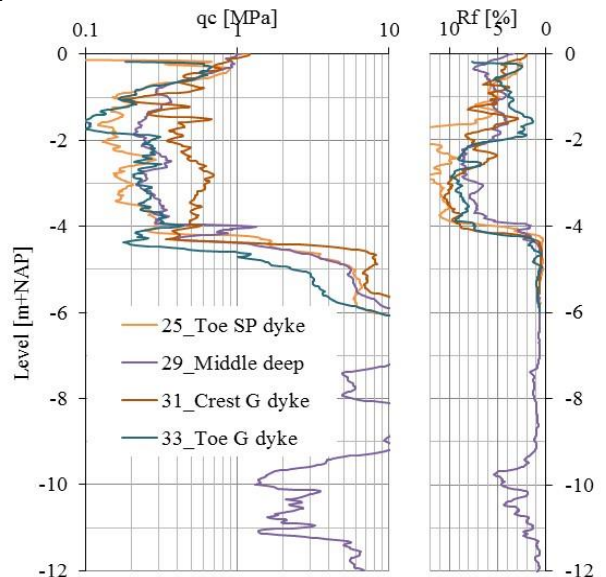
Figure 2 CPT's at toe FST site

A total of 48 CPT's have been performed in advance and during construction. Figure 3 presents four CPT's that characterize the FST site. All shallow CPT's are class 1 according to (EN 1993-5, 2007). CPT25 is located at the sheet

pile dike and CPT29 in the middle of the embankment. Both are representative for the entire site. CPT31 is located below the crest of the ground dike and shows a higher cone resistance ( $q_c=0.5$  MPa) due to the preloading by an old berm. CPT33 is located at the toe of the ground dike, where a soft silty clay layer 3a can be identified by the low cone resistance ( $q_c=0.1$  MPa) at -1.5m NAP.

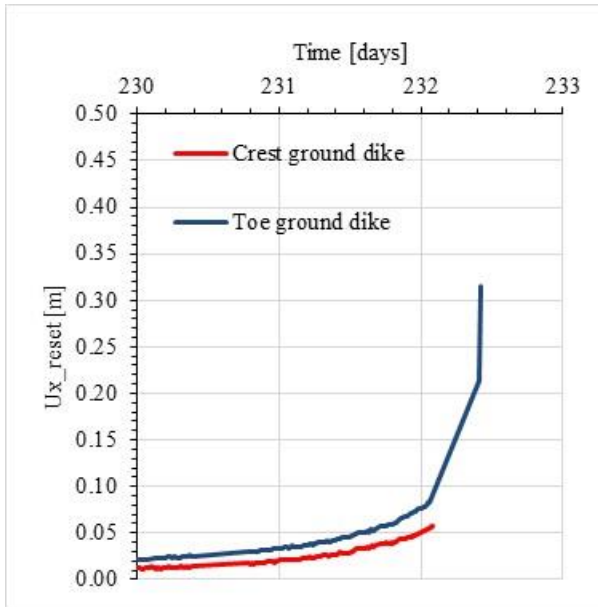
Figure 7 presents the horizontal deformations at the crest (top of the slope) and toe of the dike during the last 3 days of the ground FST. The deformations at the crest are generally 1.5 times smaller than at the toe and became clearly visible by eye one hours before failure.

Figure 7 Horizontal displacements of the Prism at the crest and toe of the ground dike.

Deformations of the ground dike are initially very limited. The deformations at the crest are generally 1.5 times smaller than at the toe.
