Impact of the Eemdijk full-scale test programme

Impact du programme d'essais à grande échelle Eemdijk

ABSTRACT: Levees in the Netherlands have traditionally been constructed from soil. Climate change and land subsidence require heightening and/or reinforcing these existing levees. Traditional reinforcements demand additional space, which in some cases conflicts with existing buildings. Applying sheet pile walls in levees allows for strengthening while minimizing needed footprint. However, a validated design approach that complies with relevant regulations lacked. To enable validation, a full-scale field test programme has been performed near the town of Eemdijk (The Netherlands). This has resulted in better insight in the soil-structure interaction of the structurally reinforced levee, on soft soil, loaded by high water and uplift conditions.

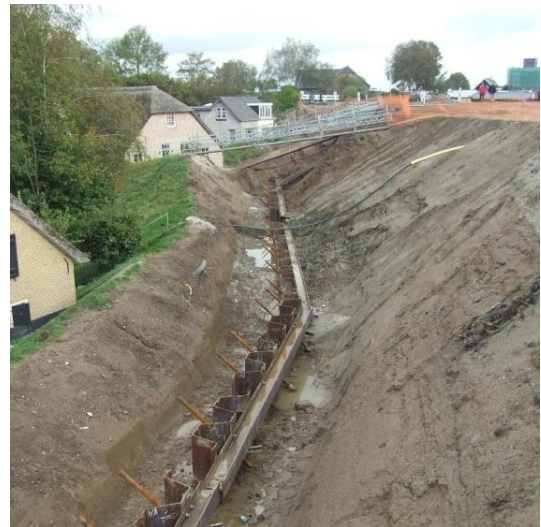
Figure 1: Installation of discontinuous sheet pile wall as reinforcement of Lekdijk Krimpenerwaard

Unlike a soil structure levee, the structurally reinforced levee is required to apply to strict deformation requirements. In the serviceability limit state both crest settlement and horizontal wall displacement need to be smaller than 0.10 m; in the ultimate limit state the wall deflection is not allowed to exceed 2% of the wall length (with a maximum of 0.5 m). Also, in contrast to what in (EN 1993-5, 2007) is allowed, if class 1 and class 2 profiles are applied, only the elastic (thus not the plastic) capacity of the steel wall may be taken into account according to the design guideline. Finally, the structure is not allowed to obstruct groundwater flow within the levee. This generally leads to a discontinuous wall from panels of several sheet piles, connected with a waling (see Figure 1).
