## Inspection and assessment of corrosion in pretensioned concrete bridge girders exposed to coastal climate

# Inspection and Assessment of Corrosion in Pretensioned Concrete Bridge Girders Exposed to Coastal Climate

To investigate the applicability and accuracy of the above measurement methods for corrosion detection in pretensioned bridge girders, we carried out a study based on experimental data collected during field investigations of Dalselv Bridge, a 33-year-old girder bridge exposed to the Norwegian coastal climate.

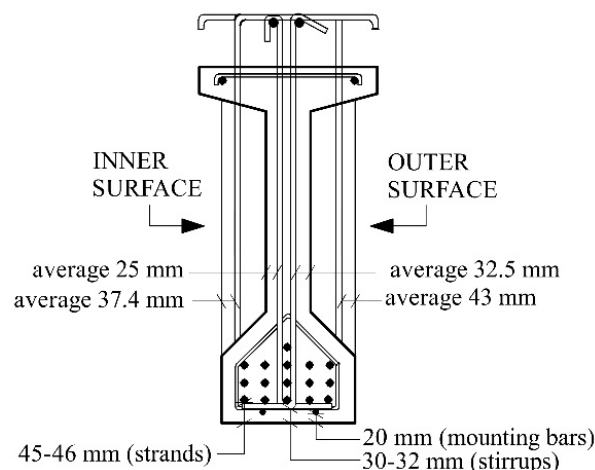
Measurement of the concrete cover up to the stirrups in Girder 2 revealed 5.5–7.5 mm more cover on the outer than the inner surface of the web, see Figure 6. This means that the mold must have moved before casting. During inspection, we also detected two visible mounting bars supporting stirrups in the girder's bottom flange, with plastic reinforcement chairs supporting the bars.

**Figure 6.** Concrete cover thickness measured in Girder 2.

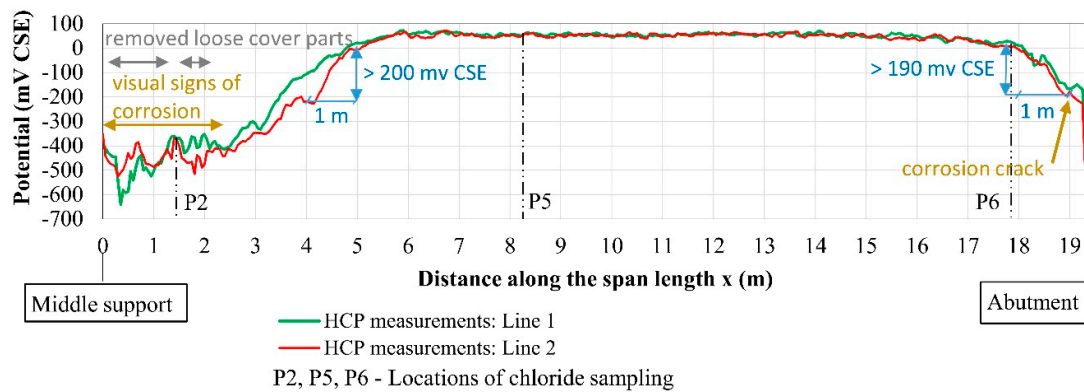
The HCP mapping along the bottom flange of Girder 2 is shown in Figure 8. Lines 1 and 2 both showed positive and stable HCP values (0 to 72 mV CSE) in the middle part of the span between 5 and 18 m from the middle support. Near the girder supports, HCP measurements decreased to their most negative values. The potential gradients near both supports were greater than 190 mV CSE/m, while no potential drops occurred in the middle of the span; see Figure 8. This indicates a higher probability of corrosion in reinforcement near the supports and a low probability of corrosion in the main part of the span.

**Figure 8.** Distribution of half-cell potentials along the bottom surface of Girder 2.

The local scatter in HCP readings from 0.1 to 1.3 m and from 1.6 to 2.1 m from the middle support is probably due to partially removed loose concrete cover; see Figure 8. Outside the area of removed cover, the HCP readings in Line 2 are slightly lower than in Line 1; see Figure 8. Otherwise, the potential gradients in both lines show the same trend. In this case, therefore, it was not possible to detect variation in corrosion probability between closely spaced (about 50 mm) and electrically connected strands. This can be explained by either active corrosion in both strands or polarization of neighboring strands by a locally active corrosion area. The area polarized depends, amongst other things, on the ER. As the ER decreases, the area polarized increases.

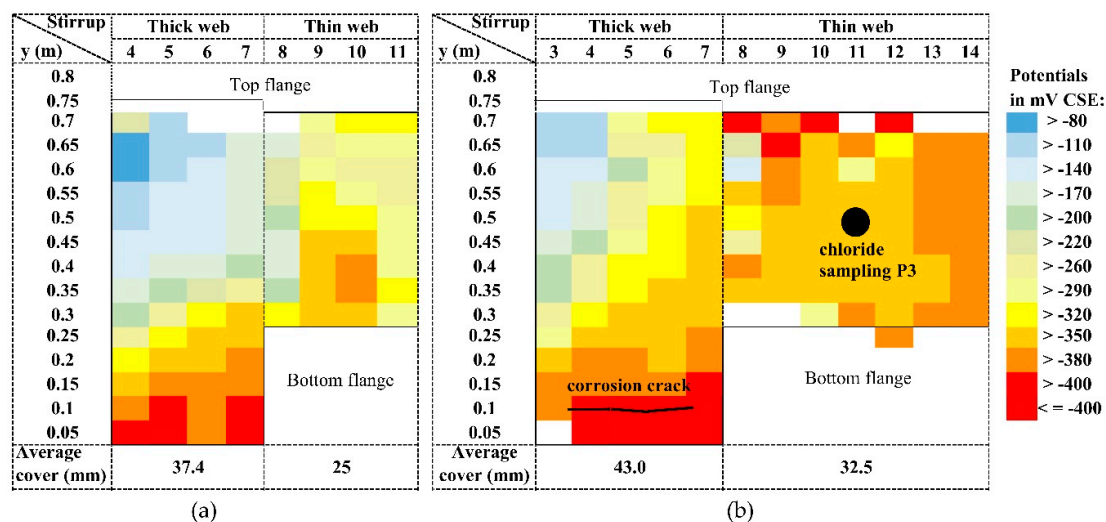
The potentials measured above the stirrups near the middle support (numbered 3–14 in Figure 2b) are shown in Figure 9. The highest HCP values were measured in the upper corner of the girder end cross section, referred to here as the thick web. The potential distribution follows the moisture pattern observed in inner NIB girders close to the middle support (see Figure 4) and confirms the influence of moisture on HCP measurements.

**Figure 9.** HCP measured above the stirrups in Girder 2: (a) inner surface; (b) outer surface (facing the sea) cf. Figures 2 and 6.

The most negative potentials (less than  $-380$  mV) were found for parts of the stirrups at the bottom of the thick web. These locations correspond to the areas with visible corrosion damage shown in Figure 4a. The HCP readings above the stirrups show more negative values for the outer web surface (facing the sea) than for the inner surface. Despite its thicker cover (by 5.5–7.5 mm), the outer surface facing the sea is more likely to corrode than the inner surface.

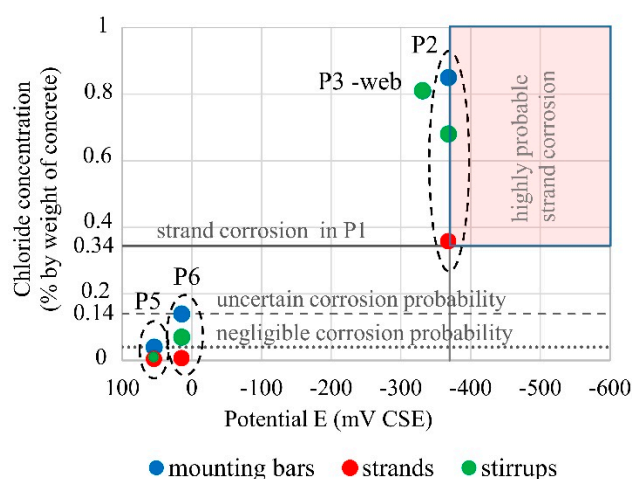
**Figure 18.** HCP and chloride concentrations for sampling locations in Girder 2. The chloride concentration at the level of the corroding strand in location P1 (in Girder 11) is included for comparison.

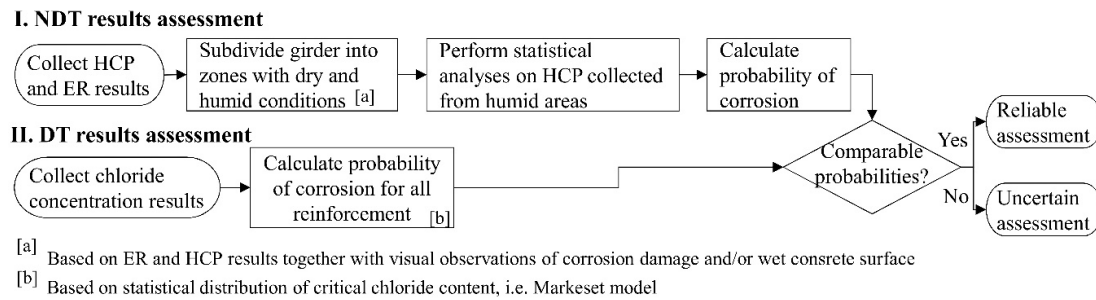
The assessment of the data collected is described in Figure 20. The statistical analysis of HCP should be performed following the procedure developed by Gulikers and Elsener [42] on data collected from areas where an increase in moisture is detected, e.g., support zones and their vicinities. Corrosion probabilities from measured chloride concentrations should be evaluated based on the statistical model for critical chloride distribution for similar structures and environmental conditions as proposed by Markeset [16]. The estimated corrosion probabilities from both chloride concentrations and HCP collected from areas with similar moisture conditions are then compared. Corrosion probability assessment can be considered reliable when both methods point to the same conclusions and coincide with the visual damage where present. The results can also be supported with reinforcement inspection results.

**Figure 20.** Procedure for assessment of pretensioned bridge girders in a marine environment.
