## Field Measurements of Very Oblique Wave Run-up and Overtopping with Laser Scanners

Oosterlo, P., Hofland, B., van der Meer, J. W., Overduin, M., & Steendam, G. J. (2020). *Field Measurements of Very Oblique Wave Run-up and Overtopping with Laser Scanners*. 1-2. Abstract from ICCE 2020: International Conference on Coastal Engineering (Virtual), . <https://doi.org/10.9753/icce.v36v.waves.20>

# FIELD MEASUREMENTS OF VERY OBLIQUE WAVE RUN-UP AND OVERTOPPING WITH LASER SCANNERS

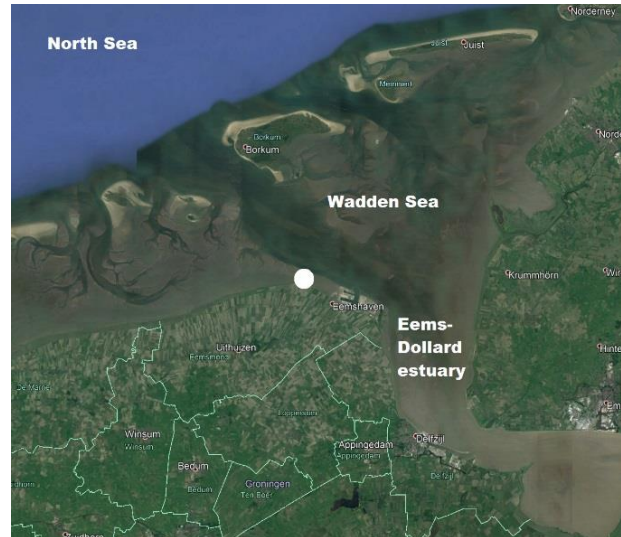
Figure 1 - The Eems-Dollard estuary in the Netherlands, area of interest of the field measurement project. Laser scanner system location indicated by white dot.

An extensive field measurement project is being performed in the Eems-Dollard estuary in the north of the Netherlands for a period of 12 years. The measurements started in 2018, measuring wind, water levels, waves and wave run-up and overtopping. The estuary consists of deep channels and shallow tidal flats and is part of the Wadden Sea, a shallow shelf sea, see Figure 1. A particular aspect for this area is that the dike design conditions are characterized by very obliquely incident waves, up to 80° relative to the dike normal. As the reliability of the models as used for the Dutch dike safety assessment has not been sufficiently validated for such conditions, the aim of the measurements is twofold. First, to better understand the processes yielding nearshore wave conditions, ultimately leading to improved numerical prediction models. Second, to better understand the processes related to oblique wave run-up and overtopping, leading to improved prediction methods. In the project, the wave overtopping is measured with four wave overtopping tanks built into dikes at two locations. The laser scanner system of Oosterlo et al. (2019) has since been upgraded and has now been placed next to two of the overtopping tanks on the dike in the Eems-Dollard estuary to measure during actual severe winter storms, see Figure 2.

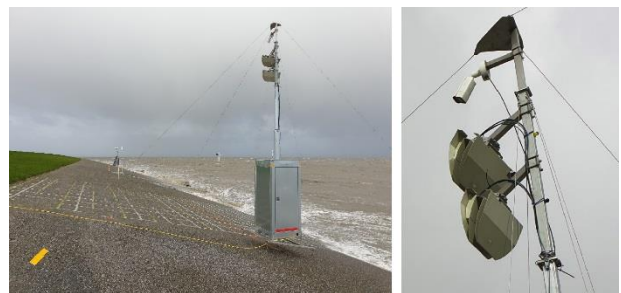
Figure 2 - Left: New laser scanner system next to the overtopping tanks on the dike in the Eems-Dollard estuary. Right: from the bottom to the top: Laser scanner 1, laser scanner 2, video camera.

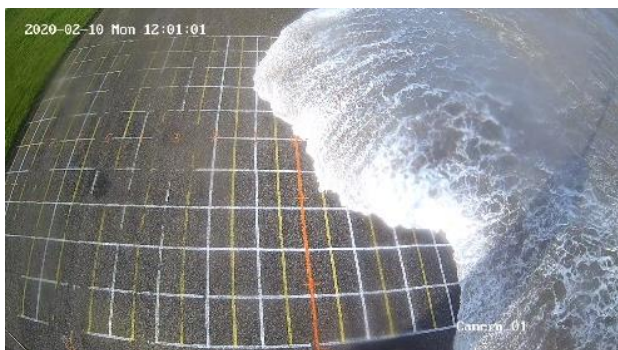
Figure 3 - Snapshot of a very oblique wave running up the slope during storm Ciara.

The focus of the paper will lie on the measurements performed during storm Ciara. Storm Ciara was an extratropical cyclone that hit large parts of northern Europe starting on 7 February 2020. Measurements were performed from 10 to 12 February 2020. Ciara was the first actual storm that was measured with the laser scanner system, and immediately tested the system to the extreme. Ciara was a highly unique storm, with offshore directed wind at the measurement location and waves that turned somewhat on the shallow flats in front of the dike to become almost alongshore directed waves at the dike. Hence, Ciara caused highly complex conditions at the measurement location with very oblique wave attack with angles of incidence up to 75°. This posed large challenges for measuring e.g. the 3D front velocities and the overtopping volumes and discharges, also see Figure 3.
