## Measurement Report on the Transition between Flexural and Shear Failure on RC Beams without Shear Reinforcement

Report 25.5-16-04  
Project C33B89  
Date November 2016  
Status Draft  
Version 0.01

# **Measurement Report on the Transition between Flexural and Shear Failure of RC Beams without Shear Reinforcement**

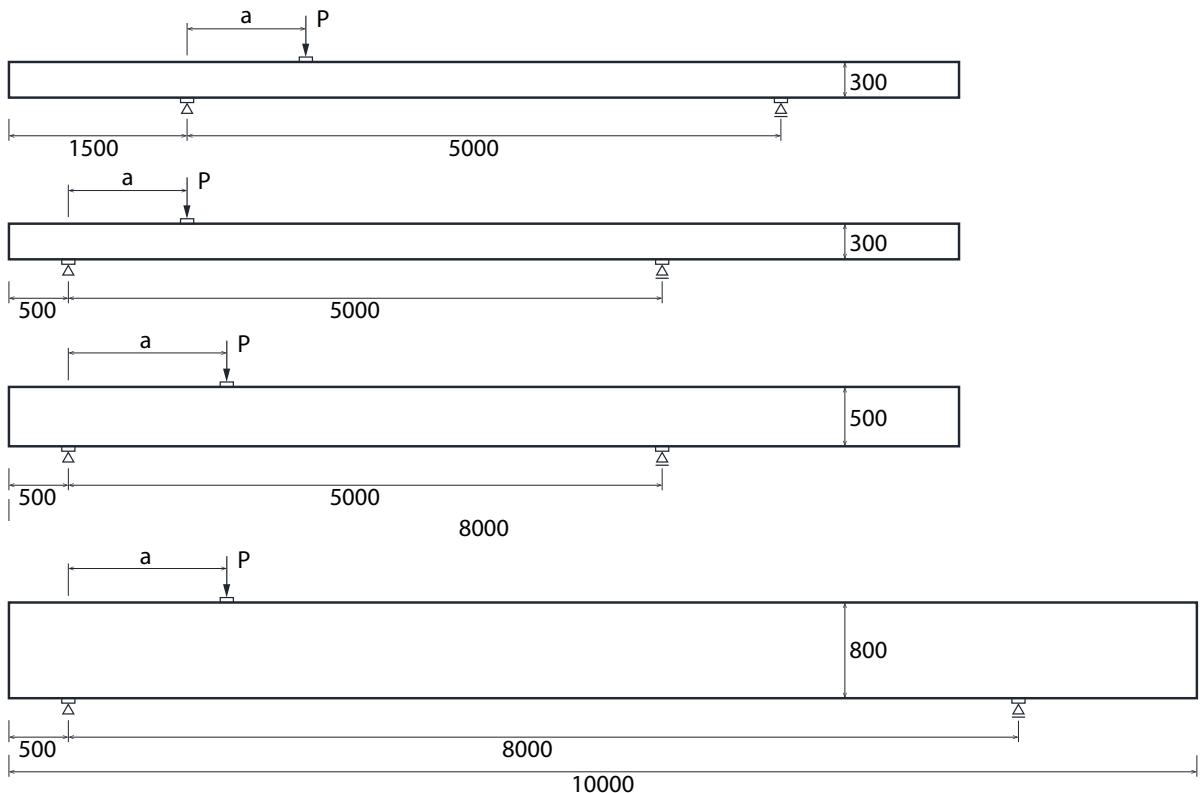
In all the tests, the tested specimens were simply supported, and loaded by a point load. The positions of the loading point varies between tests in order to find the expected failure modes. The positions of the supports and the loading points are given in Fig. 3.1.1. For all the specimens, the two ends of which were tested separately. For that purpose, a long cantilever was left out of the longer end support. In the case of the specimens with 300 mm height, a cantilever of 1500 mm long was made before the first shear failure test. The intention was that because of the smaller effective depth, not a very large  $a$  is needed to reach the required shear slenderness ratio. The additional cantilever can be reserved for additional tests.

**Fig. 3.1.1. Configurations of the boundary conditions of the tests.**

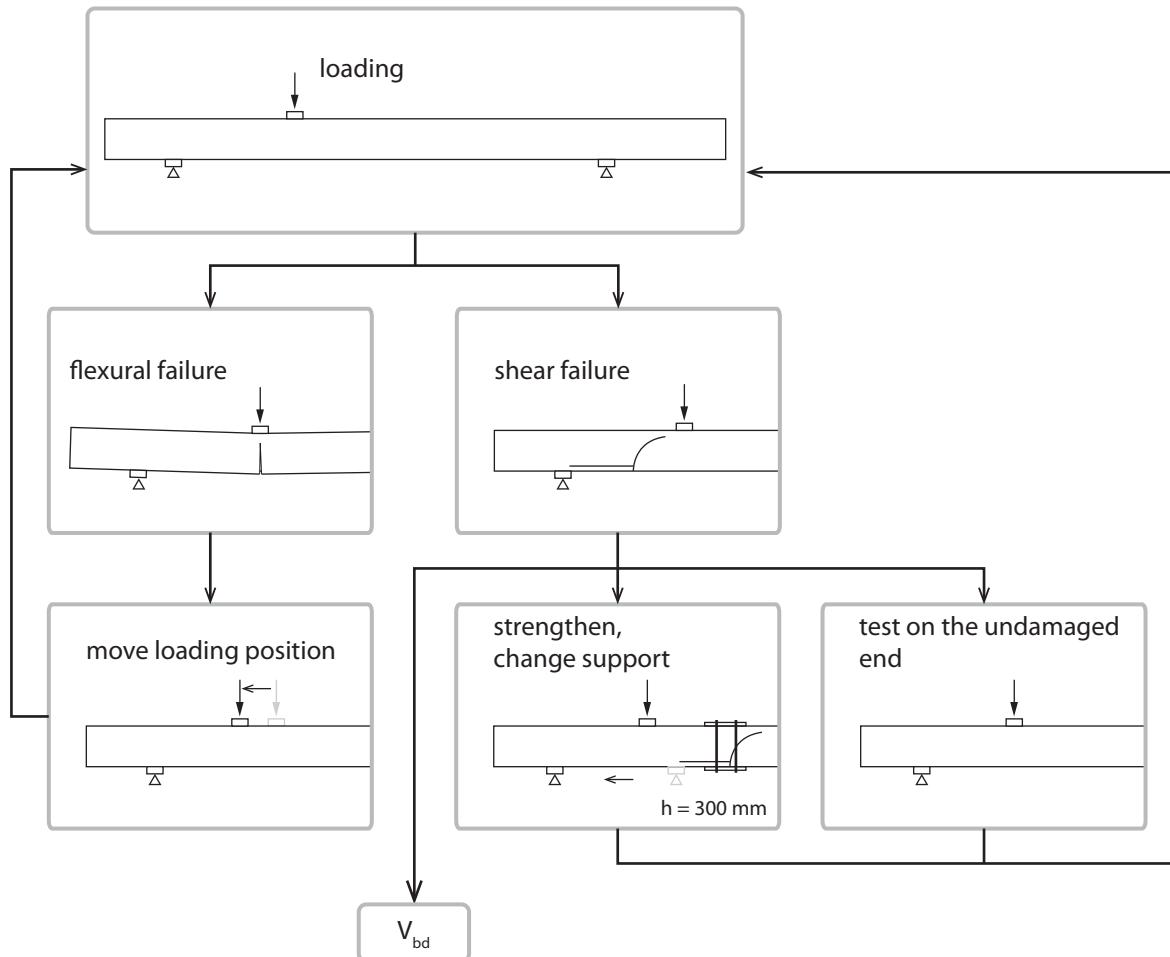
In the  $v_{min}$  study, the target of the experimental research is to find out the minimum shear force which can still cause shear failure. To serve this purpose, on the specimens with the same reinforcement ratio, more than one test were executed. The test series started from placing the point load at a location relatively further away from the support so that flexural failure is obtained. This is judged by the yielding of the longitudinal reinforcement up to certain strain. The specimen was unloaded afterwards, and the point load was moved to the next loading position which is usually closer to the support. A second test is carried out at the newer position. In case of shear failure, the loading plate will be moved further. This procedure was repeated until shear failure was obtained, which affected the integrity of the shear span of the specimen. After the first shear failure, more tests were executed with the point load located between the last flexural failure and the first shear failure. So that a refined critical position is obtained eventually. A summary of the loading procedure is given in Fig. 3.1.2.

**Fig. 3.1.2. Flow chat of the test program for a given beam configuration.**

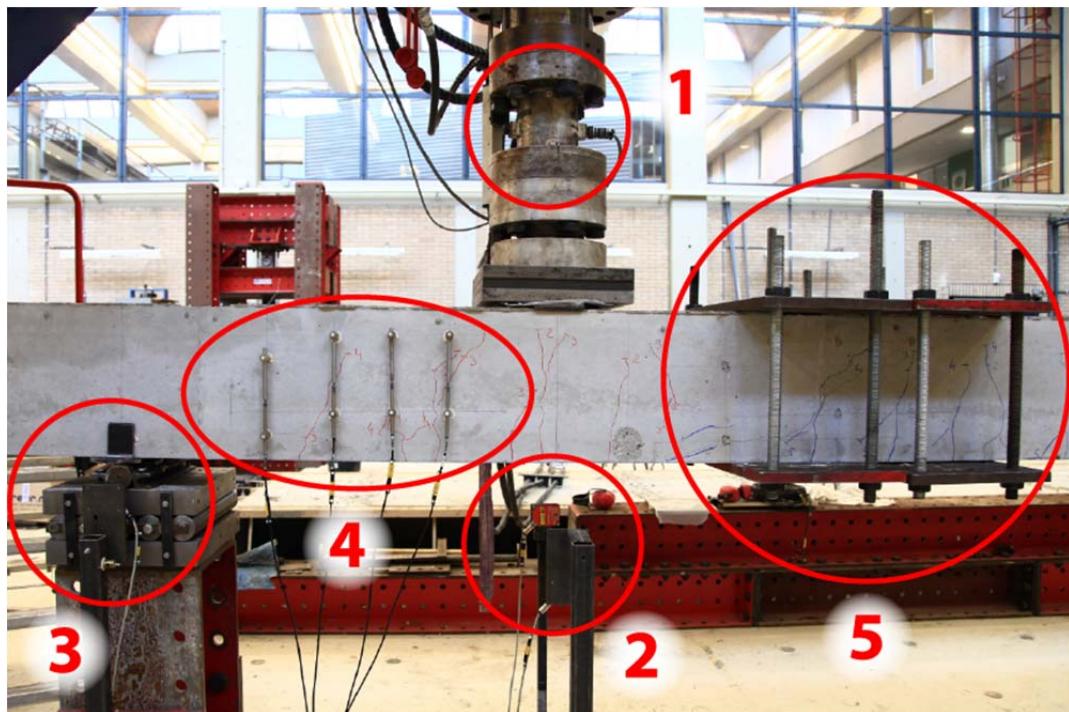
Fig. 3.2.1. Measurements (1-4) and strengthening of cracked specimen (5)

- Vertical deflection at both supports measured with lasers or LVDT's (3 in Fig. 3.2.1)
- Crack opening in vertical direction measured with LVDT's (4 in Fig. 3.2.1).

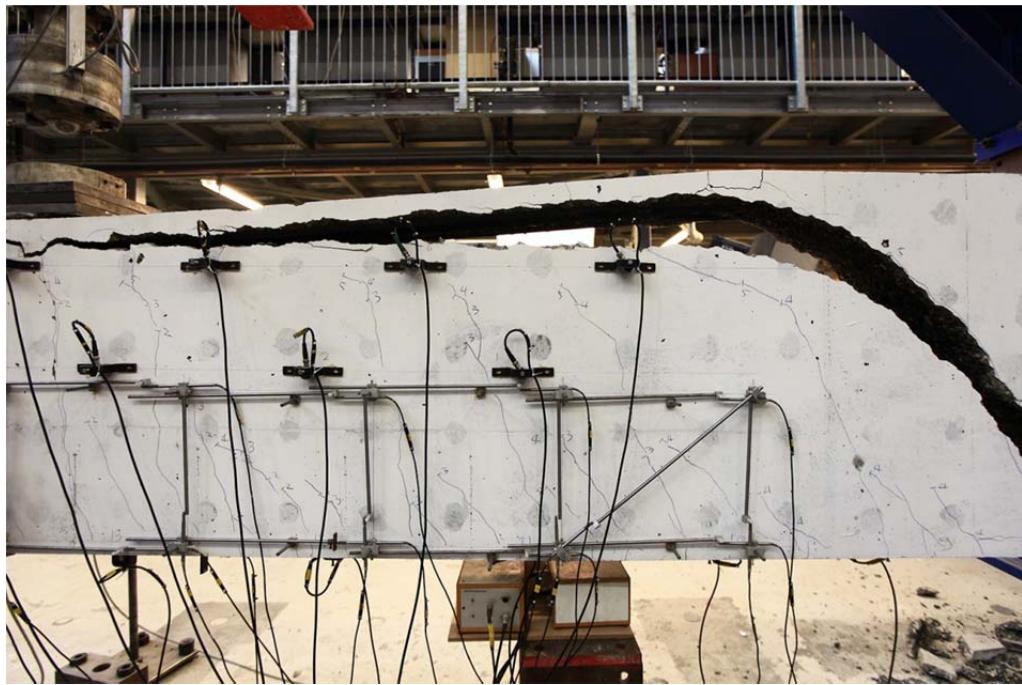
Fig. 3.2.4. Acoustic emission sensors and the LVDT grid for the deformation field.

- Crack opening in an LVDT array, which consists of longitudinal LVDT's at the level of tensile reinforcement, and at the mid-height of the specimen. Vertical LVDT's in between.(Fig. 3.2.4)

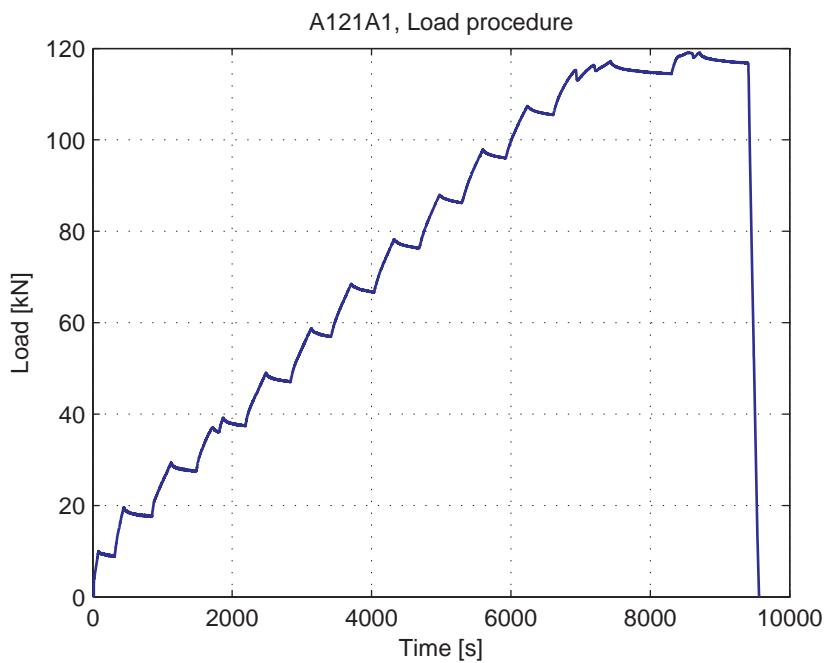
Fig. 5.1.3. Load-Time curve

Load step	Load [kN]	Miscellaneous
0	0	Connected to the AE computer
1	20	Flexural cracks are observed
2	40	Many flexural cracks. Deflection limit at 30 mm, restarted
3	50	
4	60	
5	70	
6	80	
7	90	
8	100	
9	110	
10	117.9	
11	120	Stopped at jack deflection of 70 mm

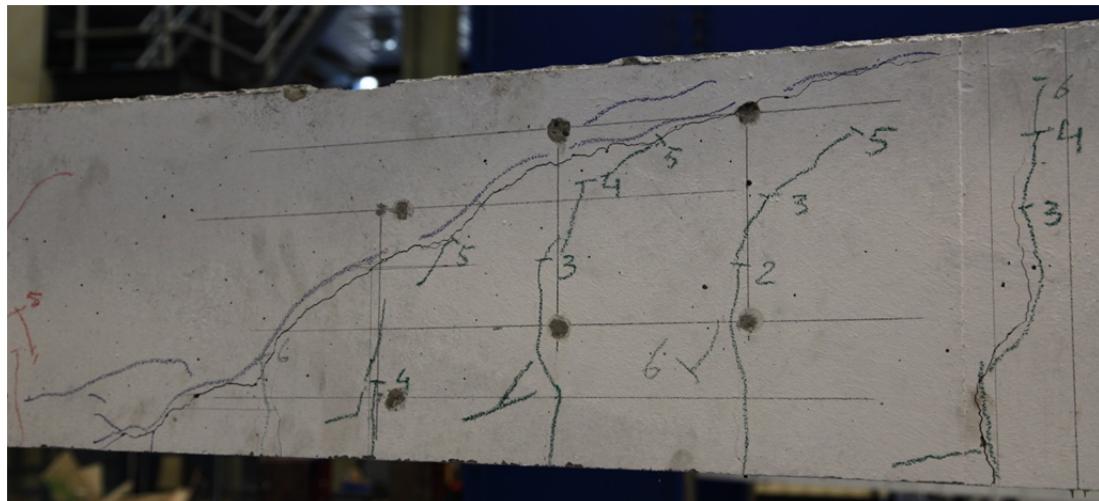
Fig. 5.27.1. Crack pattern after failure north side

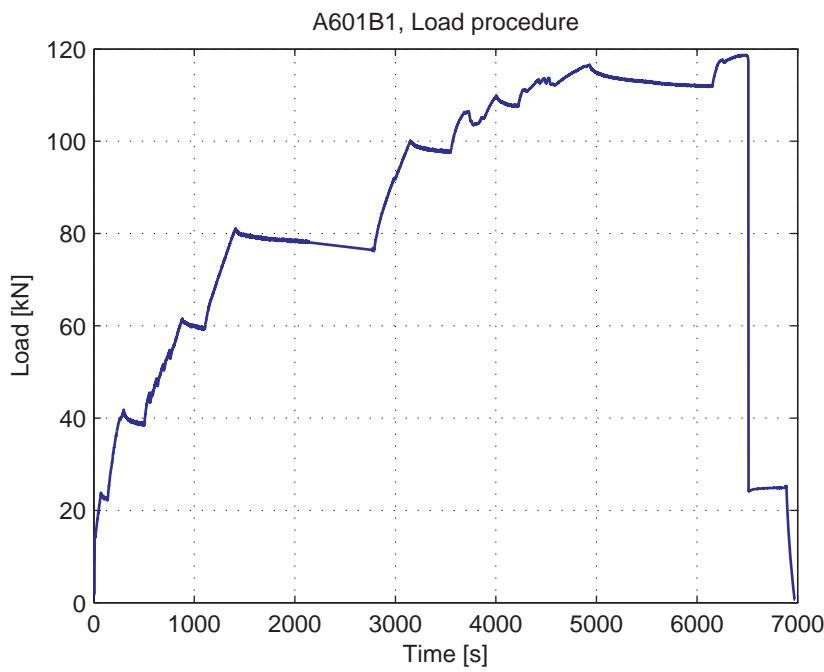
Fig. 5.33.3. Load-Time curve

Load step	Load [kN]	Miscellaneous
0	0	
1	20	
2	40	
3	60	
4	80	Placed LVDT's 1-3
5	100	Paused test to change memory card of camera
6	106.4	Crack width for shear of 6 mm, for flexural 1 mm
7	118.7	Shear failure

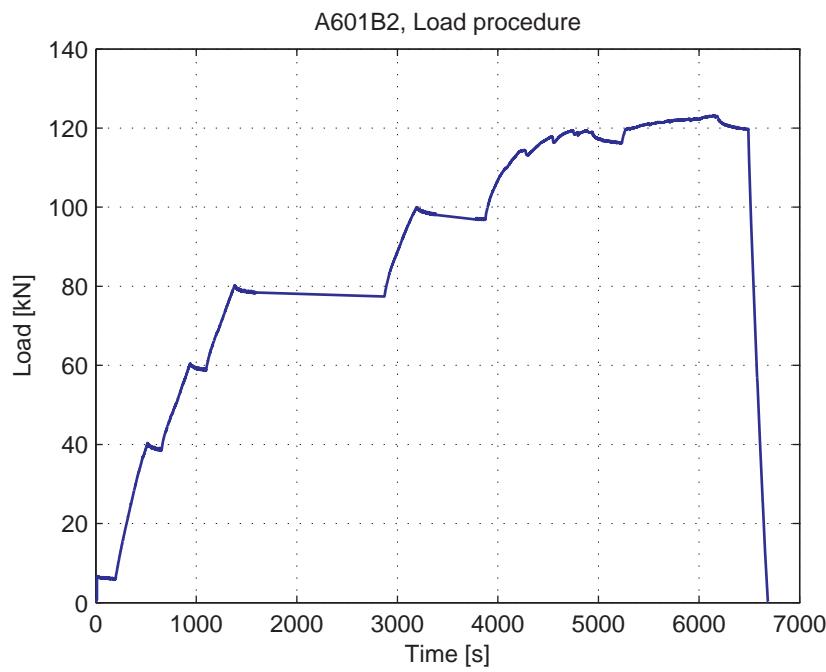
**Fig. 5.34.3. Load-Time curve**

Load step	Load [kN]	Miscellaneous
0	0	Old crack of previous test prestressed with plates and M24 bolts
1	40	
2	60	
3	80	Placed LVDT's 1-3
4	100	Placed LVDT 5
5	114.3	Shear cracks 1.5 mm, flexural cracks 2 mm. Stopped after jack displacement of 40 mm. No shear failure

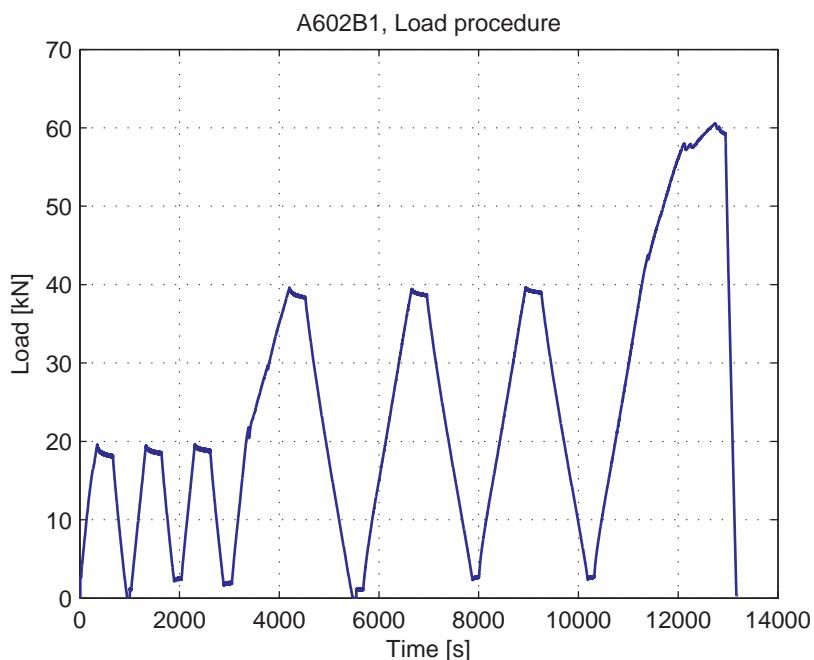
**Fig. 5.38.4. Load-Time curve**

Load step	Load [kN]	Miscellaneous
0	0	All LVDT's replaced by new LVDT's. Lasers on supports replaced by LVDT1 and LVDT2. Laser 1 and 2 are under the load. LVDT3 measures over 1000 mm under the load. For this test load cycles are performed for Acoustic emission measurements.
1	20	
2	0	
3	20	
4	2	
5	20	
6	2	
7	40	
8	2	
9	40	
10	2	
11	40	
12	2	
13	60.5	LVDT3 out of range. Stopped after jack displacement of 35 mm.

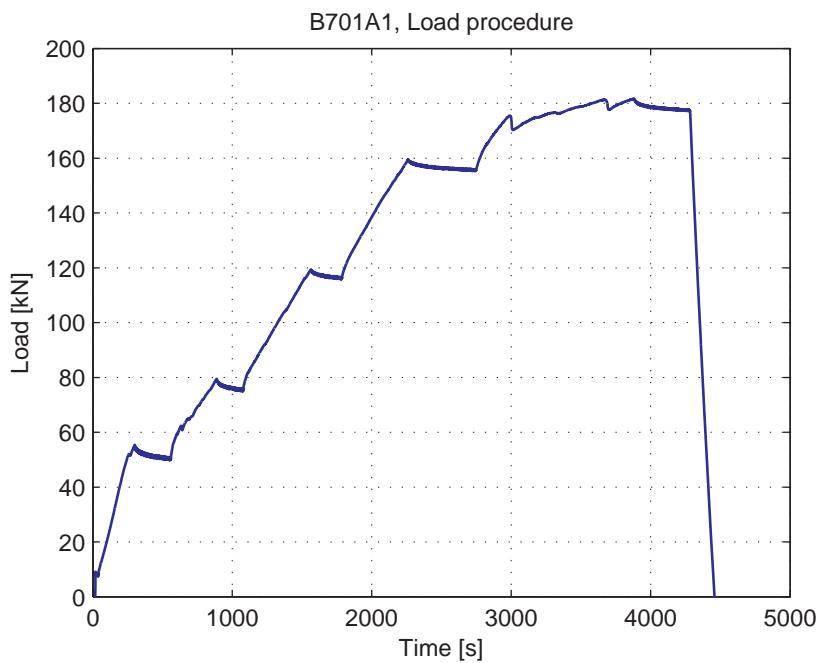
Fig. 5.40.3. Load-Time curve

Load step	Load [kN]	Miscellaneous
0	0	First test at $h = 500$ mm beam
1	55	First cracks observed
2	80	
3	120	
4	160	
5	181.7	Yielding at 175 kN, stopped after jack displacement of 35 mm.

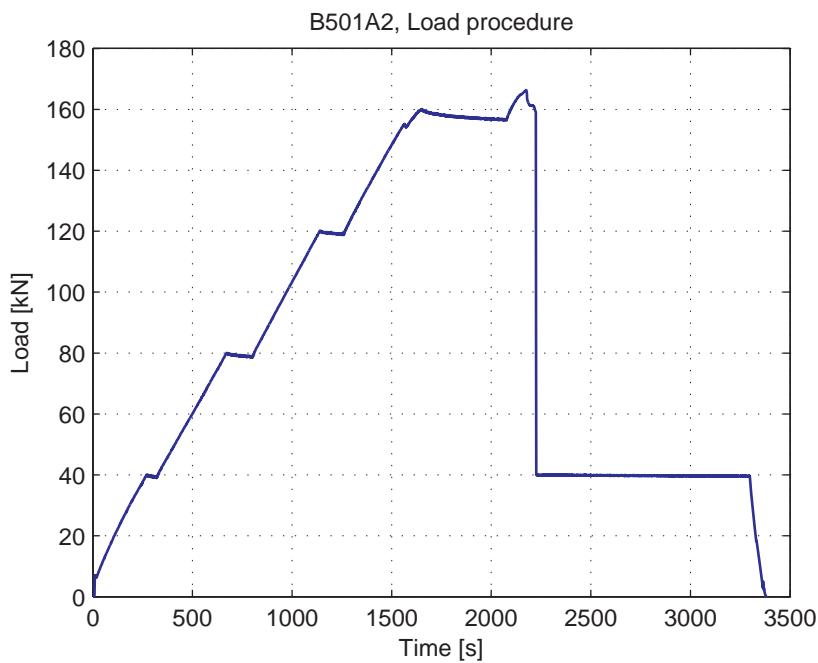
Fig. 5.48.3. Load-Time curve

Load step	Load [kN]	Miscellaneous
0	0	
1	40	
2	80	
3	120	
4	166.4	Shear failure

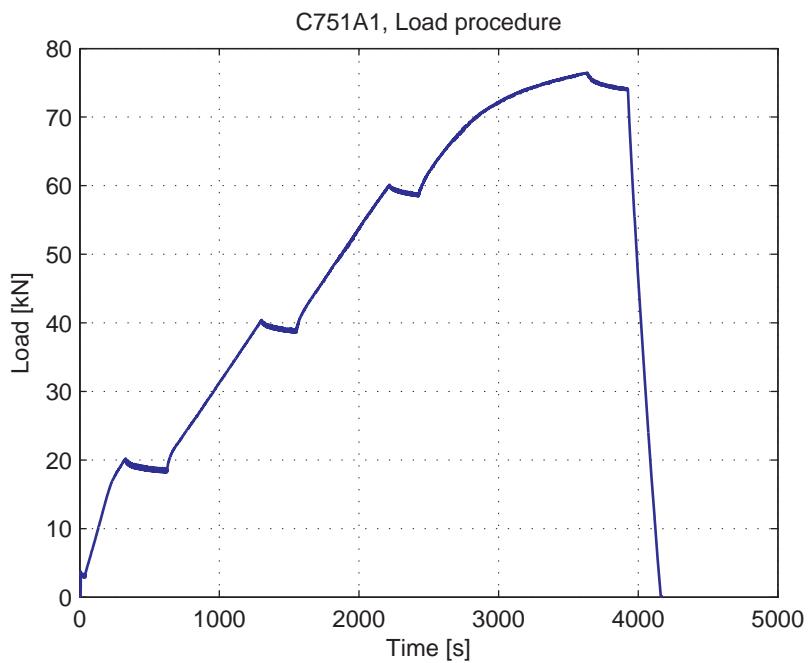
**Fig. 5.58.3. Load-Time curve**

Load step	Load [kN]	Miscellaneous
0	0	LVDT1 broken, replaced by LVDT 16, channel is the same
1	20	
2	40	
3	60	
4	76.5	Stopped after jack displacement of 35 mm

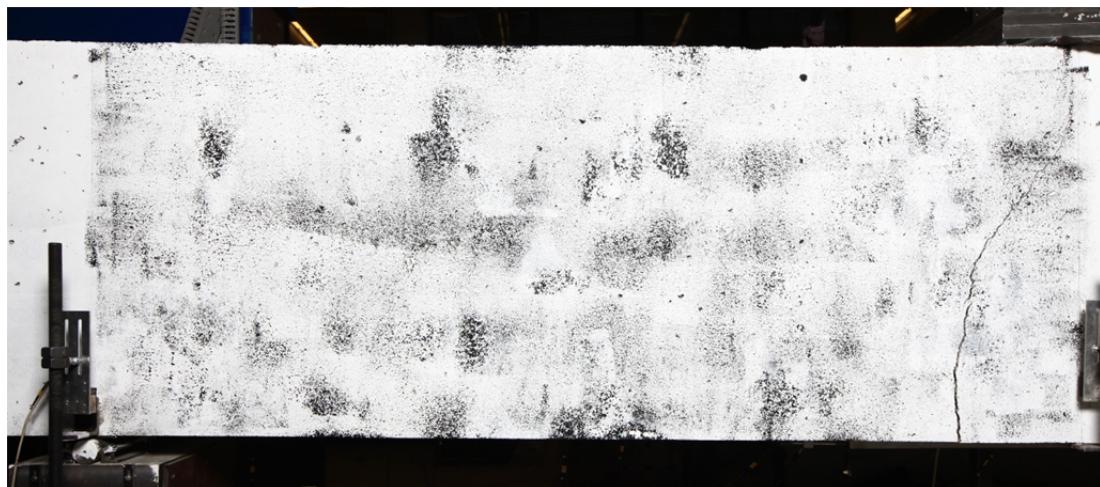
Fig. 5.83.1. Crack pattern after failure north side

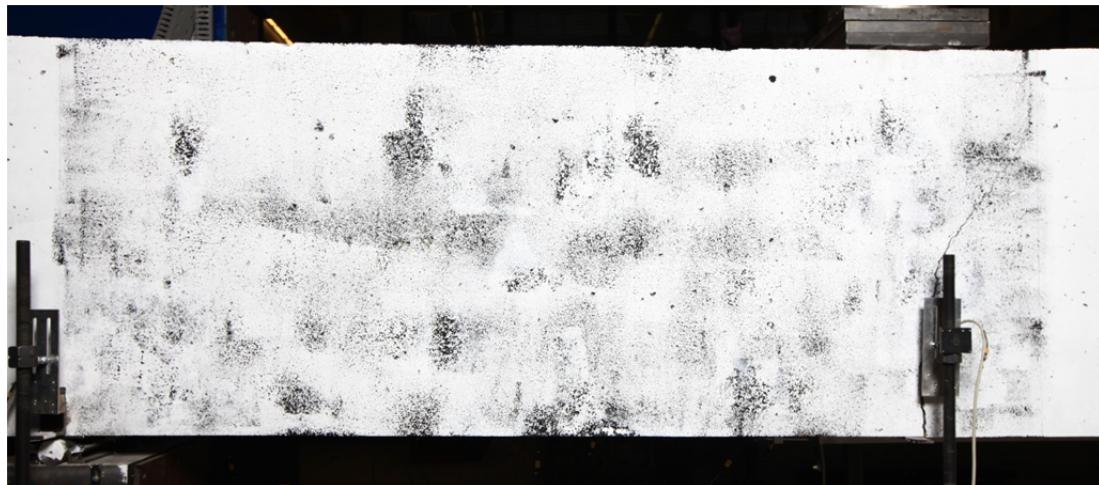
Fig. 5.84.1. Crack pattern after failure north side

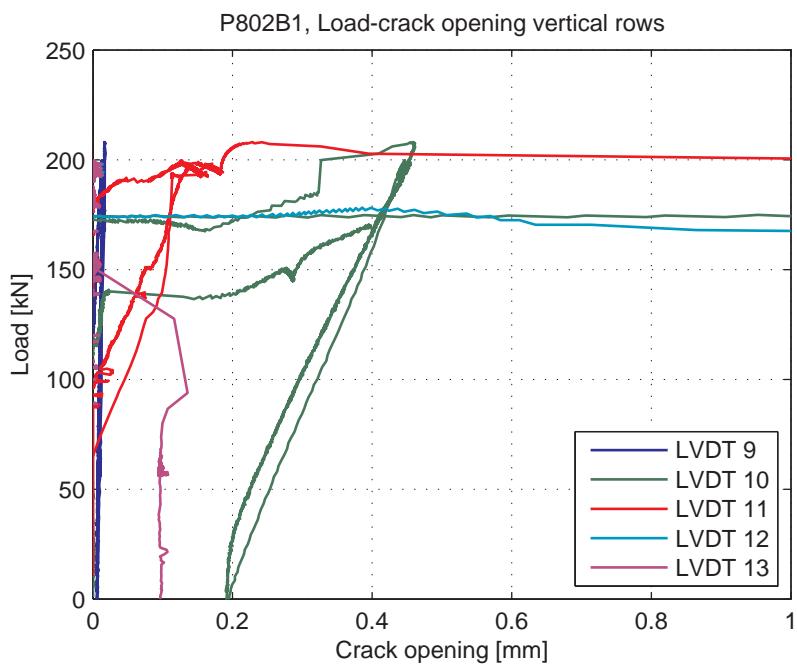
Fig. 5.88.7. Load-Crack opening for LVDT's 9-13 (vertical LVDT's)

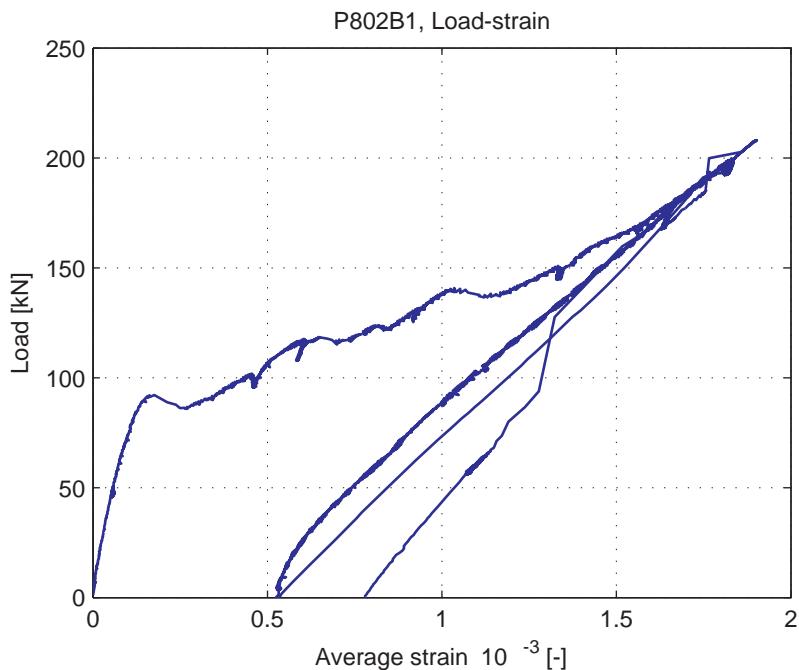
Fig. 5.88.11. Average strain over 1m length, measured at bottom of specimen (LVDT 14)

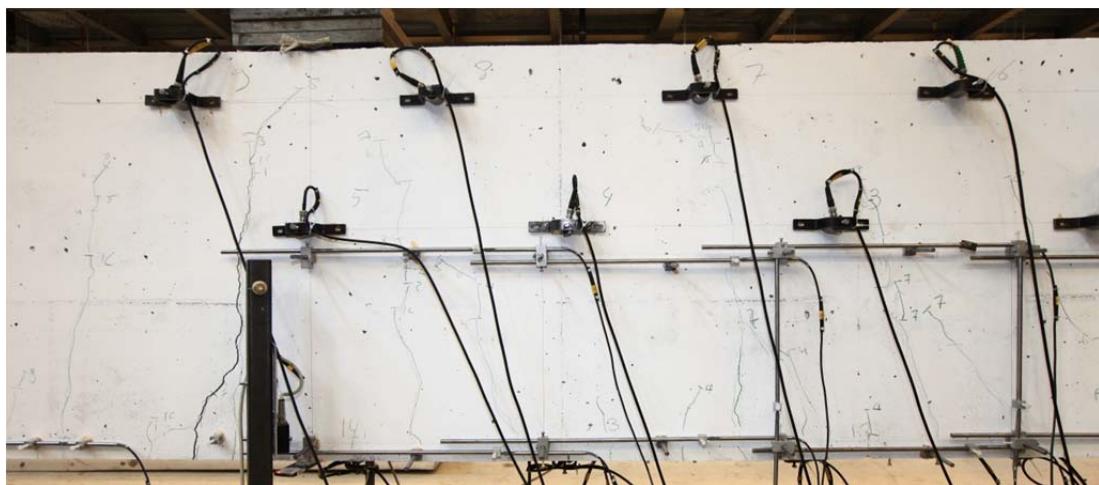
Fig. 5.92.2. Crack pattern after failure west side

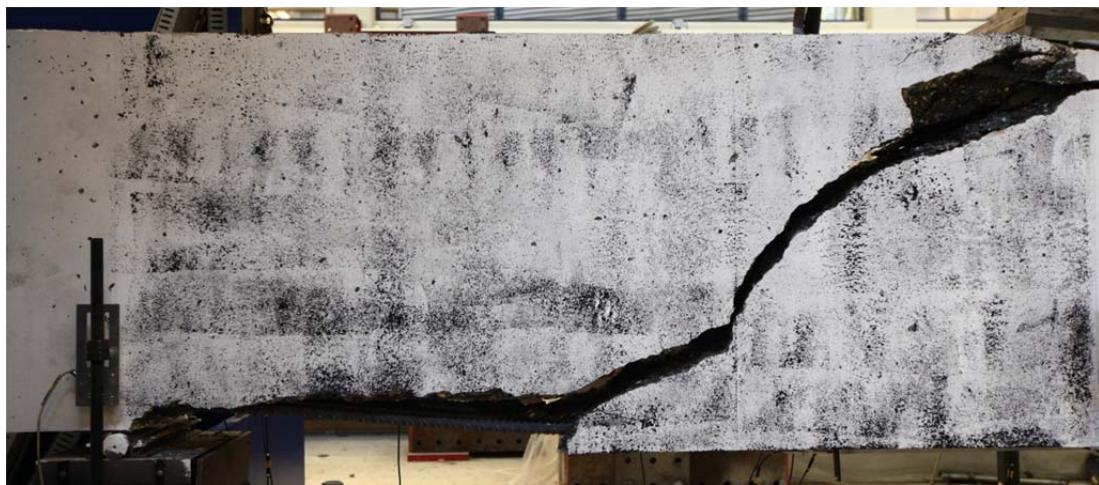
Fig. 5.100.1. Crack pattern after failure north side

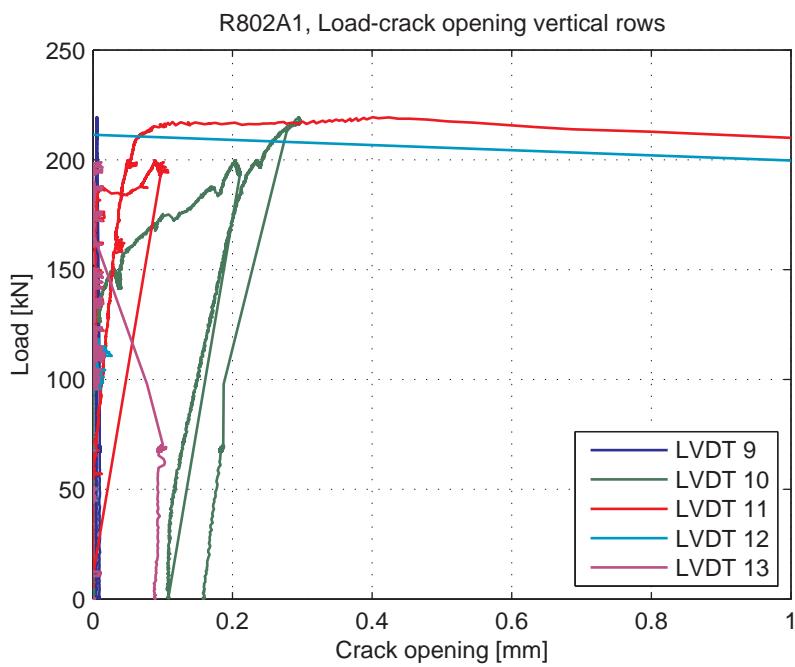
Fig. 5.102.7. Load-Crack opening for LVDT's 9-13 (vertical LVDT's)

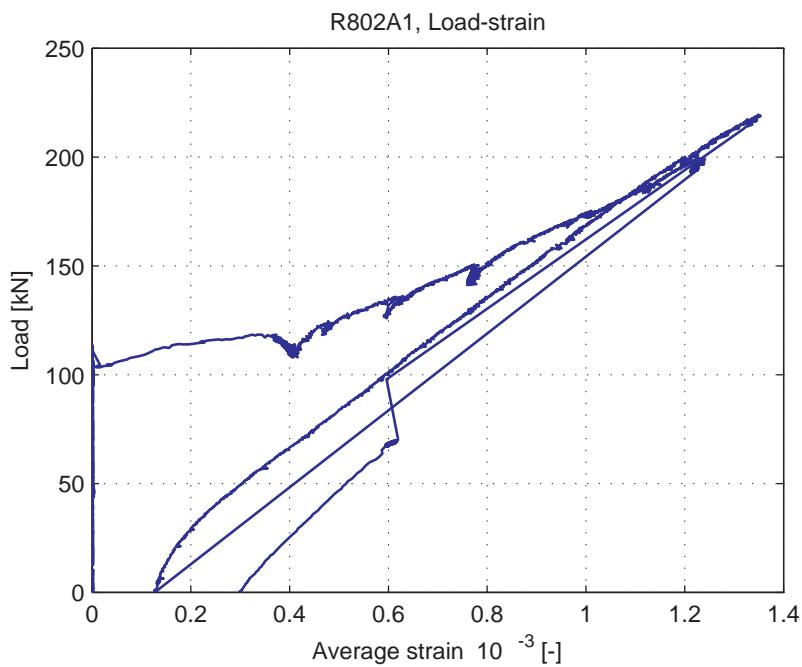
Fig. 5.102.10. Average strain over 1m length, measured at bottom of specimen (LVDT 14)

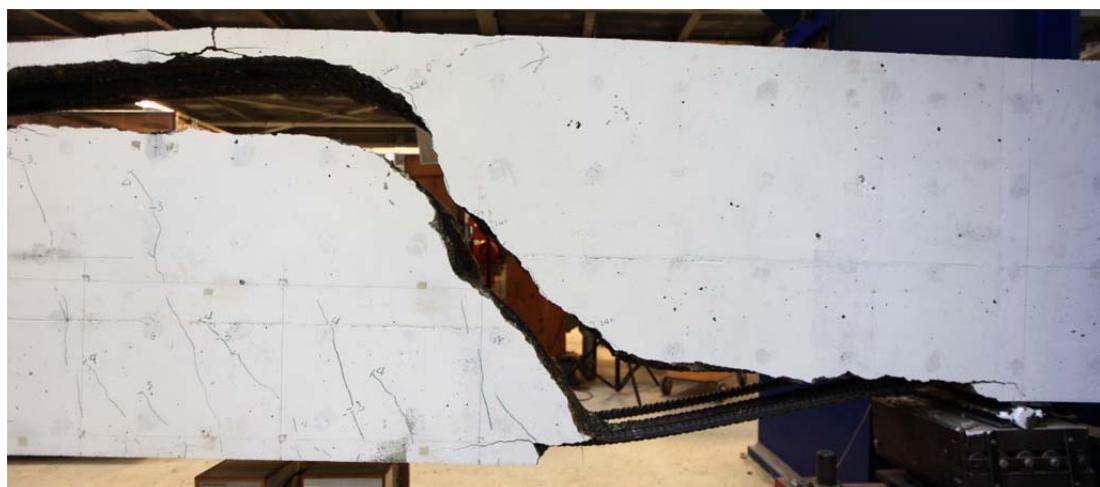
Fig. 5.107.2. Crack pattern after failure and part of LVDT layout at west side of beam
