Proceedings of SWBSS 2021

Fifth International Conference on Salt Weathering of Buildings and Stone Sculptures

22-24 September 2021
Delft, the Netherlands

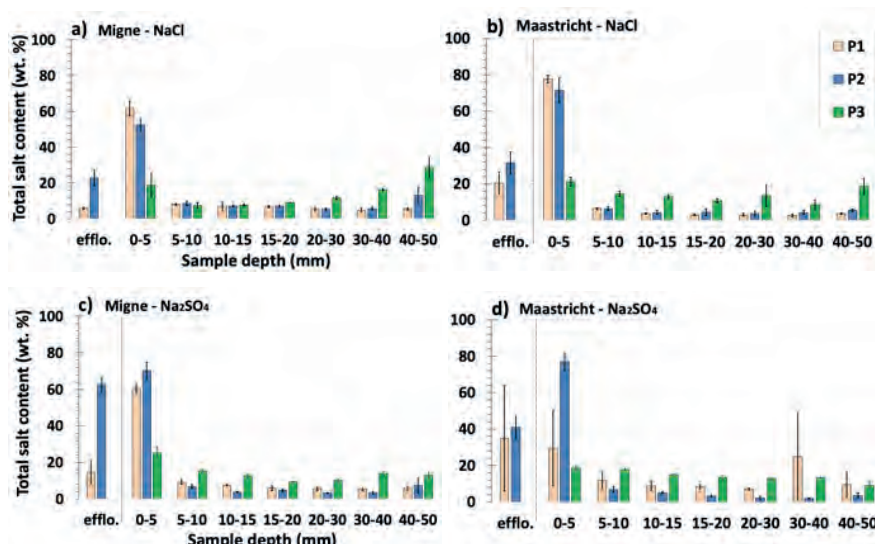
Figure 5: Salt content in the specimens' depth determined with IC: a) Migné contaminated with NaCl; b) Maastricht contaminated with NaCl; c) Migné contaminated with Na₂SO₄; d) Maastricht contaminated with Na₂SO₄. Note: *efflo.* corresponds to the weight of salt efflorescence collected in respect to the amount of salt introduced in the specimens.

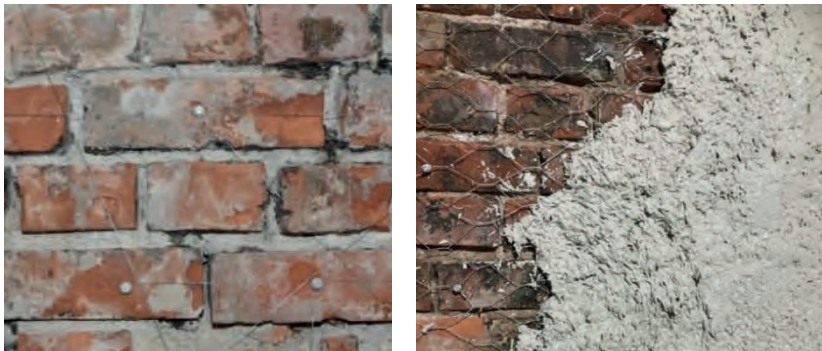
Figure 3: Stainless-steel wire (left) and chicken wire (right) acted as a reinforcing and plaster-bearing system. The hemp-lime had been applied here in a thickness of 10-30 mm directly against the brick wall.
