PROCEEDINGS OF SWBSS 2021

Fifth International Conference on
**SALT WEATHERING OF BUILDINGS
AND STONE SCULPTURES**

22-24 September 2021
Delft, the Netherlands

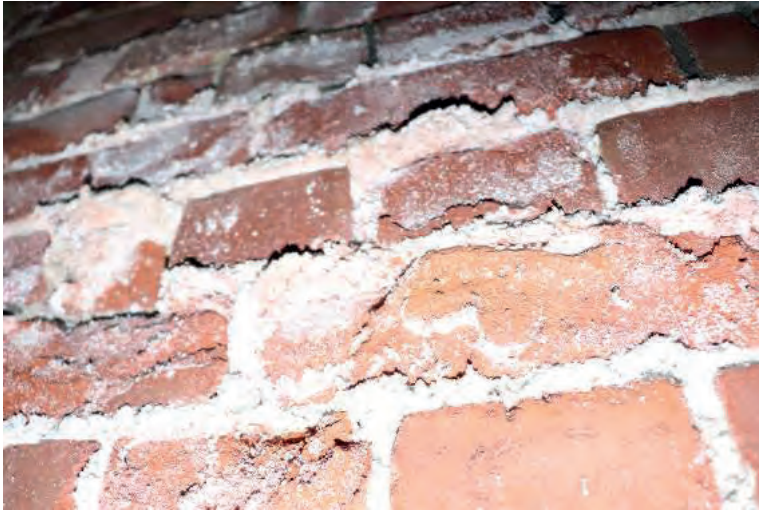
Figure 2: Brick surfaces and salt at the south side of the brick chimney in October 2019

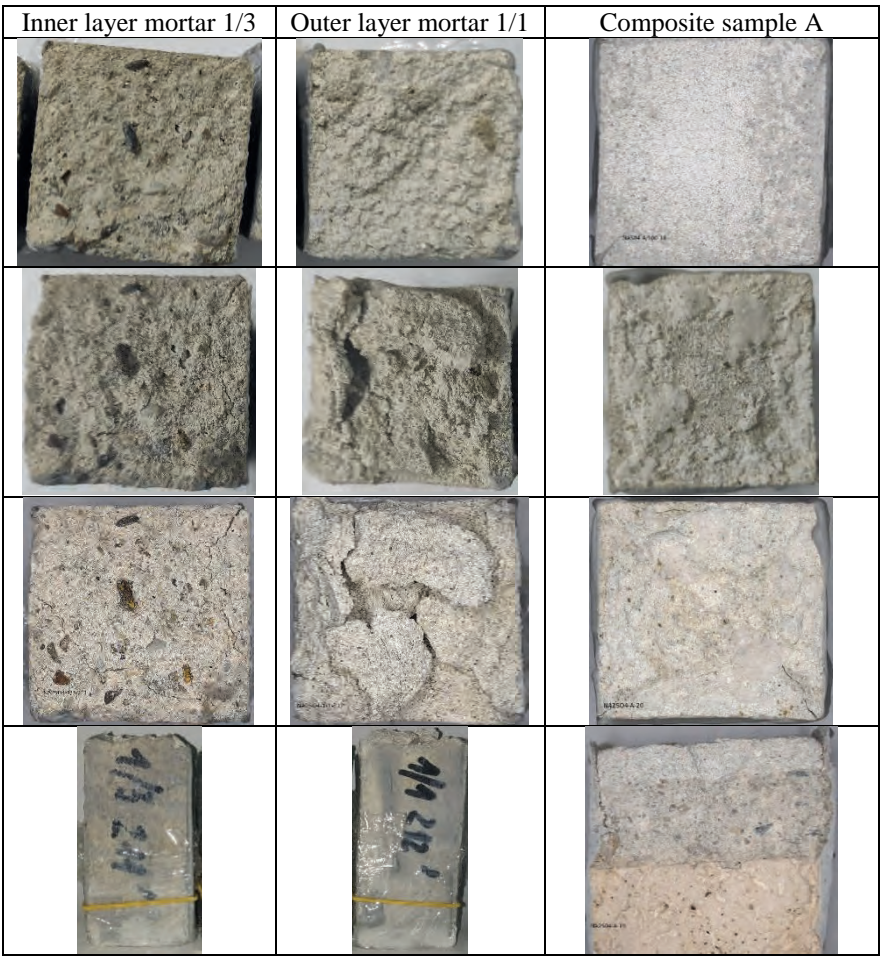
Figure 5: Composite and standardized specimens with rendering mortars 1/1 and 1/3 after 1st, 3rd and 5th cycle, treated with Na₂SO₄ solution.

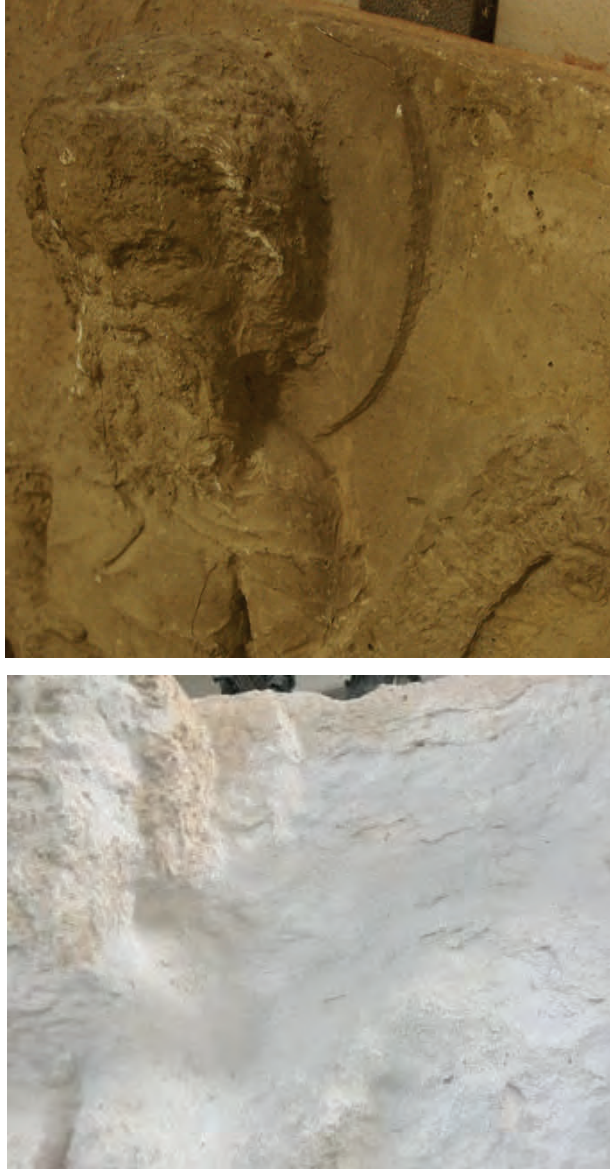
Figure 1: Comparison of details of progressive deterioration: detail from the replica from the 1950s (above) and the present state on the original (below).

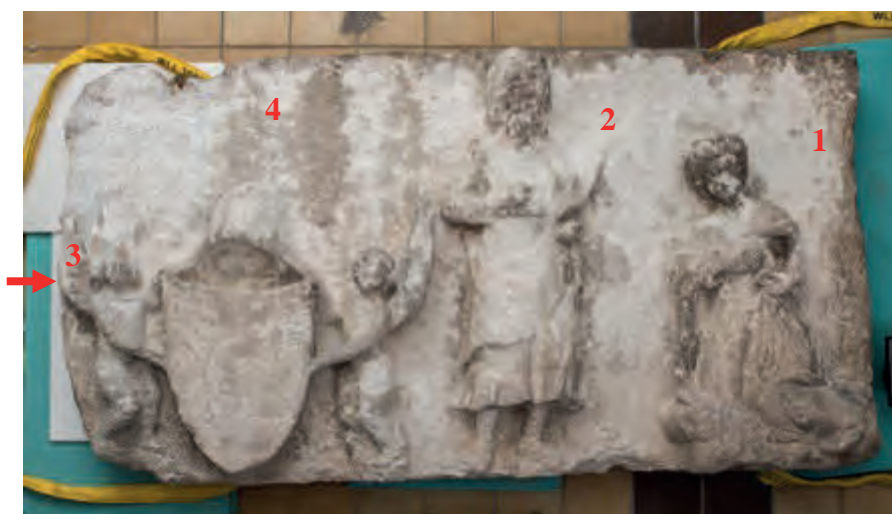
Figure 2: Photograph of stone relief with sample points.

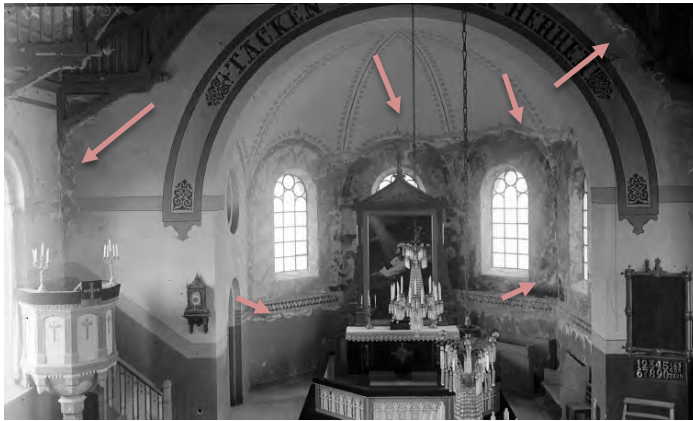
Figure 1: Extensive internal salt deterioration in 1920 in Smögen Church, designed by Adrian C. Peterson, built in 1905. The arrows indicate extensive salt damage. (Photographer Hanna Eggertz-Hegart 1920, kmb.raa.se, 2021-03-16).

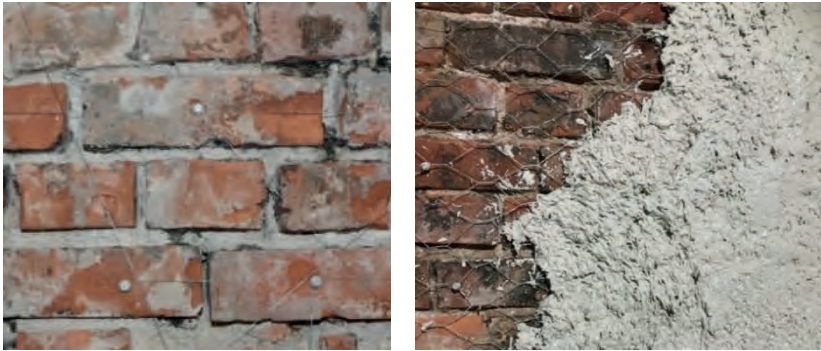
Figure 3: Stainless-steel wire (left) and chicken wire (right) acted as a reinforcing and plaster-bearing system. The hemp-lime had been applied here in a thickness of 10-30 mm directly against the brick wall.

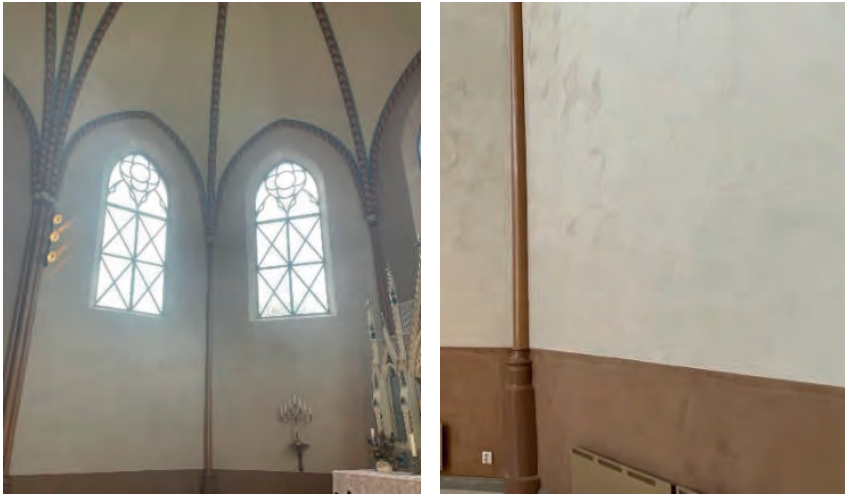
Figure 5: The two walls that have been plastered with hemp-lime in the choir. After two years there are no signs at all of salts on the surface. Only the normal liveliness of the lime wash gives the surface its expression.

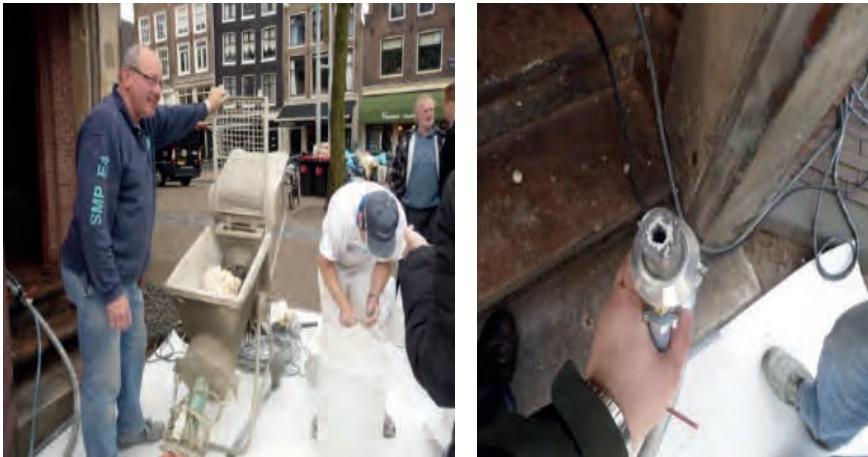
Figure 2: Using a stucco sprayer.

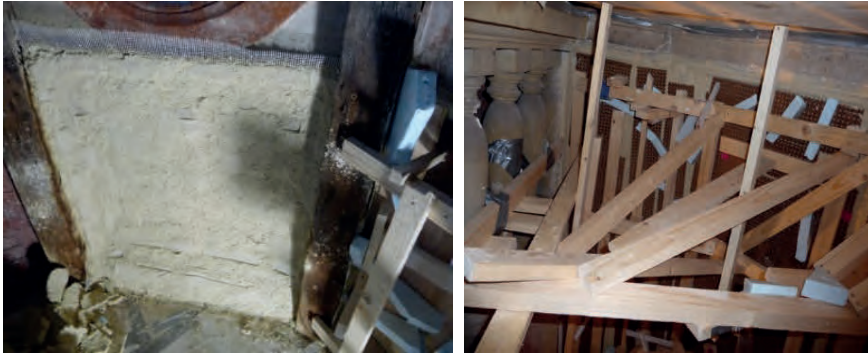
Figure 4: Test with (fibreglass) stucco mesh (left) and clamping of the poultice (right).

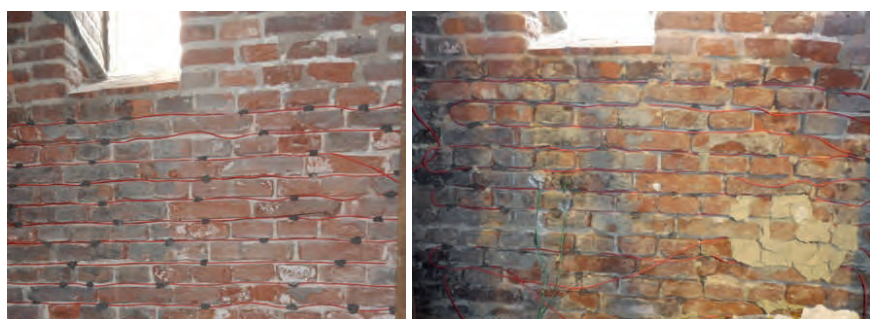
Figure 8: Location C (heated) before desalination (left) and after desalination (right): no further damage due to desalination is observed.

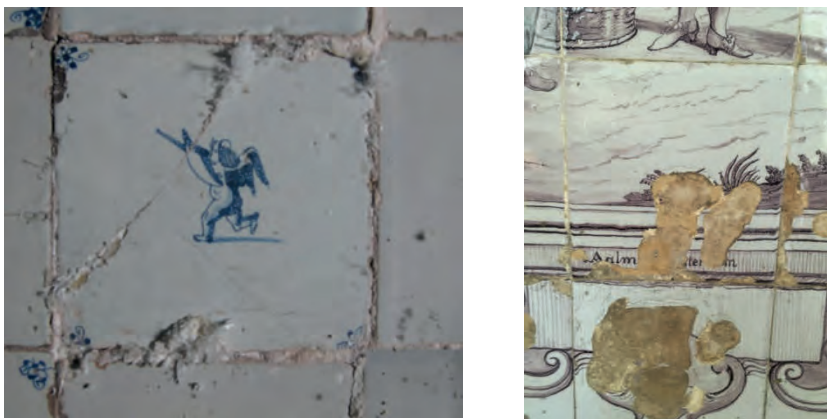
Figure 1: Salt efflorescence on the sides of a tile and along a breakage (left); blistering of the glaze (right).

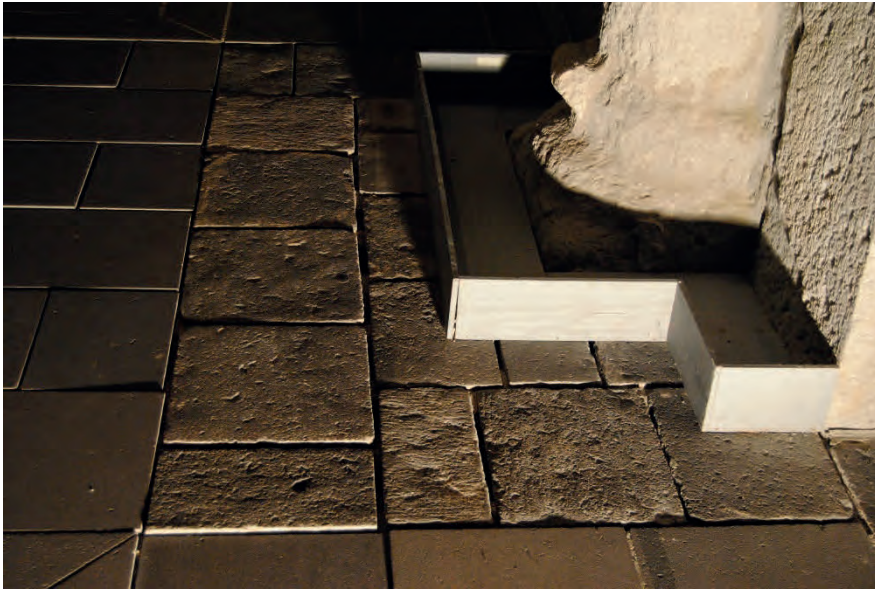
Figure 3: Floor plates with open joints and boxes made of wood to sample the fell off for the monitoring.

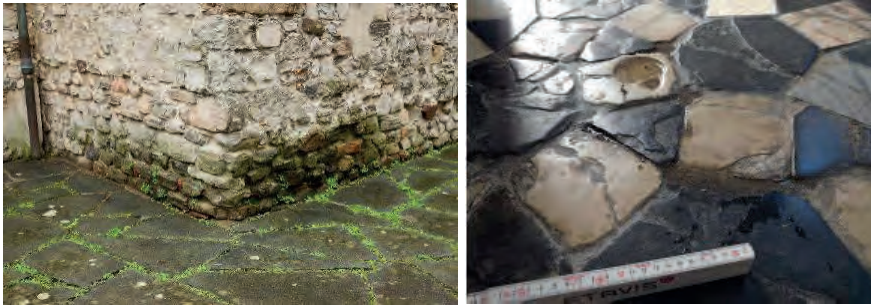
Figure 2: a) Phenomenon of capillary rising damp along the perimeter and biological colonization; b) Puddles of rainwater formed following water entry from the main door during heavy rains.
