**Proceedings of SWBSS 2021**

**Fifth International Conference on Salt Weathering of Buildings and Stone Sculptures**

Fifth International Conference on  
**SALT WEATHERING OF BUILDINGS  
AND STONE SCULPTURES**

22-24 September 2021  
Delft, the Netherlands

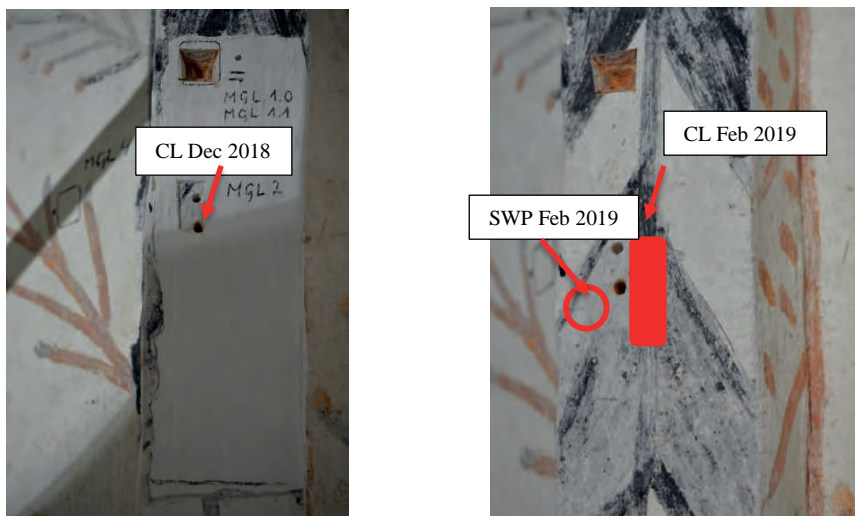
Figure 1: location of the collection of the samples in Dec, 2018 (left) and February 2019 (right).

In Dec 2018, a sample of the covering layers was cut out (CL Dec 2018) and powder samples (8 mm diameter drill bit ) were taken starting from the painted layer, through the plaster until 10 mm depth (see figure 1 left). Six additional samples were collected at different depths into the brick of the rib (10-20 mm; 20-30 mm etc. until 70 mm depth).

In February 2019 an additional area was uncovered, and samples were collected next to CL Dec 2018. A scrape with an area of 1 cm<sup>2</sup> (red circle in the picture) of the wall painting was made from the area uncovered in Dec 2018 and named SWP Feb 2019 (see Figure 1 right)

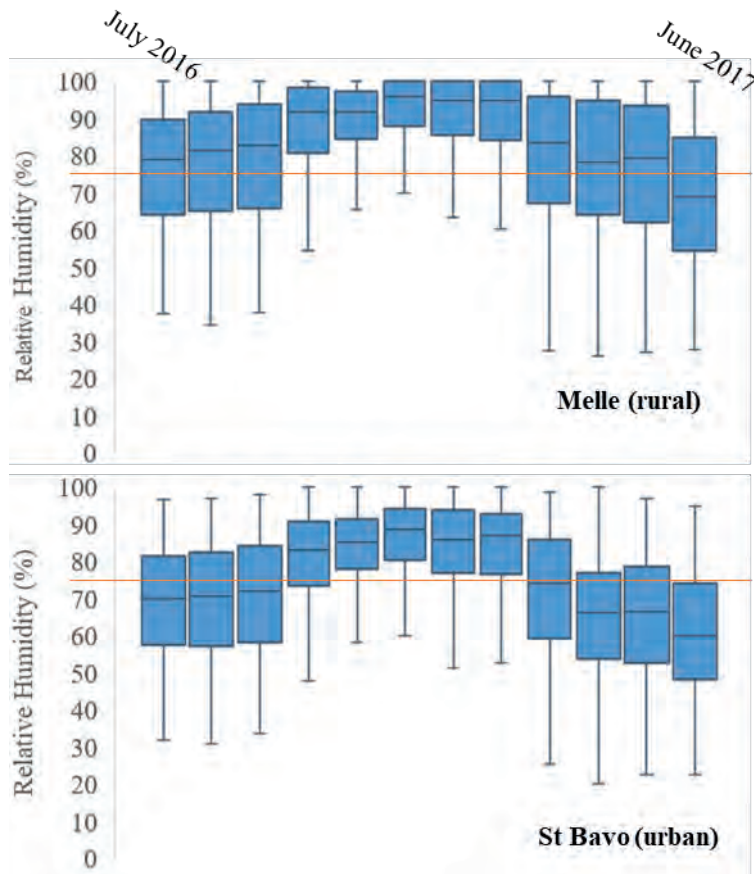
Figure 2: Boxplot showing the RH variations in Melle (rural) and St Bavo school (urban) for 12 consecutive months in the period July 2016 (left) to June 2017 (right). The orange line depicts the 75.5% RH threshold. It can be observed that the RH fluctuates more around the threshold in spring and summer, implying a higher NaCl single salt environmental risk during this period, compared to winter and spring.

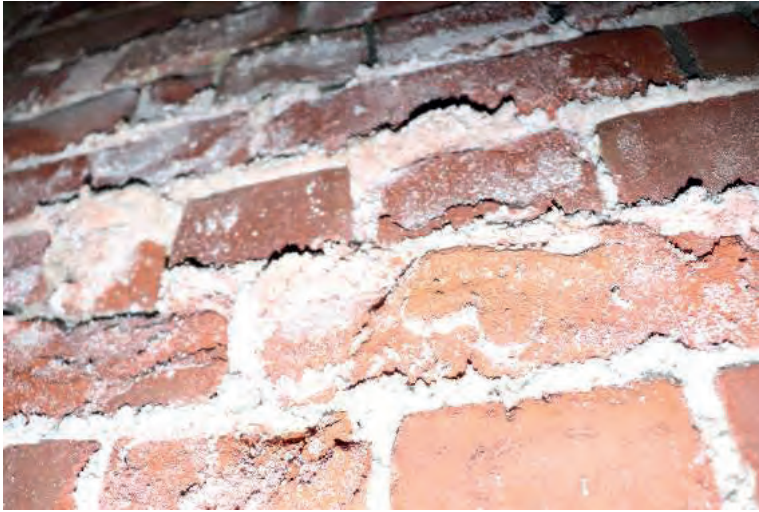
Figure 2: Brick surfaces and salt at the south side of the brick chimney in October 2019

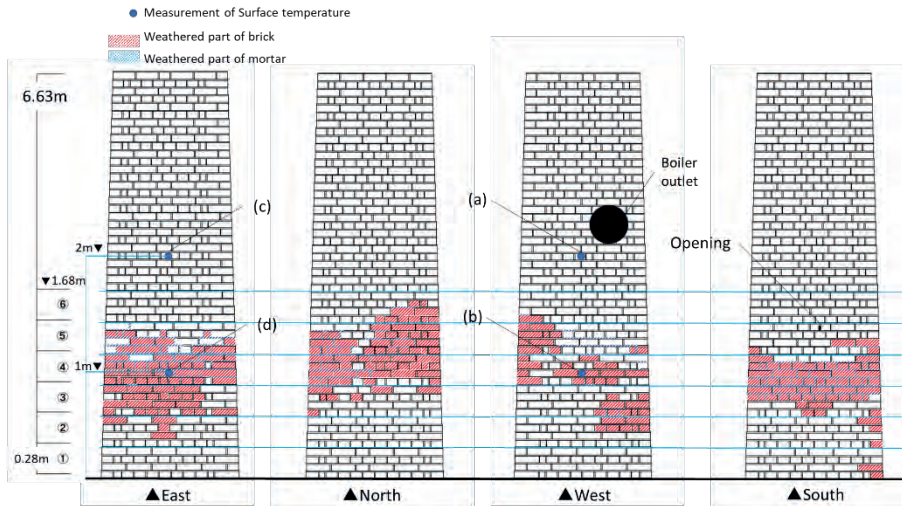
Figure 3: Map of the decay of the masonry of the chimney (east, north, west and south sides)

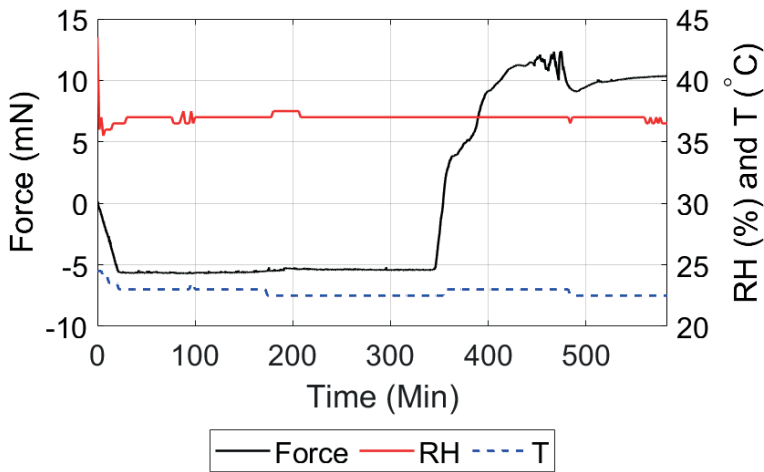
Figure 2: Force measurement from 5.54 m NaCl droplet.

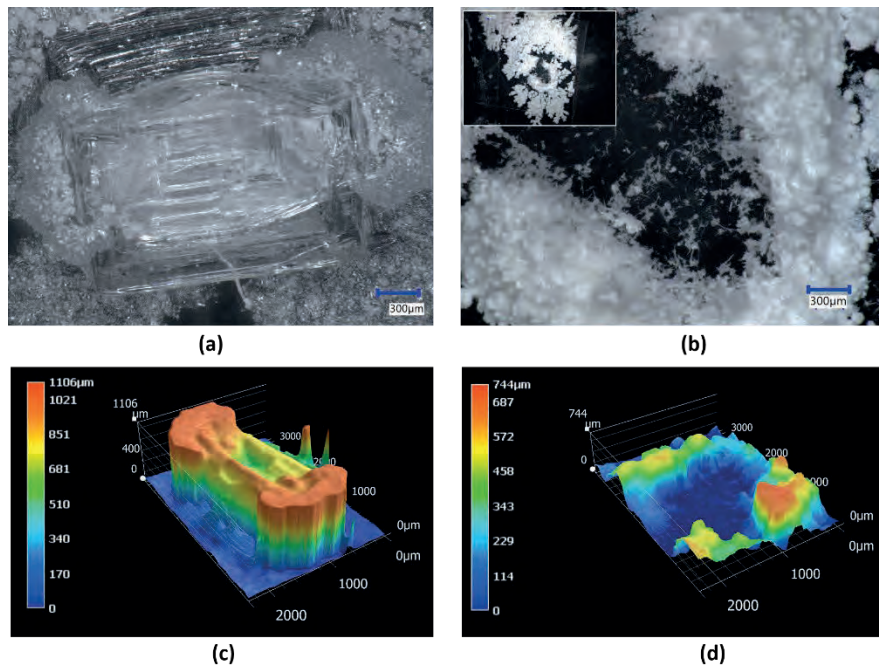
Figure 4: (a) Micrograph of  $3\ \text{m NaCl}$  (b) Micrograph of  $3\ \text{m NaCl} + 0.01\ \text{m In.}$  Inset: a low magnification micrograph to show the degree of spread (c) 3D reconstruction of  $3\ \text{m NaCl}$  (d) 3D reconstruction of  $3\ \text{m NaCl} + 0.01\ \text{m In.}$

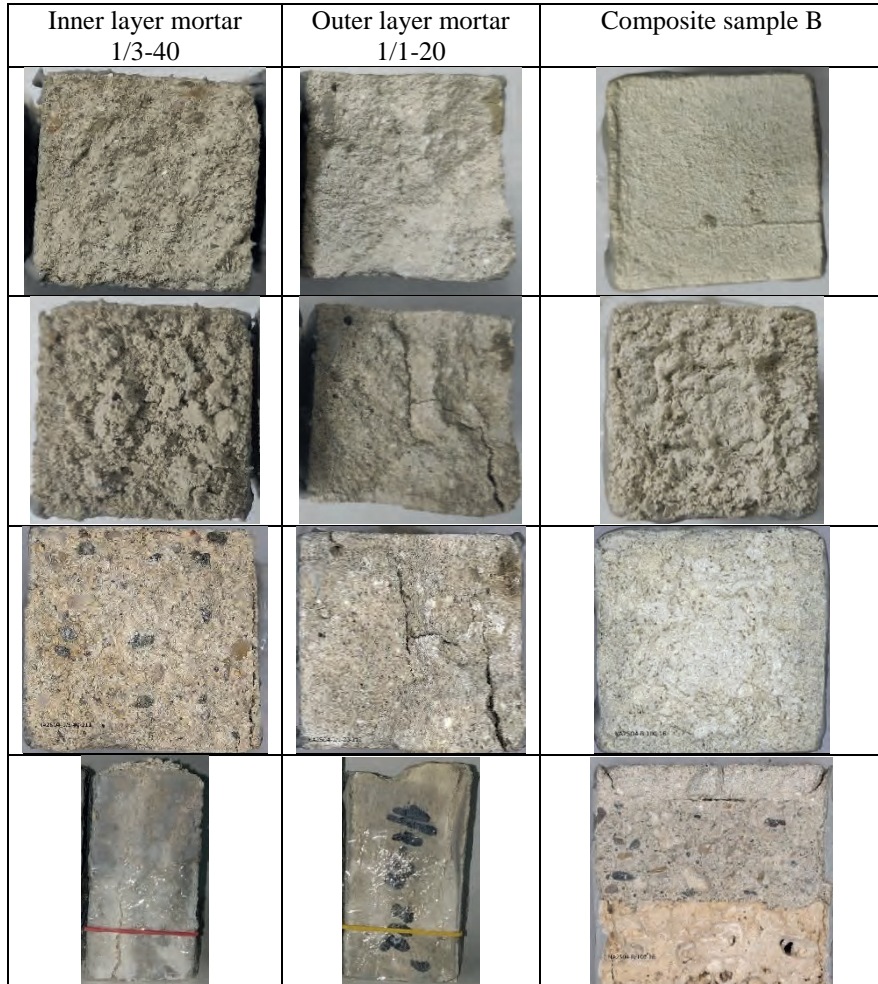
Figure 6: Composite and standardized specimens with rendering mortars 1/1-20 and 1/3-40 after 1<sup>st</sup>, 3<sup>rd</sup> and 5<sup>th</sup> cycle, treated with Na<sub>2</sub>SO<sub>4</sub> solution.

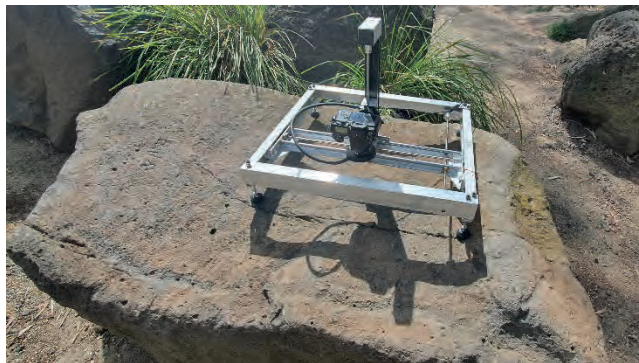
Figure 2: The microscope on camera positioned above the surface in the motorized frame. Levelling feet maintain a minimal scanning height range across the plane.

To provide a steady acquisition at regular depth intervals and to ensure the traverse across the surface is precisely regulated, a purpose made scanning frame has been constructed. Unlike many other similar scanning frames, the requirements here are that it must be able to be transported by plane, be carried to site by foot and be applied to irregular surfaces of all inclinations from horizontal to vertical, in which case additional support is required. It must also be flexible in how it remains steady on the rock surface, both to meet the custodians' concerns that the surface is not impacted or contaminated and in situations where, for example, a vertical surface may reside tightly up against an overhang that negates support from above.

The overall dimensions of the frame have been set at 600 mm, providing scan area of 340 x 440 mm. Hence the 100 x 100 mm nominal scan area can be expanded in situations where morphology demands a larger study surface.

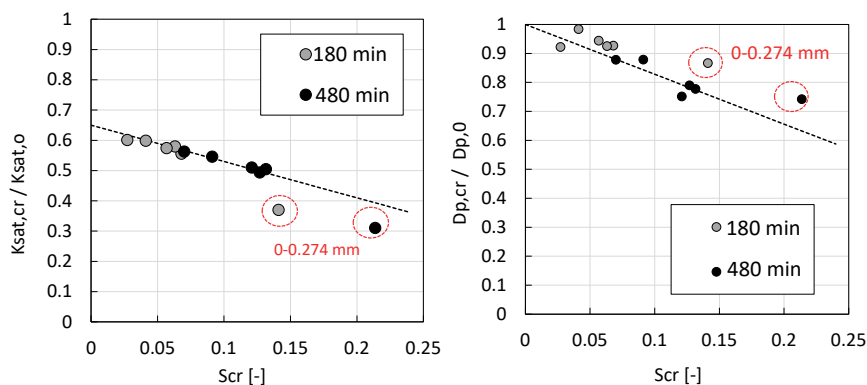
Figure 6: Decrease of saturated hydraulic conductivity and vapour diffusivity due to salt precipitation.

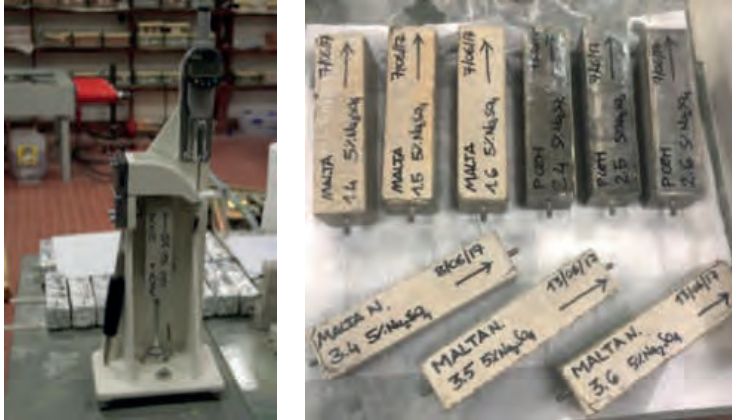
Figure 1: Specimens during the measurement phase (left); specimens during the last curing period (right).

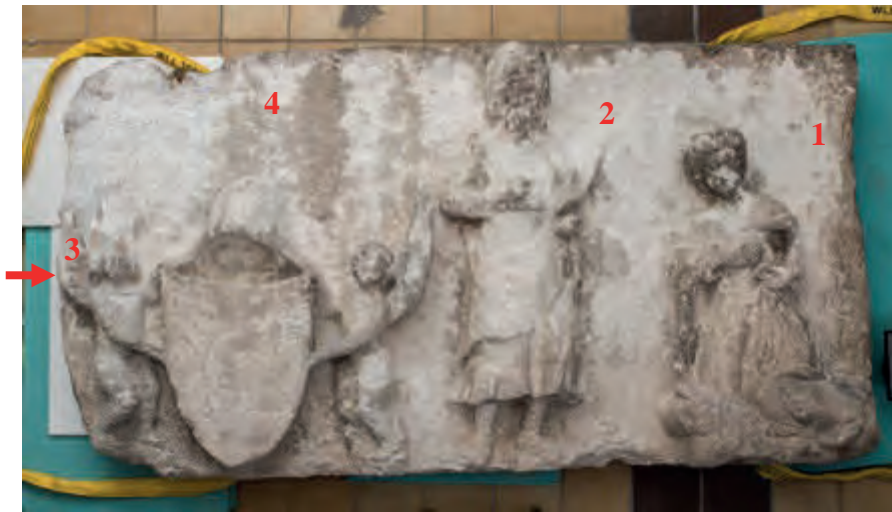
Figure 2: Photograph of stone relief with sample points.

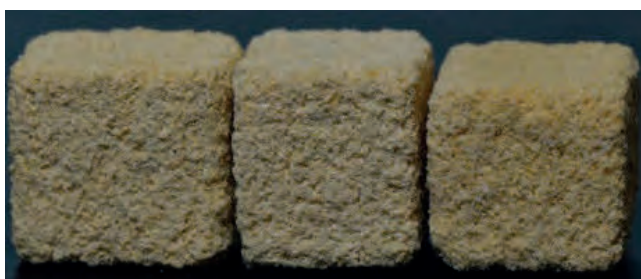
Figure 5: Untreated Maastricht limestone (left), Maastricht limestone treated with the solution of calcium citrate (middle), Maastricht limestone treated with calcium citrate and MTEOS (right).

One of the most important criteria that treatments for stone must meet is not to change their appearance or color; the treatment must be as much as possible imperceptible. Figure 5 reveals that the treatment with calcium citrate and MTEOS leaves the stones unchanged.

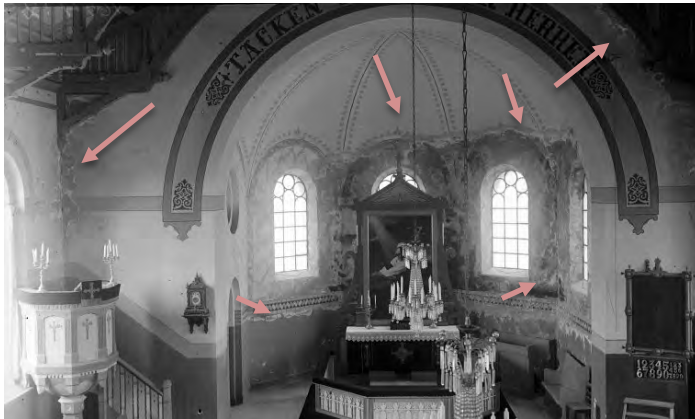
Figure 1: Extensive internal salt deterioration in 1920 in Smögen Church, designed by Adrian C. Peterson, built in 1905. The arrows indicate extensive salt damage. (Photographer Hanna Eggertz-Hegart 1920, kmb.raa.se, 2021-03-16).

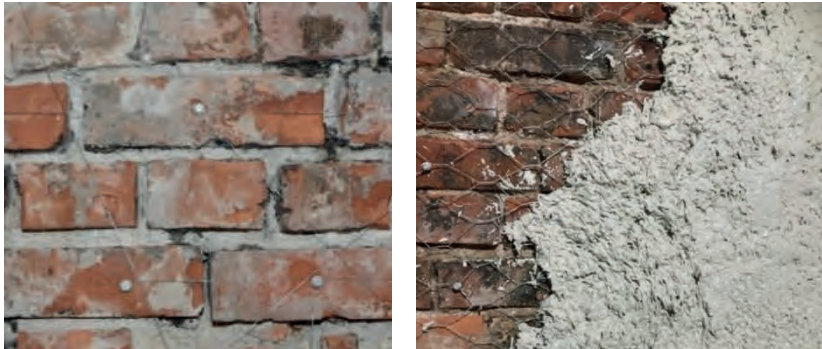
Figure 3: Stainless-steel wire (left) and chicken wire (right) acted as a reinforcing and plaster-bearing system. The hemp-lime had been applied here in a thickness of 10-30 mm directly against the brick wall.

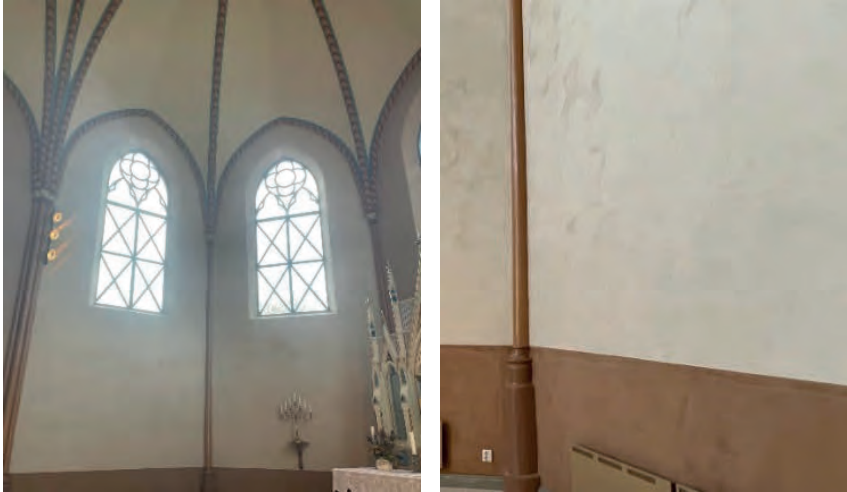
Figure 5: The two walls that have been plastered with hemp-lime in the choir. After two years there are no signs at all of salts on the surface. Only the normal liveliness of the lime wash gives the surface its expression.

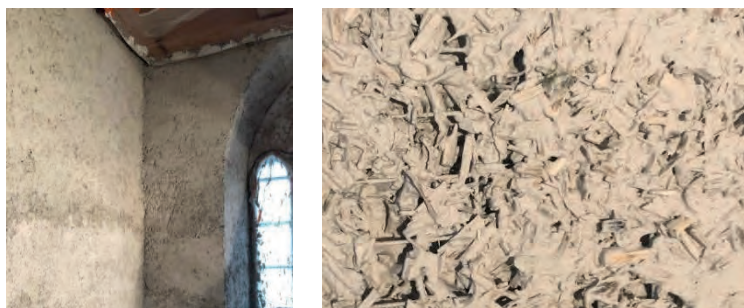
Figure 6: Hemp-lime as an insulating base layer at Örgryte New Church.

In Örgryte New Church was designed by Adrian C. Peterson and consecrated in 1890. In this church the test surface is situated in the tower behind the organ stands. There were three small test surfaces made with different materials in 2016. The test surface with hemp-lime and lime plaster had no signs of salts on the surface after four years [12]. During the summer of 2020 a hemp-lime plaster was applied to an area in the choir of the church. All the internal sacrificial plaster including the test surfaces was removed. The 20-year-old sacrificial plaster was removed and instead a layer of hemp-lime and a plaster of NHL3.5 were applied, see Figure 6.

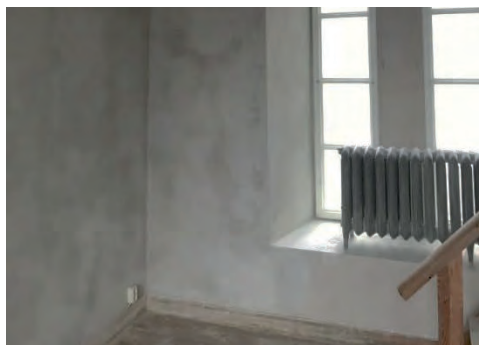
Figure 7: Lime plaster finish of NHL3.5.

The hemp-lime was prepared from hemp shiv and hydraulic lime NHL3.5, approx. 1: 1 by volume. The thickness of the hemp-lime layer was adapted to the wall surface, and was approx. 20-30 mm. The surface plaster was made of hydraulic lime mortar 1: 1.5 by volume of NHL3.5 and sand 0-4 mm. The walls were whitewashed with lime paint 1: 3 (lime:water) in one coat to get a uniform appearance against the adjacent existing lime plaster, see Figure 7.

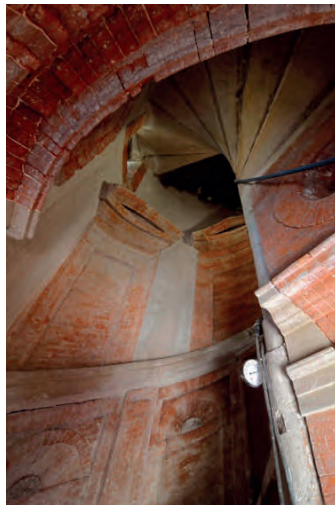
Figure 1: Example of the masonry master's pieces in the De Waag building

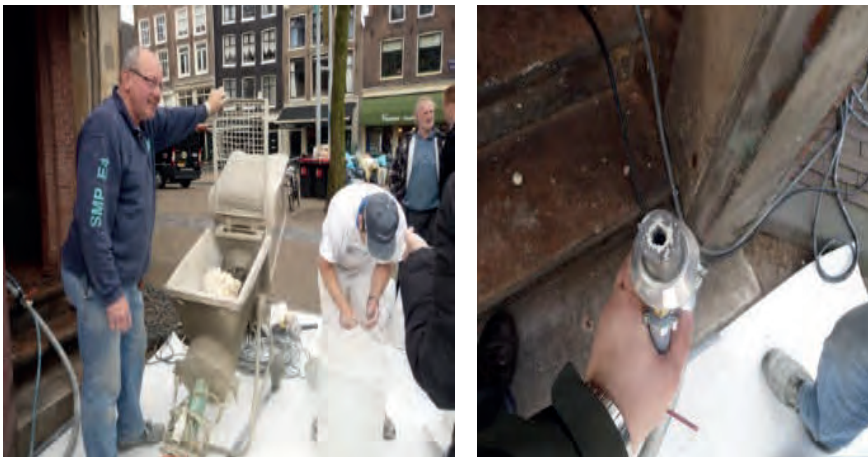
Figure 2: Using a stucco sprayer.

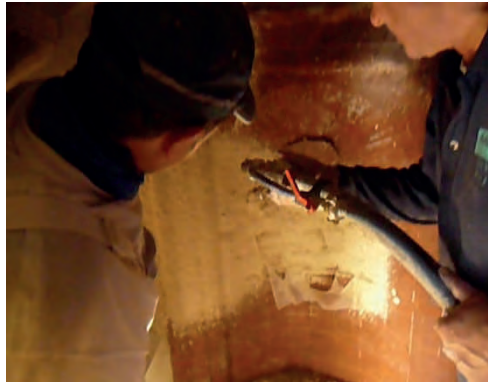
Figure 3: Spraying of the poultice.

Together with the contractor selected for the work, we selected an application method that made it easier to apply the poultice without the material coming loose from the surface. For this purpose, a stucco sprayer was altered, using a nozzle with a 12 mm diameter. With this method it was important that the poultice was firm enough to allow it to be pressed through the nozzle as homogeneous putty, while sufficient water was present for the treatment. This could be achieved by preparing the poultice at least one day before use, to allow the clay and the cellulose water to bind. Once these preconditions were met, the poultice could be applied with the sprayer to the desired thickness with an air pressure of 10 bar at the nozzle.

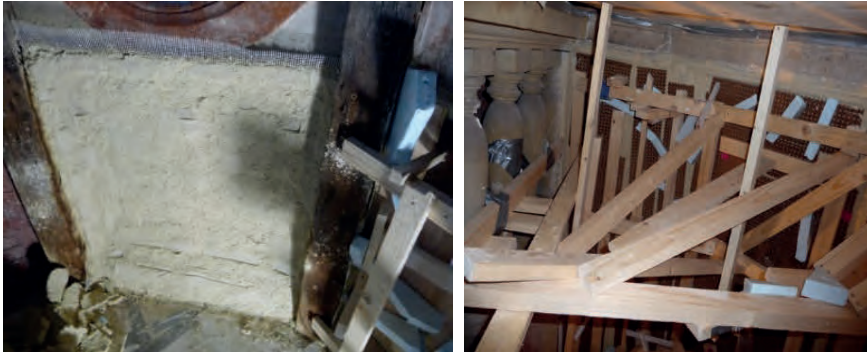
Figure 4: Test with (fibreglass) stucco mesh (left) and clamping of the poultice (right).

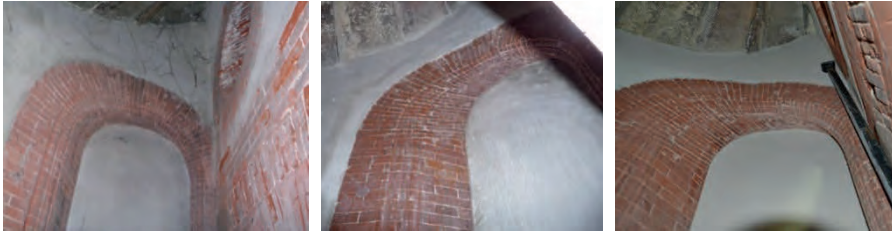
Figure 5: Situation before desalination (left), immediately after desalination (middle) and after 10 years after desalination (right).

The work was completed over 10 years ago, and it is still clearly visible that the objective of the treatment was achieved. Before the treatment, the deterioration of the masonry was clearly discernible, with newly affected areas showing up and stone debris on the floors and stairs. This has diminished a lot in recent years. There is still some stone debris, but this can be attributed to the already deteriorated areas, where the material was already loose. There are no new damaged areas and the existing damage has not visibly increased.

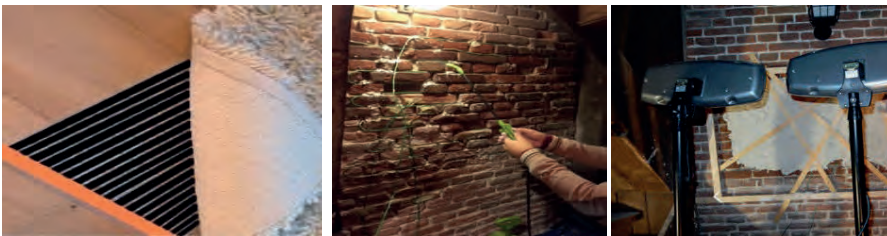
Figure 6: Electric floor heating mats 120 W/m<sup>2</sup> (left); heating wire in joint (middle); infrared patio heaters (right).

Three electric heating methods were used to heat up the façade: Infra-red heating using floor heating mats, infra-red patio heaters, and electric heating wire. All three methods were suitable for heating the wall to the desired temperature, but it was important to make a choice in terms of use and risks. With floor heating mats, clamped on a frame and with insulation material to prevent heat loss, the façade could be heated on the surface and up to a depth of 10 cm. Due to the technique used, the process was relatively slow and there was a big difference in temperature on the surface and deeper in the masonry. It is also a relatively safe solution, because it does not create a fire hazard for the wooden interior structure of the tower. However, the main disadvantage is that the frame must be removed for the installation of the poultice, which allows the surface to cool down quickly. The temporary use of the patio heaters could largely prevent this, but this had a negative impact on the working conditions (too hot at very close range). Although it is a suitable and safe method for heating the wall, the foil proved less suitable for the actual desalination. The foil is impermeable and stops the evaporation of moisture in the poultice. Also, the poultice heated up faster than the masonry, causing it to dry out too quickly for effective treatment.

The use of patio heaters only proved to be insufficient to heat the façade to the required temperature. This is mainly because these heaters are too far from the wall, and the cold air in the tower also cools the walls down. We also deemed the risk of using these heaters in a tower with a wooden floor structure to be too high to apply this method on a large scale.

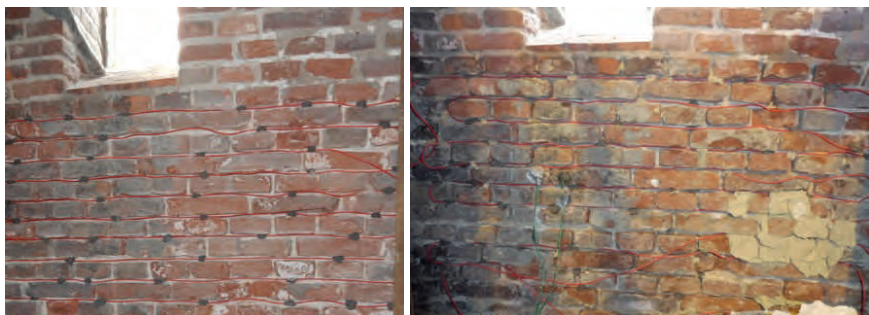
Figure 8: Location C (heated) before desalination (left) and after desalination (right): no further damage due to desalination is observed.

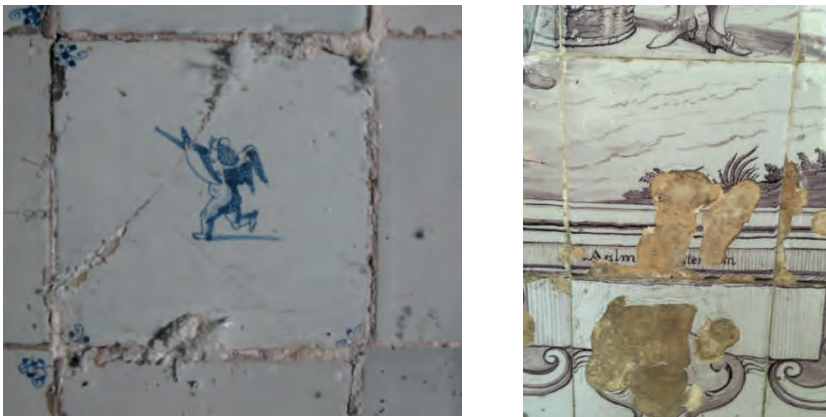
Figure 1: Salt efflorescence on the sides of a tile and along a breakage (left); blistering of the glaze (right).

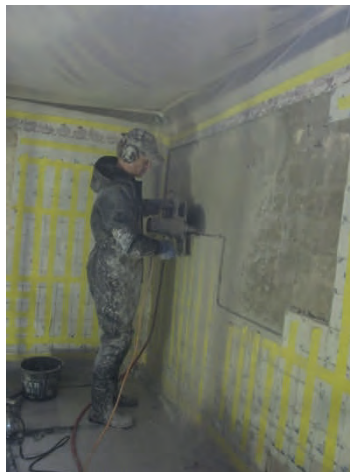
Figure 3: Removing the tiles using a diamond saw.

If the salt problem is more pervasive and the tiles are badly affected, the tiles themselves will have to be treated. In order to do so, the tiles will have to be removed from the wall. There are several ways to do this, however, all of them are very invasive, and include risks for the tiles. The use of chisels to loosen the mortar can put a lot of stress on the tile. Sawing into the mortar layer behind the tile is best done with large diamond blades that require large amounts of water for cooling (Figure 3). The conservator will have to weigh the risk posed by removal against the risk posed by the soluble salts.

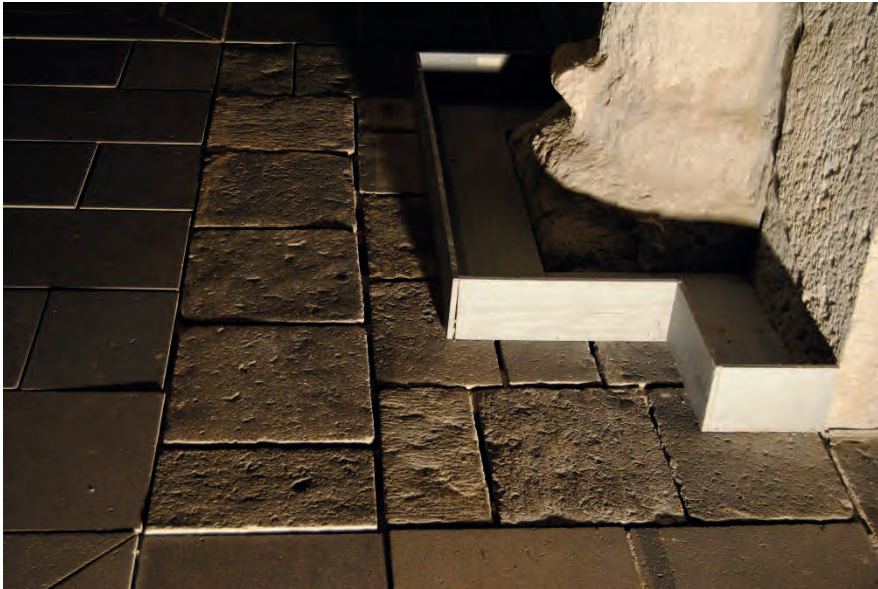
Figure 3: Floor plates with open joints and boxes made of wood to sample the fell off for the monitoring.

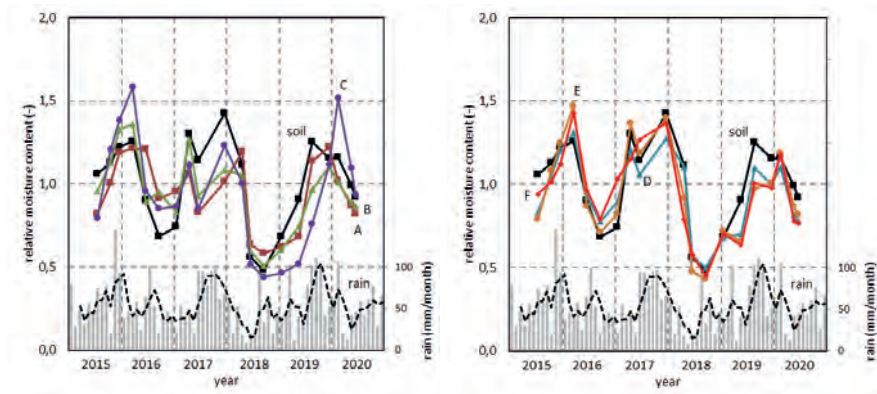
Figure 5: Moisture measurements in all six test areas, relative to the average. The monthly rainfall is shown with grey bars below in the diagram, and the moving average of 3 months is shown with a black dotted line.

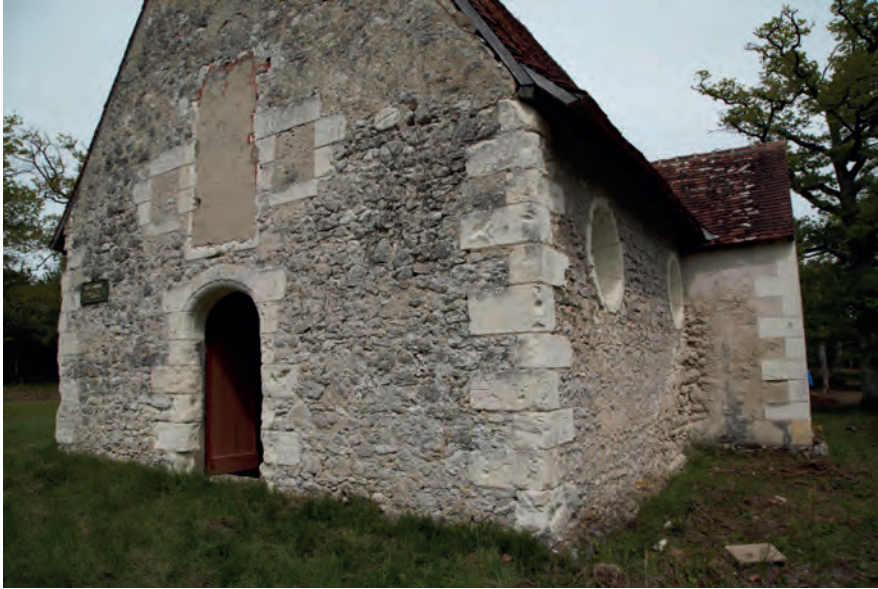
Figure 1: Photograph of the Chapel of Maurepas located in the Domaine National de Chambord, France.

Built on lake limestone foundations, the elevations of the chapel are made of tuffeau rubble covered with lime coating, with corner quoins in tuffeau stonework. This chapel follows a generally rectangular plan, only the south wall opens onto a small chapel, framed by stonework quoins, and crowned with an arch. The subject of this study is the interior corner quoins supporting the arch.

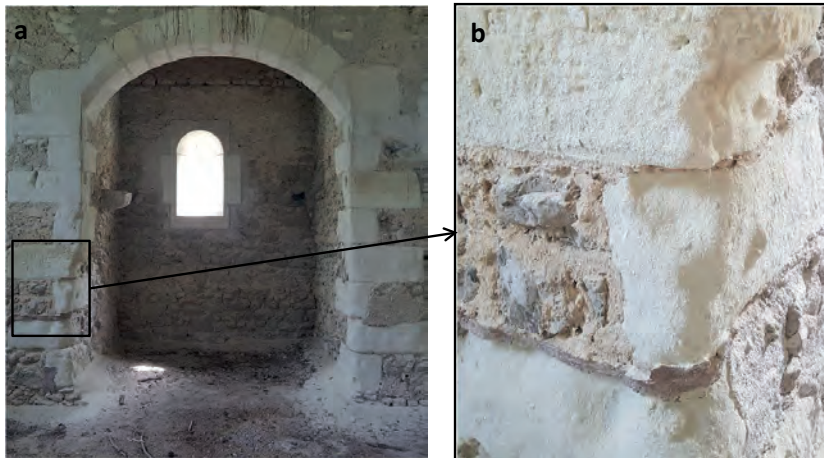
Figure 2: Interior corner quoin in tuffeau stonework supporting the arch (a) – detail of powdering (b).

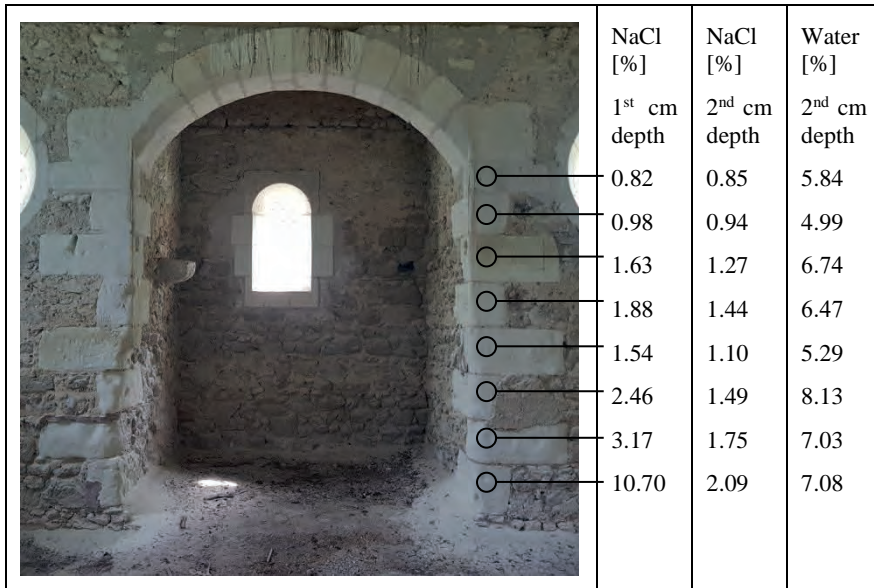
Figure 6: Salt NaCl content and water content in the tuffeau corner quoins

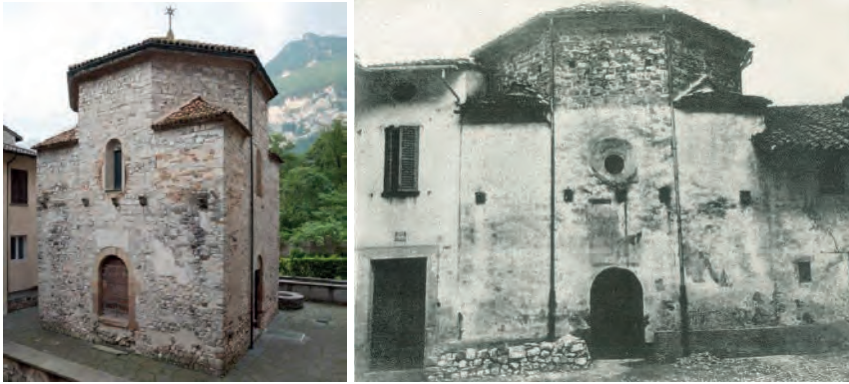
Figure 1: a) Current view of the Baptistery. (Photograph by A. Vattilana, courtesy of the Municipality of Riva San Vitale); b) The Baptistery before the restoration in the 1950s [4].

Now the Baptistery is an isolated building standing at the center of a courtyard. It is located approximately 1 meter below the road level. Furthermore, inside the building, the floor of the apse is 30 cm lower than the internal floor and the external sidewalk. This situation influences the flow of rainwater, which converges near the external perimeter walls. Furthermore, the proximity of the building to Lake Ceresio and the Laveggio river has caused, in the past, periodical floods, especially during heavy rain periods.

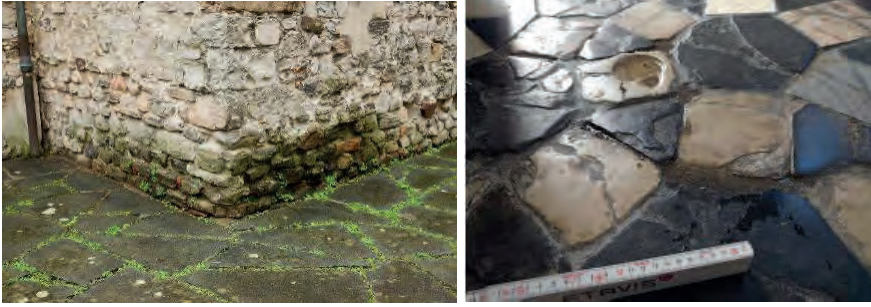
Figure 2: a) Phenomenon of capillary rising damp along the perimeter and biological colonization; b) Puddles of rainwater formed following water entry from the main door during heavy rains.

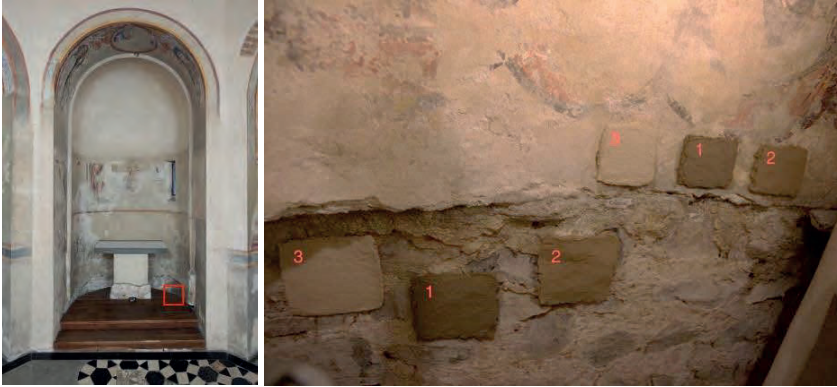
Figure 4: Specimens of 15x15x2 cm were placed on the masonry without plaster, and tests of smaller dimensions 10x10x1 cm were placed on the above mural painting in the apse.

Poultice specimens of 15x15x2 cm were placed in the lower part of the apse on an area of masonry without plaster, while tests of smaller dimensions 10x10x1 cm were placed on the mural paintings above, without wetting (Figure 4). After application, the poultices were transported to the laboratory where they were immersed in an aqueous solution to extract soluble species. After 24 hour of sedimentation, 30 ml of each aqueous solution were placed in an oven at 50 ° C for drying. The dry residue was analyzed with ATR - FT - IR spectroscopy.

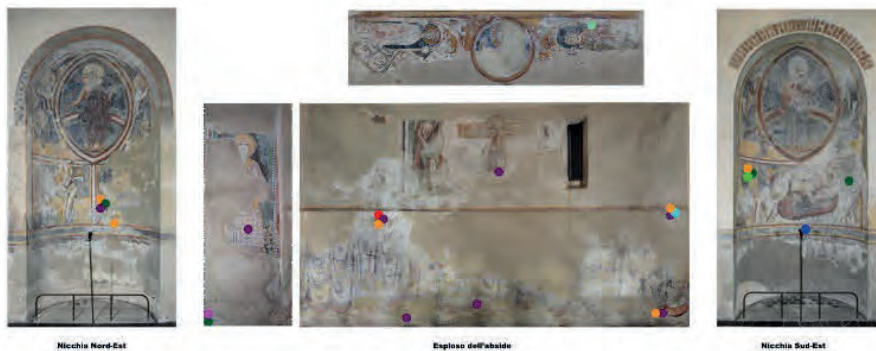
Figure 9: Distribution of salt efflorescence on painted walls. Red dot: epsomite; orange dot: gypsum; blue dot: hydromagnesite; light blue: magnesium carbonate; purple dot: calcite; pink dot: thenardite; green dots: other substances (biological colonization) and polymeric film layer.
