Synthesis report on the composition and quality of ZOAB

Report 7-18-195-3

Pavement Engineering
Delft University of Technology

Client: Rijkswaterstaat

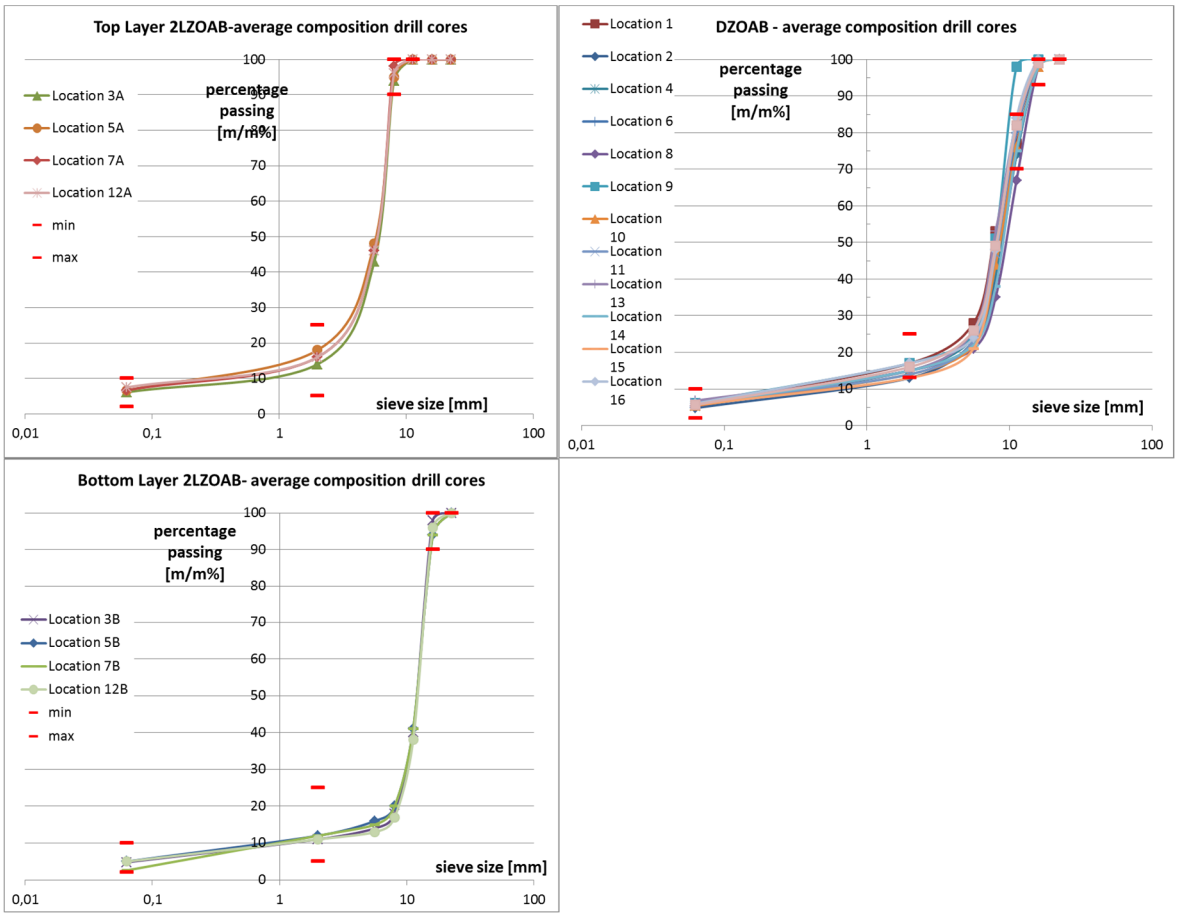
Figure 3.4: Average grading curves (n=3) for each of the test locations, split over the three kinds of mixes

It can be seen that the 2L-ZOAB mixtures follow the overall requirements, but that several of the DZOAB 16 mixtures do not meet the standard grading requirement, used to identify a mixture as a certain mixture kind.

The mixture in Location 9 seems to be a ZOAB 11 rather than DZOAB 16 (with 98% too much material passes the 11,2mm sieve for a (D)ZOAB16, although the CE mixture information provided is for a DZOAB 16. Location 8 has too little material passing this sieve (11,2mm) and locations 2, 10, 11 and 15 fall below the minimum requirement for the 2mm sieve. So from the 13 (D)ZOAB mixtures 5 do not meet the basic grading criteria on one sieve. That seems a lot and as such, it would be worthwhile to check the average grading found per location to the reference grading provided for that specific mixture.

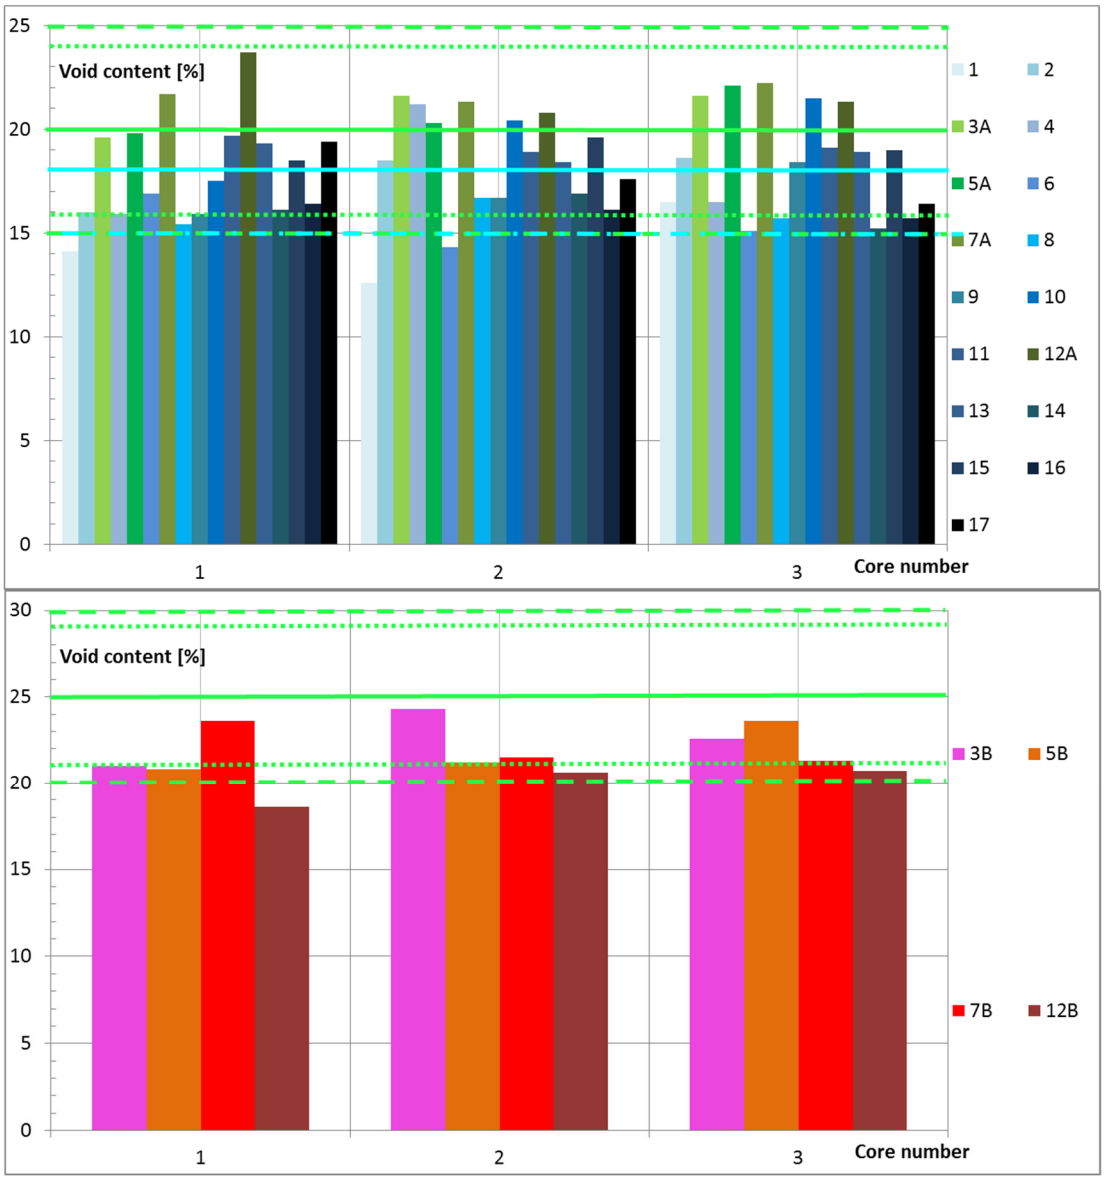
Figure 3.9: Void content from field cores for all 17 locations (D)ZOAB 16 (=blueish) and 2L-ZOAB 8 (greenish) in the top graph and 2L-ZOAB 16 in the bottom graph, *continuous green lines give required minimum void content (20% for top graph, 25% for bottom graph), dotted green lines show the maximum deviation in the average of three cores (+/-4%), striped green lines the maximum deviation for a single core (+/-5%). The blue lines give the minimum requirement RWS sets for the average (continuous) and individual (dotted) void content of cores.*

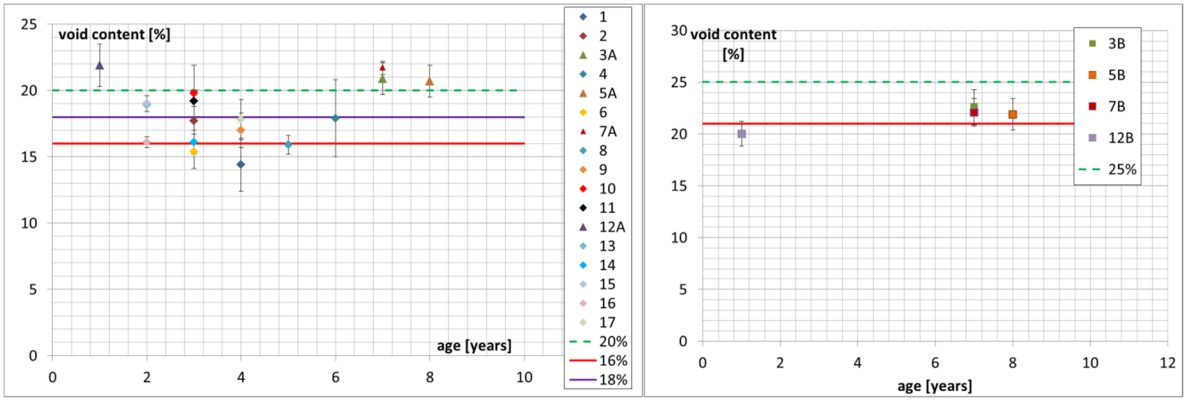
Figure 3.10: Average void content versus the age of the sections (at the time of sampling in 2016), left DZOAB 16 and 2L-ZOAB 8, right 2L-ZOAB 16

From this, and the underlying data (Table 3.9) it can be seen that indeed locations 1 and 6 do not meet the minimum requirement based on the average of three cores. Additionally, sections 8 and 12B also do not meet the requirement, while Locations 16 and 14 only just make it. Location 9 meets the overall requirement, its average value is higher than the minimum boundary of 16%, but lower than the design value of 20%. Of all DZOAB 16 mixtures, none have an average result that is higher than this minimum design void content of 20%. The locations in the left hand side of Figure 3.10 that are above 20% are all 2L-ZOAB 8 mixtures.

From Figure 3.10 it seems that the low void contents do not have a relation with the age of the specimens. However, it must be noted that the oldest three samples as well as the youngest are all top layers of 2LZOAB. But samples in between also do not seem to show an age related trend. This is in line with the expectations, since there are no known indications that PA mixtures are further compacted by traffic. Studies into rutting of pavements with a top layer of PA usually find that the cause of the deformation is in the underlying layers or the subgrade (Voskuilen et al., 2001,Voskuilen et al., 2002). Still, since there are no known studies determining the void content of DZOAB 16 and 2L-ZOAB mixtures, or standard ZOAB 16 for that matter, several years after construction, it cannot be fully excluded that some reduction of the void content could take place.

From Figure 3.10 the low void contents do not seem to have a relation with the age of the specimens. This is in line with the expectations, since there are no indications that PA mixtures are further compacted by traffic to this extend. However, there has also been little study into this. To be absolutely sure, it is recommended to randomly follow the void content development over time in a number of these mixtures (see Section 3.5 for suggestions on the sampling details). Generally, it is useful to know the development of crucial properties over time in standard materials, both in case of disputes and to speed up the assessment of innovations.

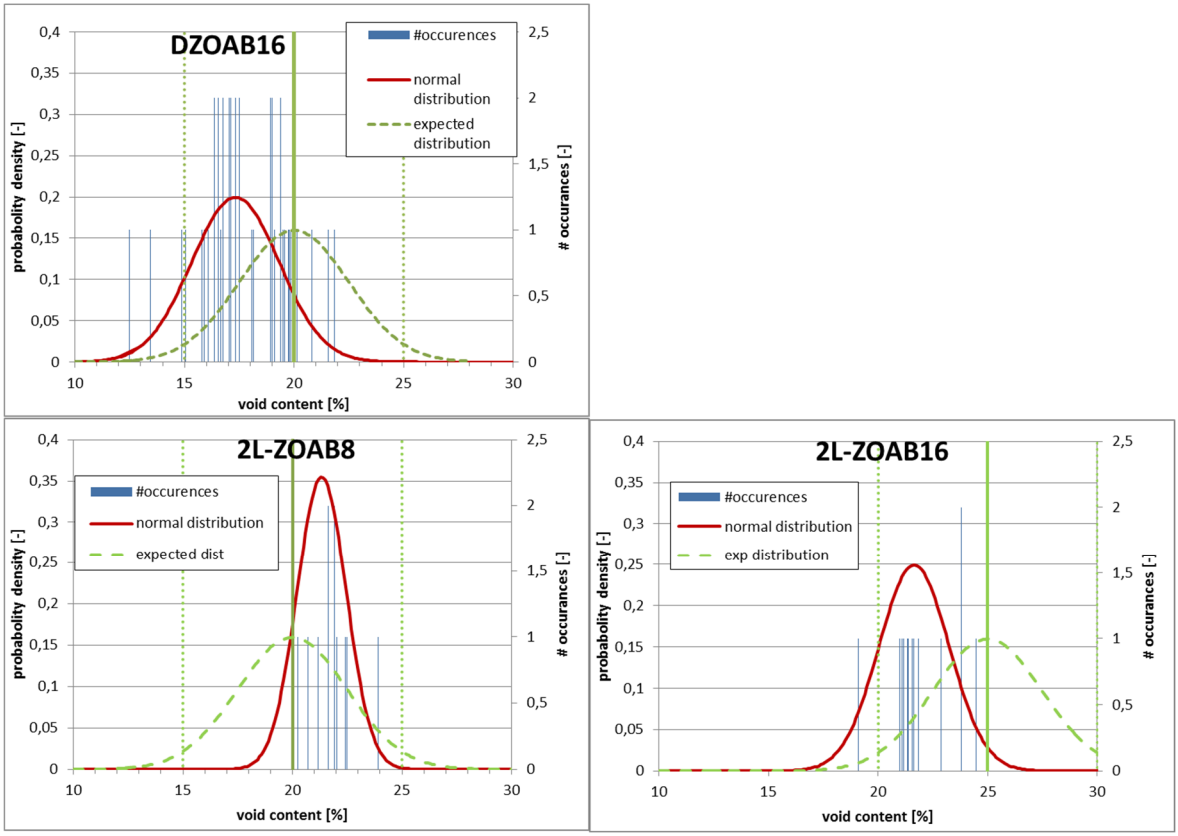
Figure 3.11: Distribution (lines, left axis) and occurrence (columns, right axis) of void content for the three types of mixtures

These normal distribution (red and green curves) have their maximum at the average value, for the red curve the average found from the cores, for the green the required void content. The width of the curves is determined by the variation. In all three cases the width of the green curve is larger than that of the red. This indicates that the variation found in the cores used for this project (13 or 4 separate projects for DZOAB 16 and 2L-ZOAB) is less than that allowed for a single core in one project (based on the individual values). This seems to indicate that the current margins are rather wide.

As can be seen from figure 3.10, both DZOAB 16 mixtures have an actual distribution (red line) that is shifted to the left compared to the expected (dotted green line curve). The 2L-ZOAB 8 actual distribution is shifted somewhat to the right, but falls almost completely within the expected distribution curve. This indicates that the void content for the D=16 mixtures is on the low side, while for the 2L-ZOAB8 it is more or less as expected.

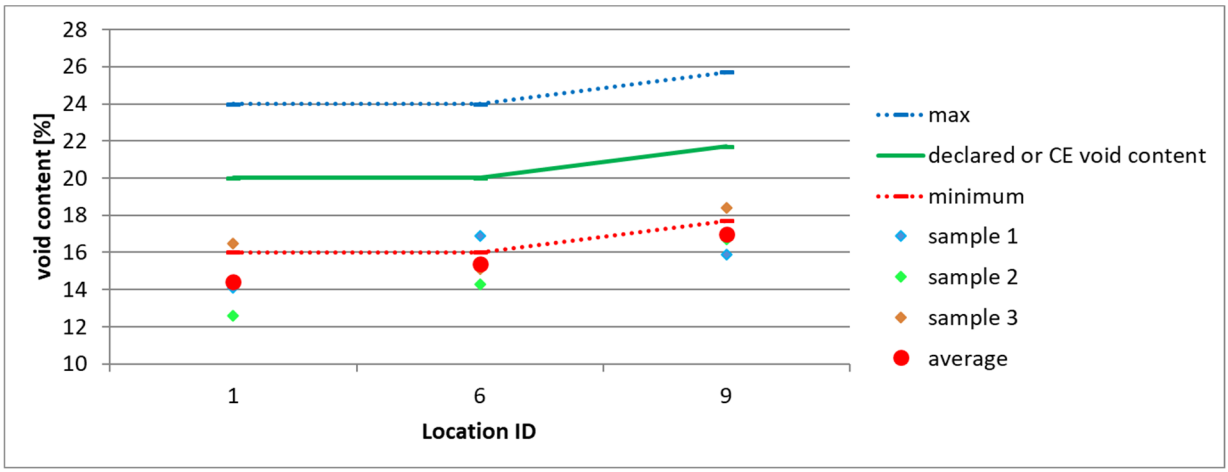
Figure 3.12: Individual results and requirements for three locations (L1, L6 and L9)

For the three locations studied in more detail (L1, L6 and L9), for only one a value for the void content that differs from the general requirement (20%) is given. The location for which a different value is declared on the CE information (L6, 21,7% (or 23,7% for the second mixture19) fulfils the requirements when looking only at the general requirement (20%). However, the deviations allowed are linked to the value found in the TT (art 81.22.14 part 05, CROW, Standaard 2015, 2015). If this is applied, two out of the three cores and the average of the three do no longer fulfil the requirements (Table 3.10). This shows that it is important to have and use the detailed information for a given mixture, not just the overall group information.

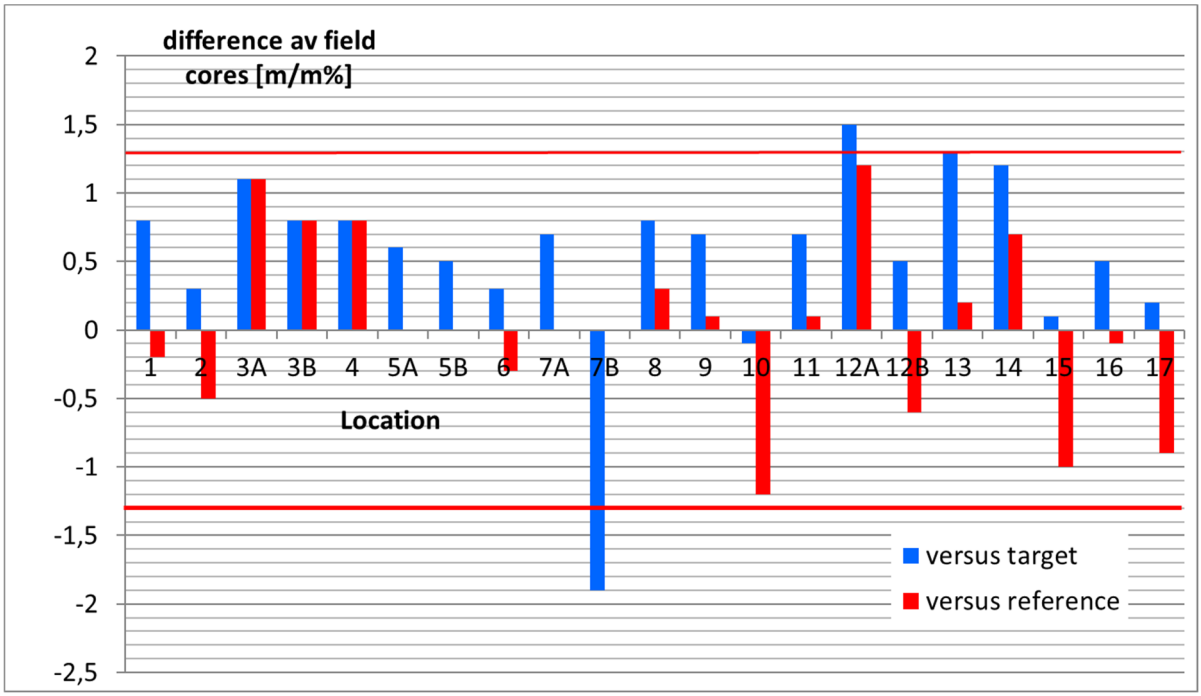
Figure 3.13: Difference in m/m% material ≤ 0,063mm in the field cores vs target and reference composition

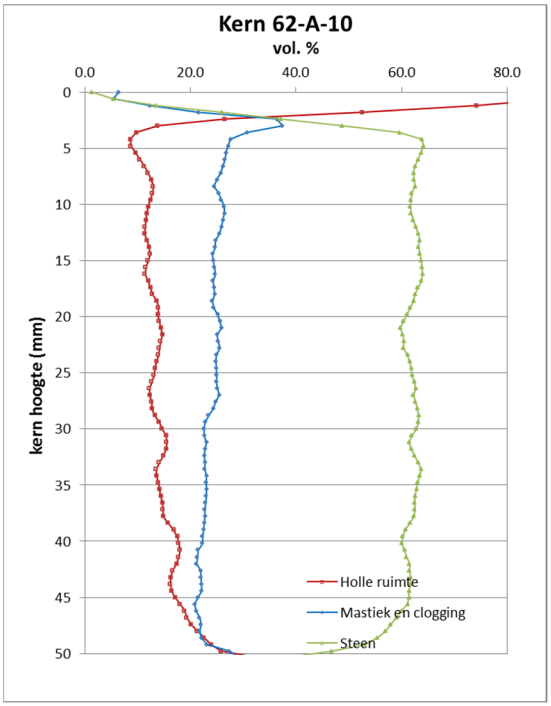
Figure 3.16: Low percentage of voids at the top increasing with depth. Increasing percentage of mortar with depth

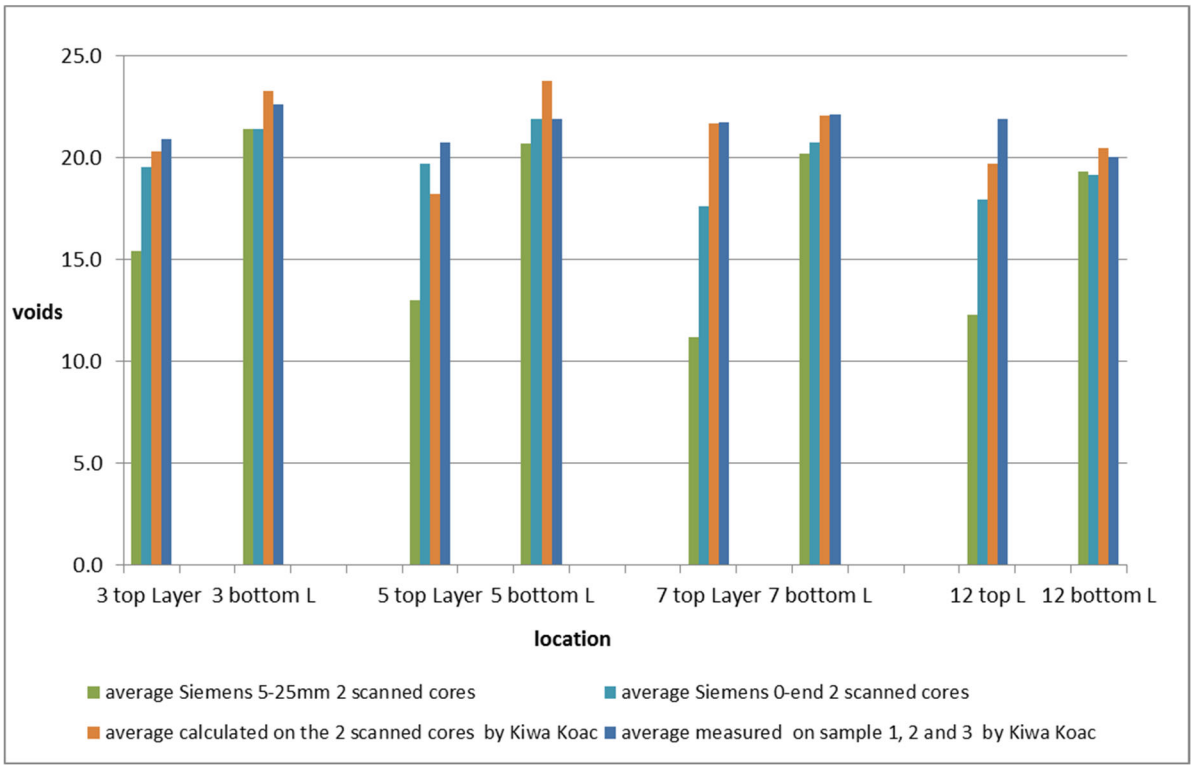
Figure 3.18: Calculated overall void content and void content over part of the height from the scans of 2L-ZOAB 8 and 16 samples compared to the calculated and measurement values by Kiwa KOAC

The same is done for the 2L-ZOAB 8 and 2L-ZOAB 16 cores and the results are given in Figure 3.18. It is important to note that in order to determine the void content in the classical way, the layers have to be separated. As such, the cores always have a flat, cut, surface at the bottom. For 2L-ZOAB 16, which is located underneath 2L-ZOAB 8, both the top and bottom are cut surfaces. As such, these cores should be easiest to compare. As can be seen from the graphs, the 2L-ZOAB 16 results are indeed most comparable. Another aspect of core geometry that affects the void content is any deviation from a 90° (perpendicular) angle between the core surface and its axis. In several cases of the cores used here, this angle was not 90°, which affects the percentage voids found. Finally, missing coarse aggregates at the cutting surfaces will affect the void content found in the traditional assessment, while for CT-scanning that part of the core can be excluded, to get a more representative void content.

Alternatively, CT-scanning could be done on uncut cores. There are limits for cross-sectional area, but the height of the cores is not really limited. As such, cores could be scanned and analysed for their composition and void content, without separating the layers and losing material. This would provide additional information about the interface between two pavement layers.

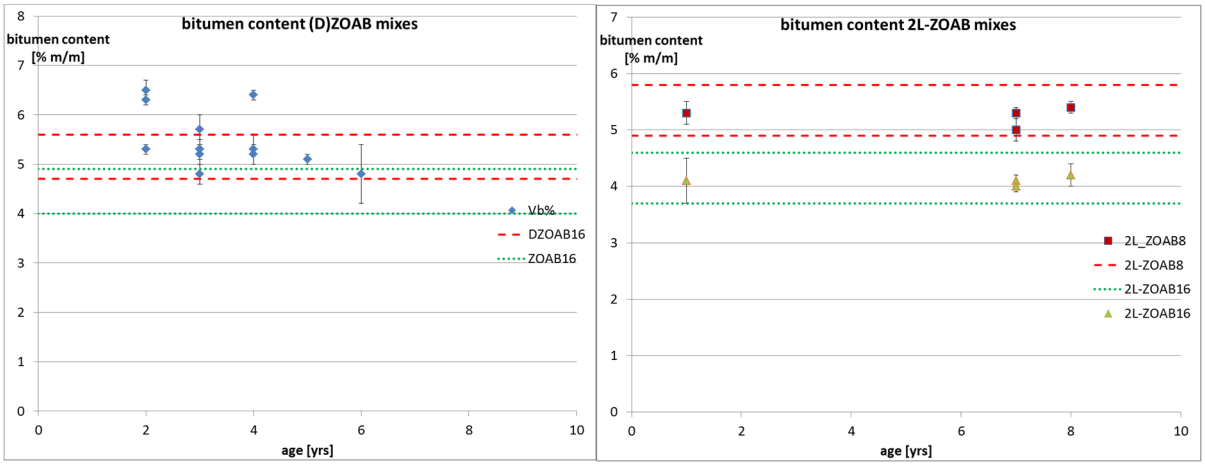
Figure 3.19: Bitumen content (n=3) for (D)ZOAB 16 (left) and 2L-ZOAB 8 and 2L-ZOAB 16 (right), with the corresponding margins

The results are summarized in Table 3.12 and Figure 3.19. As can be seen, in most cases the bitumen content is reasonably close to the target content per mixture group. No location has too little bitumen, based on the average value and there is only one sample that has to low a bitumen content.

The results are summarized in Table 3.12 and Figure 3.19. As can be seen, in most cases the bitumen content is reasonably close to the target content. Surprisingly, there are four locations where the bitumen content of the DZOAB 16 mixtures exceeds the upper limit for the binder content. This is surprising, since bitumen is the most expensive component in the material, so usually attention is paid to ensure that no more than needed is used. To exceed the upper boundary is therefore unexpected. It would be worthwhile to discuss this with contractors, because it either points to a lack of control

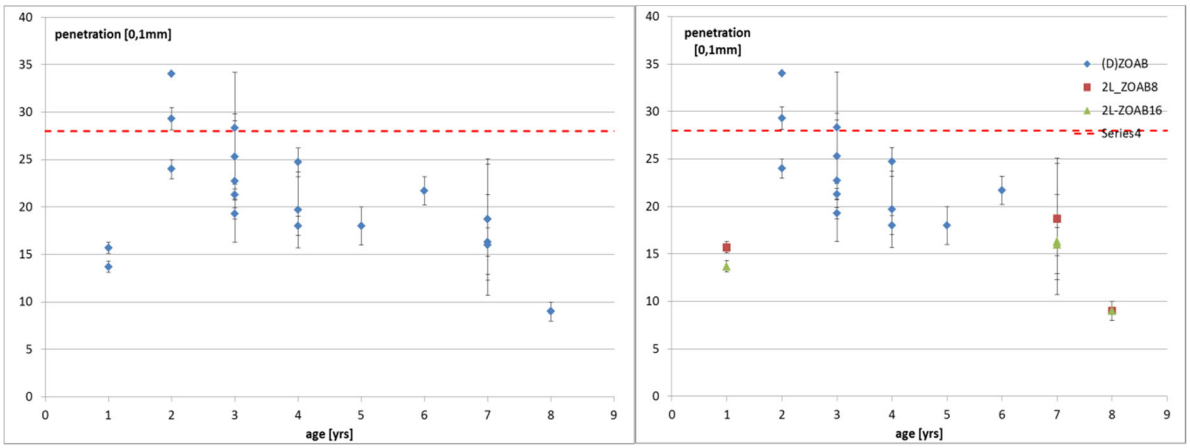
Figure 3.22: Penetration as a function of age for all sections (left) and with the different types of PA indicated (right)

In Figure 3.22 the penetration as a function of the age of the section (and the type of mixture) is given for the sections studied in this project. As can be seen, the penetration decreases roughly with time, but there is a lot of variation. It does seem clear that something odd happened in section 12, the 2L-PA that is only one year old. Both layers show a very low penetration, while the three older 2L-PA materials (there are two sets of 7 years old) do not show behaviour that deviates much from the overall data set. Based on this observation, the information provided on the mixtures was checked and it was found that a Styrelf PmB 40/100-65 AAP was used in both top- and bottom-layer. Additionally, according to the additional information ("verkort verslag") in the bottom-layer fibres were used (Arbocell ZZ 8/1). The specifications for 2L-ZOAB (VBW Asfalt et al. (2002), Bouwend Nederland (2012) and CROW, Standaard 2015 (2015)) indicate polymer (SBS or EVA) modified bitumen for the top-layer and a choice between pen grade 70/100 or PMB for the bottom-layer. If an PMB is used the rather low bitumen content prescribed for the bottom-layer does not usually require an additional drainage inhibitor.

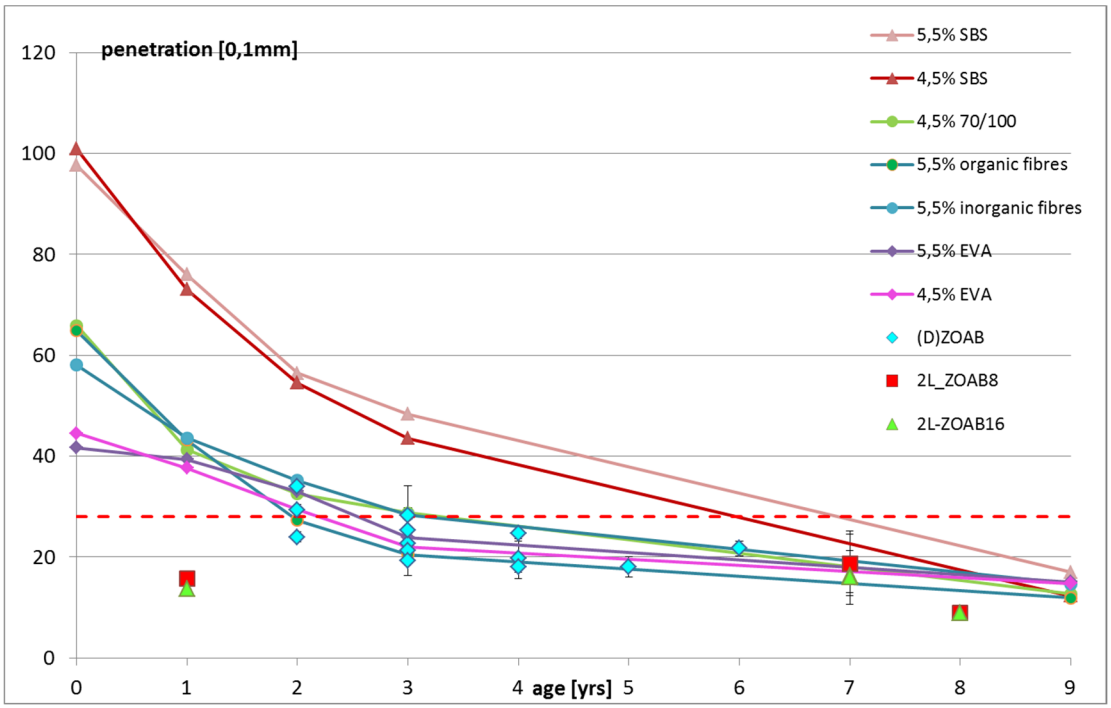
Figure 3.23: A selection of the penetration over time results from Voskuilen et al. (2004) combined with the values found for the cores from the road sections in this project

In Figure 3.23 the results from the test sections reported on in Voskuilen et al., 2004 are digitized and combined with the results found in this project. As can be seen, the pen grade 70/100 bitumen results for (D)ZOAB 16 seem to be in line with what was observed in the project that followed the penetration over time. The results from the 2L-ZOAB mixtures, aged 1 and 8 years (Location 12 and 5, respectively) however, deviate considerably.

Based on these results, most samples would appear to perform as expected regarding the penetration development. The exceptions are the 2L-ZOAB mixtures that are one year old (Location 12) and possibly the 8 year old (Location 5).

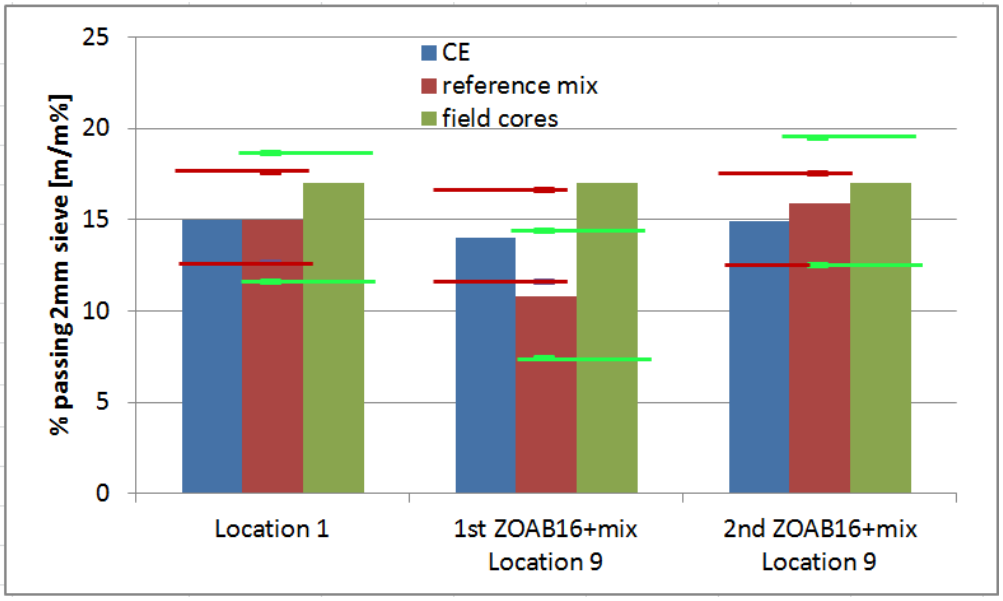
Figure 3.60: Individually declared and measured values compared to the boundaries between CE and reference composition (red) and reference composition and field values (for n=3, green)

As can be seen, the reference mixture value for the percentage passing the 2 mm sieve is too much smaller than the target composition for the 1 st DZOAB 16 mixture at Location 9, so this reference composition is not acceptable for this target composition. As a result, if this is the mixture used in this location, its variation found in the field cores is also too large. As a matter of fact, it would have been too large if the reference composition had been equal to the target value, as well. The 2nd DZOAB 16 mixture had a larger percentage passing the 2 mm sieve and this amount was increased in the reference composition. The value found in the field was even larger, but the differences between the three sets of values would, in this case, pass the requirements.

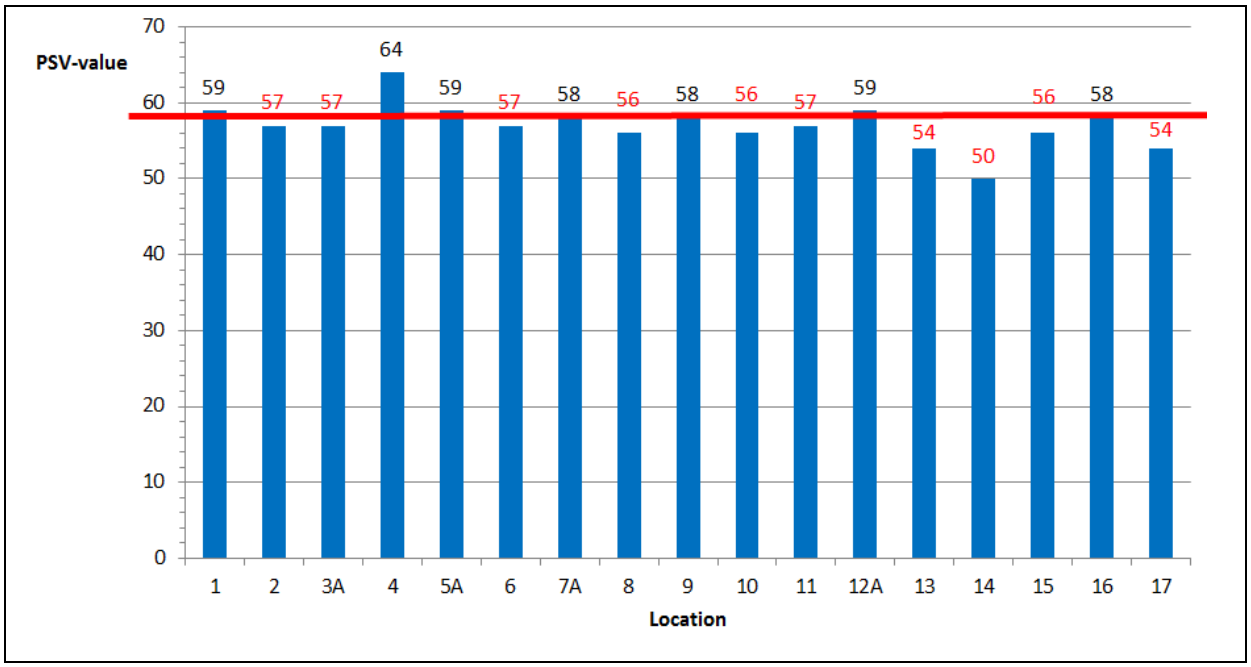
Figure 3.61: PSV values course aggregates relative to the PSV=58 requirement

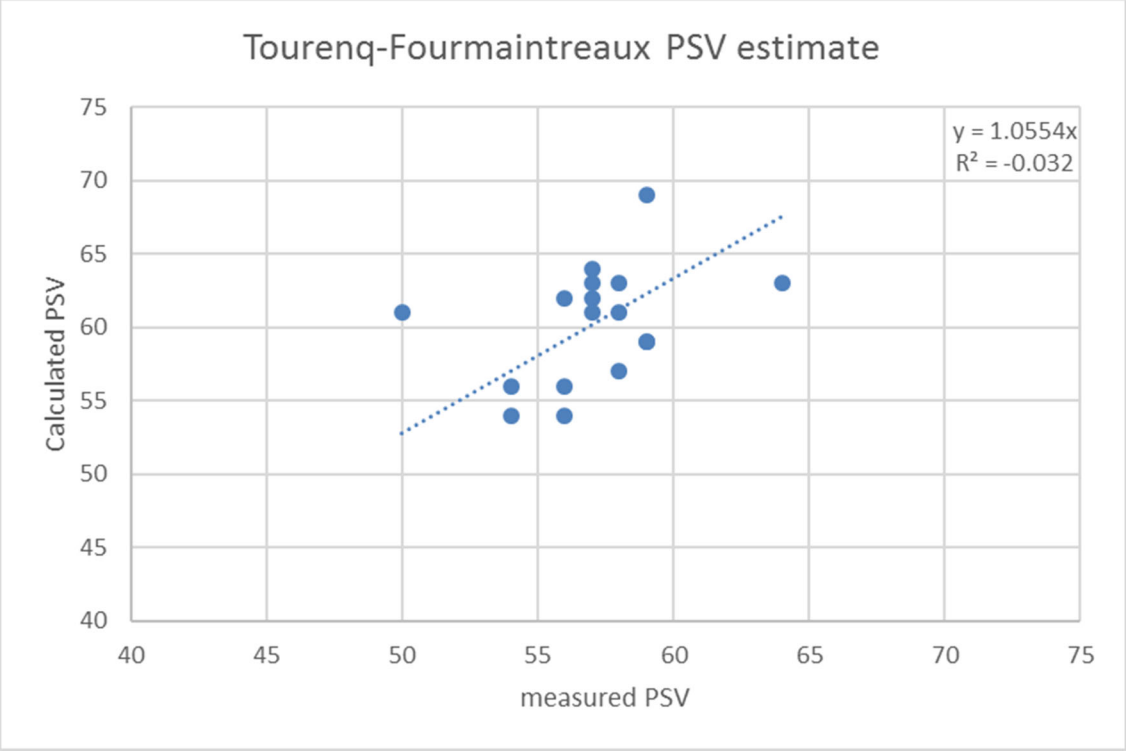
Despite the high correlation coefficient that Tourenq reports, for the rocks of this study the correlation is very low (see Figure 3.62). Apparently rocks from outside the rock database on which the regression equation is based do not fit the equation, which is therefore not generally applicable.

The poor results of the regression equations can be explained by other aspects that are known to influence resistance to polishing which are not included as variable in the regression analyses, such as the texture (microscopic structure) of the rock. Those aspects were considered in earlier research work done for Rijkswaterstaat DWW by Delft University (GEOMAT project; Pieters, W.E. , 1992, Pieters, W.E. et al., 1992, Van de Wall, 1992 and Verhoef et al., 1998). In that study the relationship of microscopic structure (texture), grainsize of minerals and PSV test results was investigated. There is a relationship, but this can be shown only within rock types of similar texture. Another outcome of this study is that using only the mineralogical composition is not enough for PSV estimation.

Figure 3.62: PSV calculated with the Tourenq regression equation (Tourenq et al., 1971) compared with the measured values.

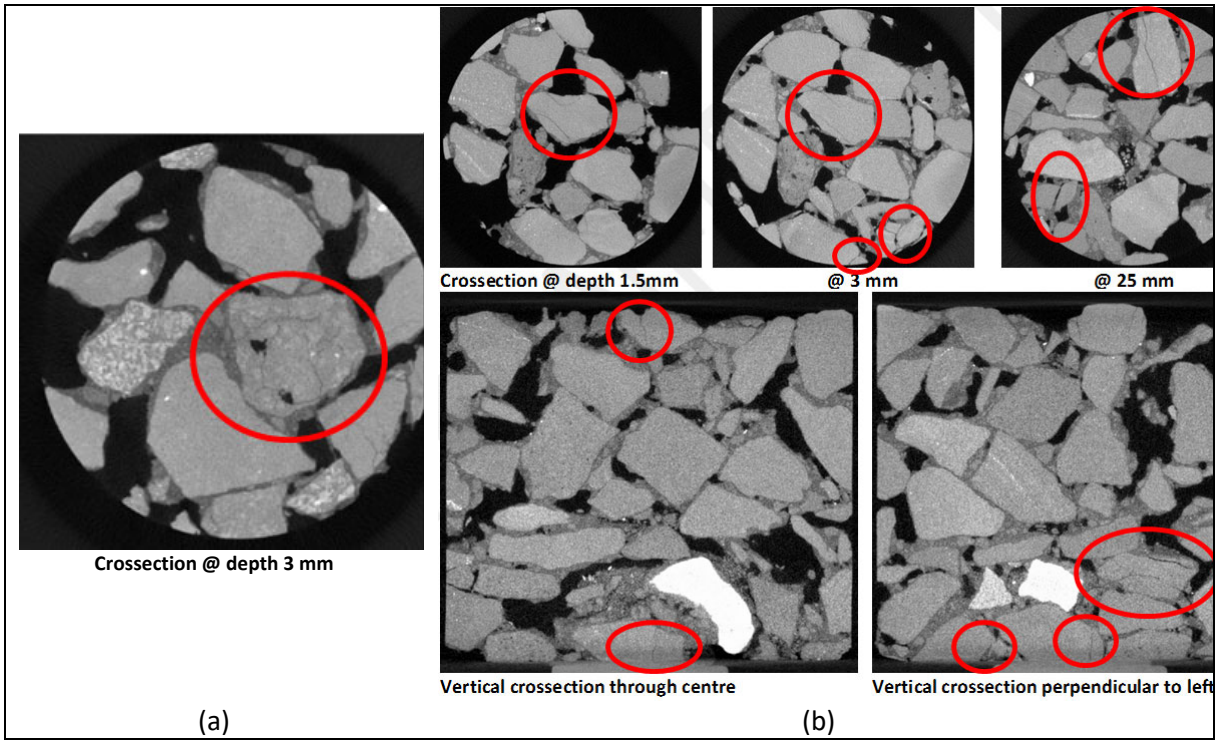
Figure 3.63: Example of (a) weathering patterns (location 17) and (b) cracks (location 9)

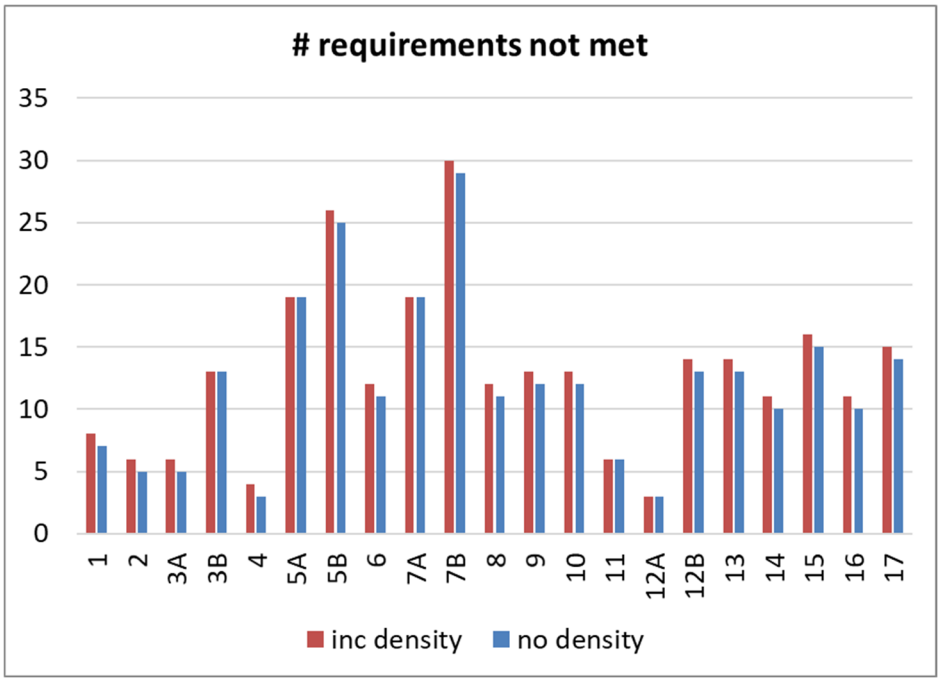
Figure 3.64: Overview of the number of requirements not met overall per project/location
