Restoration of the Interior

Colour, Form and Space

3 / RESTORATION OF THE INTERIOR

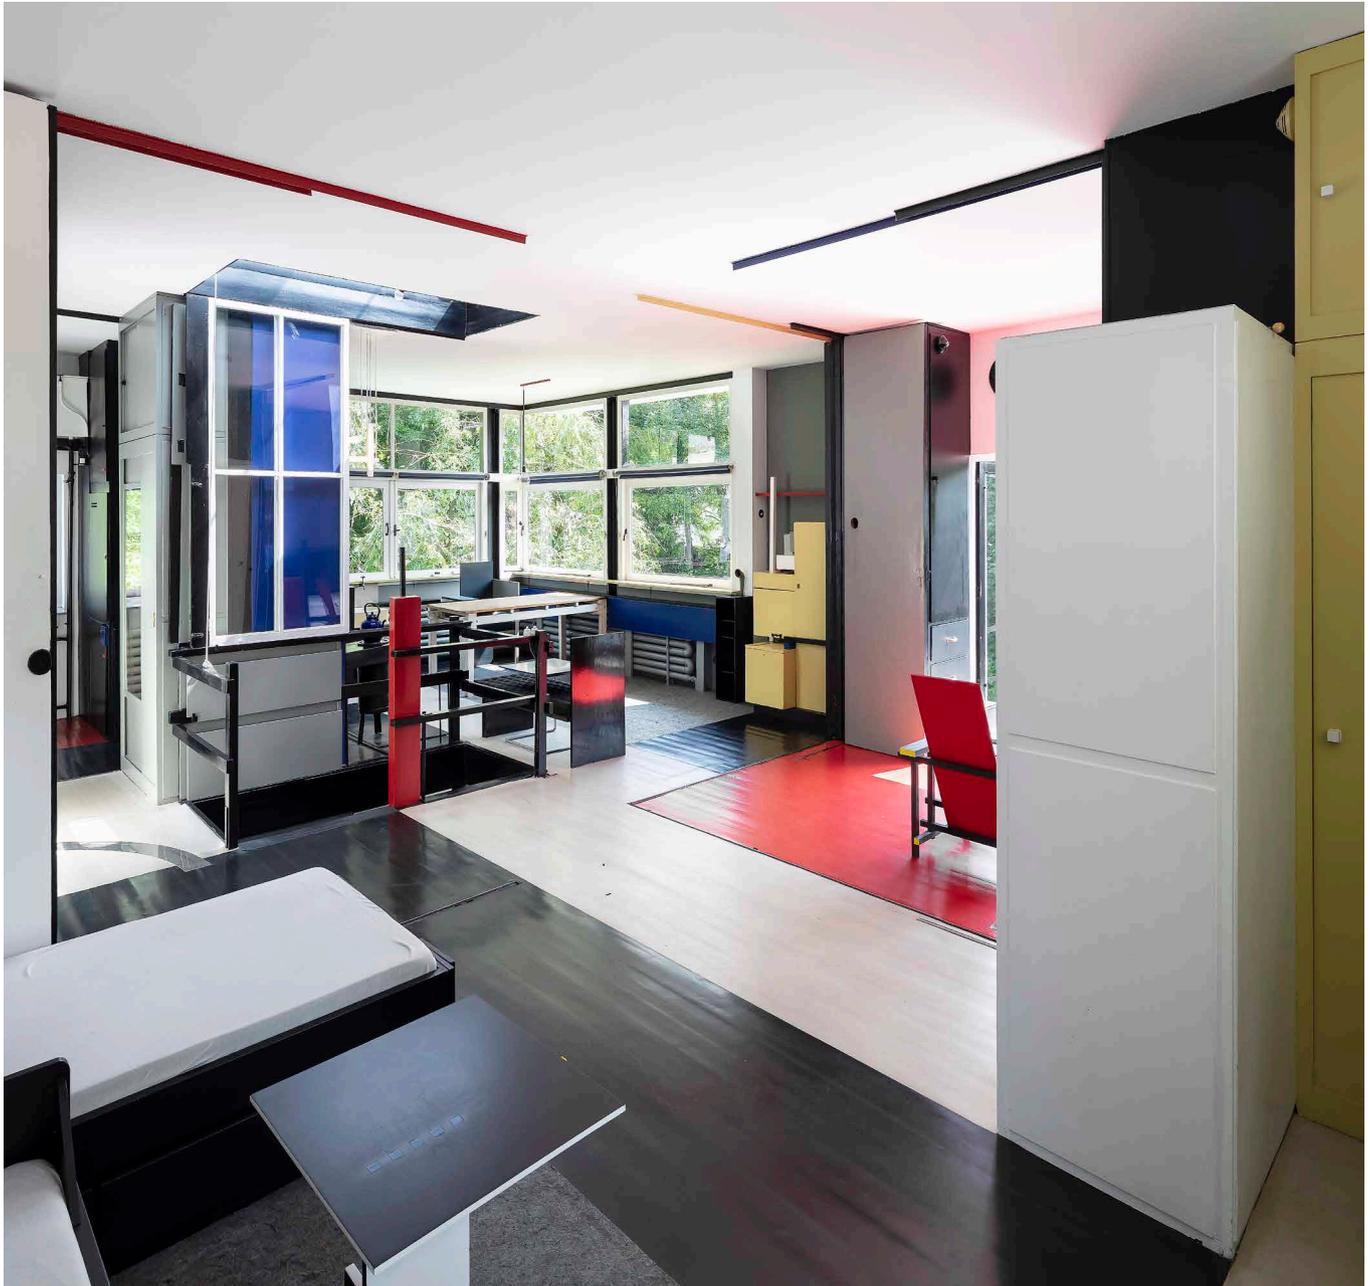
FIG. 3.10 The colour composition of the floor, 2018

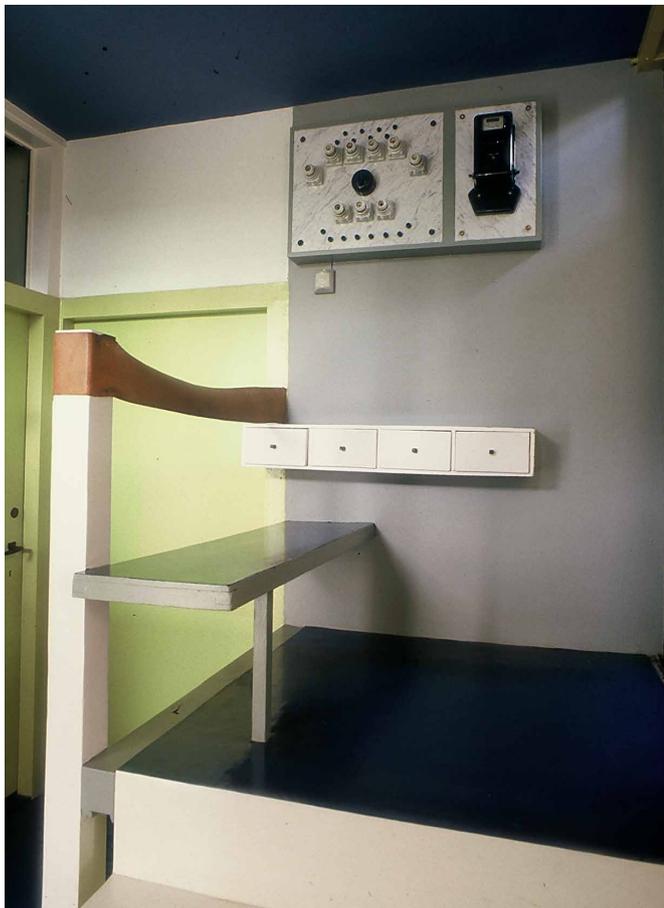
FIG. 3.11 Hall, 1985

Most of the illustrations in *Het Rietveld Schröderhuis* were of this floor, plus one or two photographs of the reconstructed kitchen or freshly painted hall on the ground floor. If we compare the hall in its current state with a photograph taken in 1985, immediately after Truus Schröder's death, the differences in colour are obvious [FIG. 3.11/3.12]. The architect repeatedly stressed that everything in the interior was created by him, that he had stripped the inner surface of the walls back to the structural shell, and

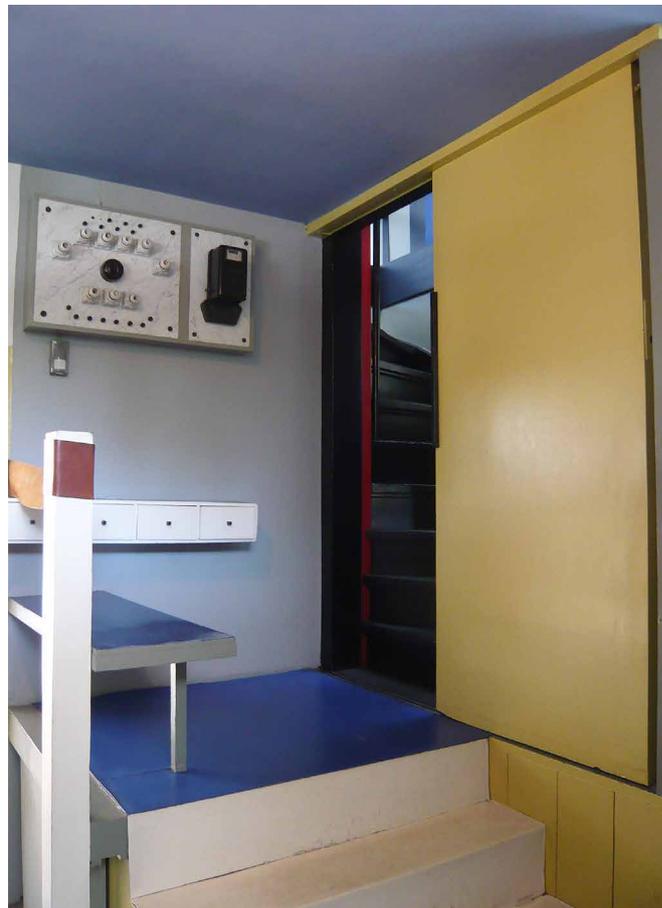
FIG. 3.12 Hall, 2015

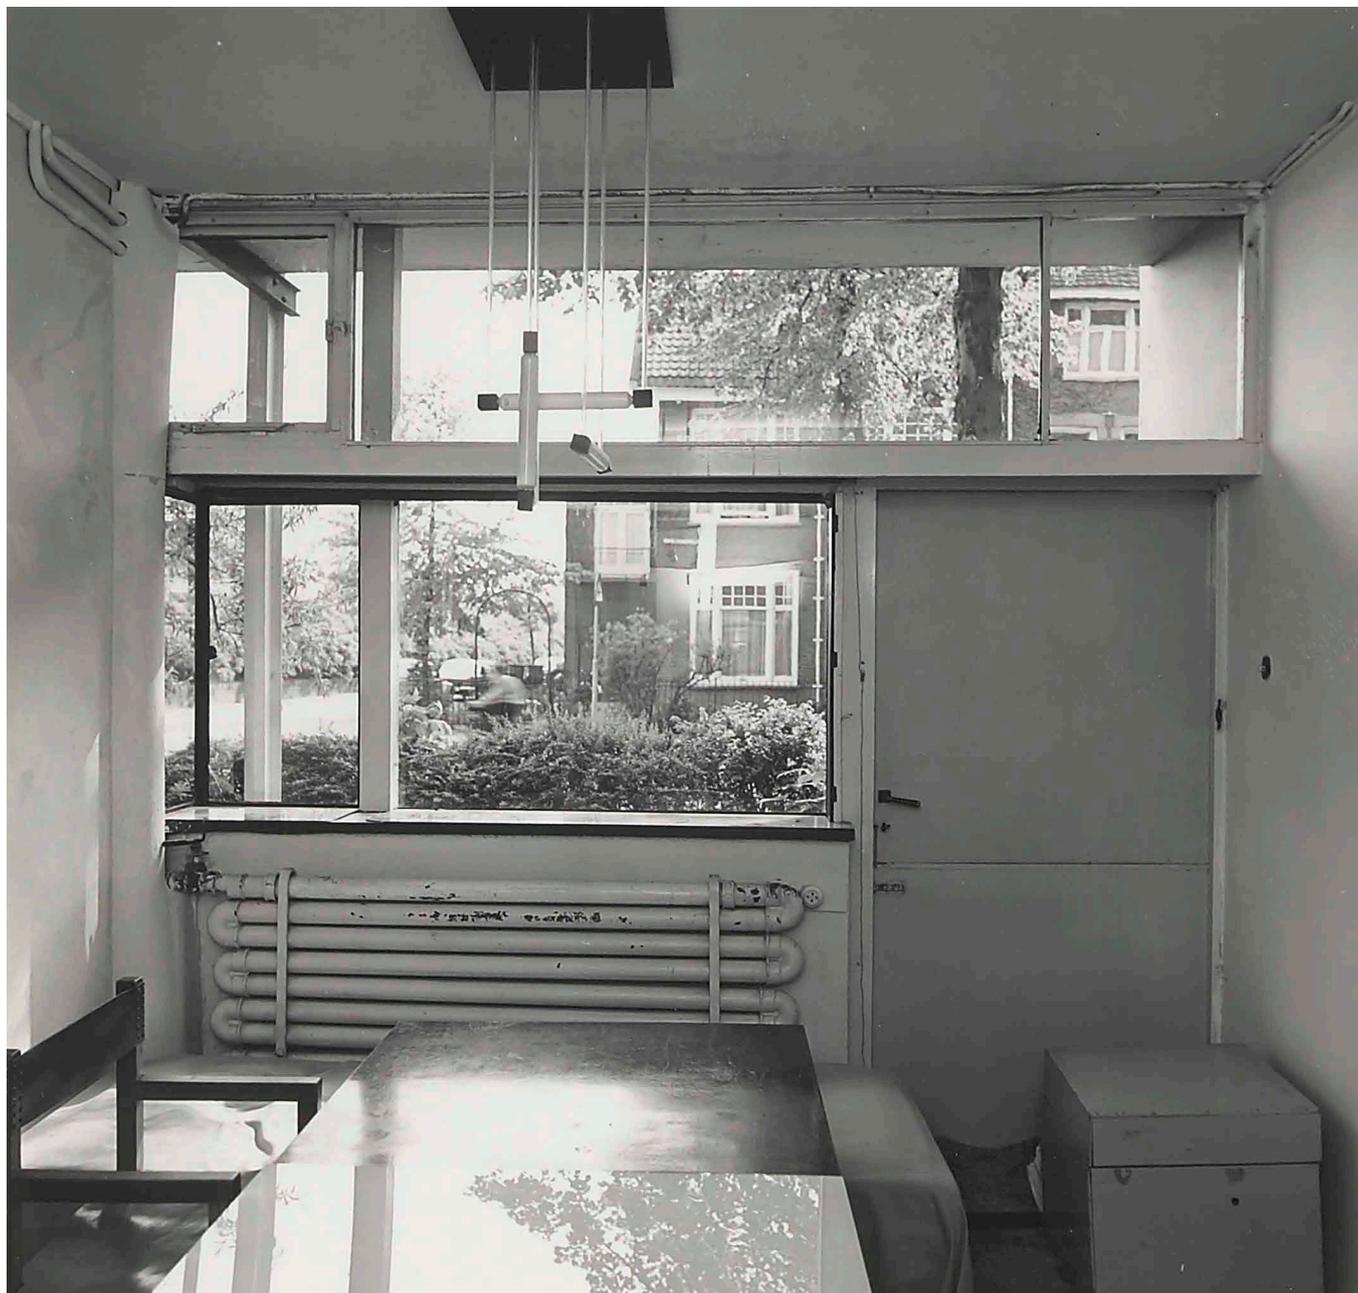
Armed with this information, we spoke again with the architect and took another look at the archival documents. We also obtained access to previously unavailable documents and photographs.³⁹ Given that the kitchen and adjoining daily help's room had been radically renovated, we focused on the study, next to the entrance, and on Rietveld's former studio, on the Prins Hendriklaan side. The latter was conceived as a garage, but was first used as studio and later served a number of different purposes. Various colour schemes can be gleaned from the historical photographs, all with an emphasis on white [FIG. 3.14].

FIG. 3.14 Undated photograph of the studio with view of Prins Hendriklaan; predominantly white colour scheme

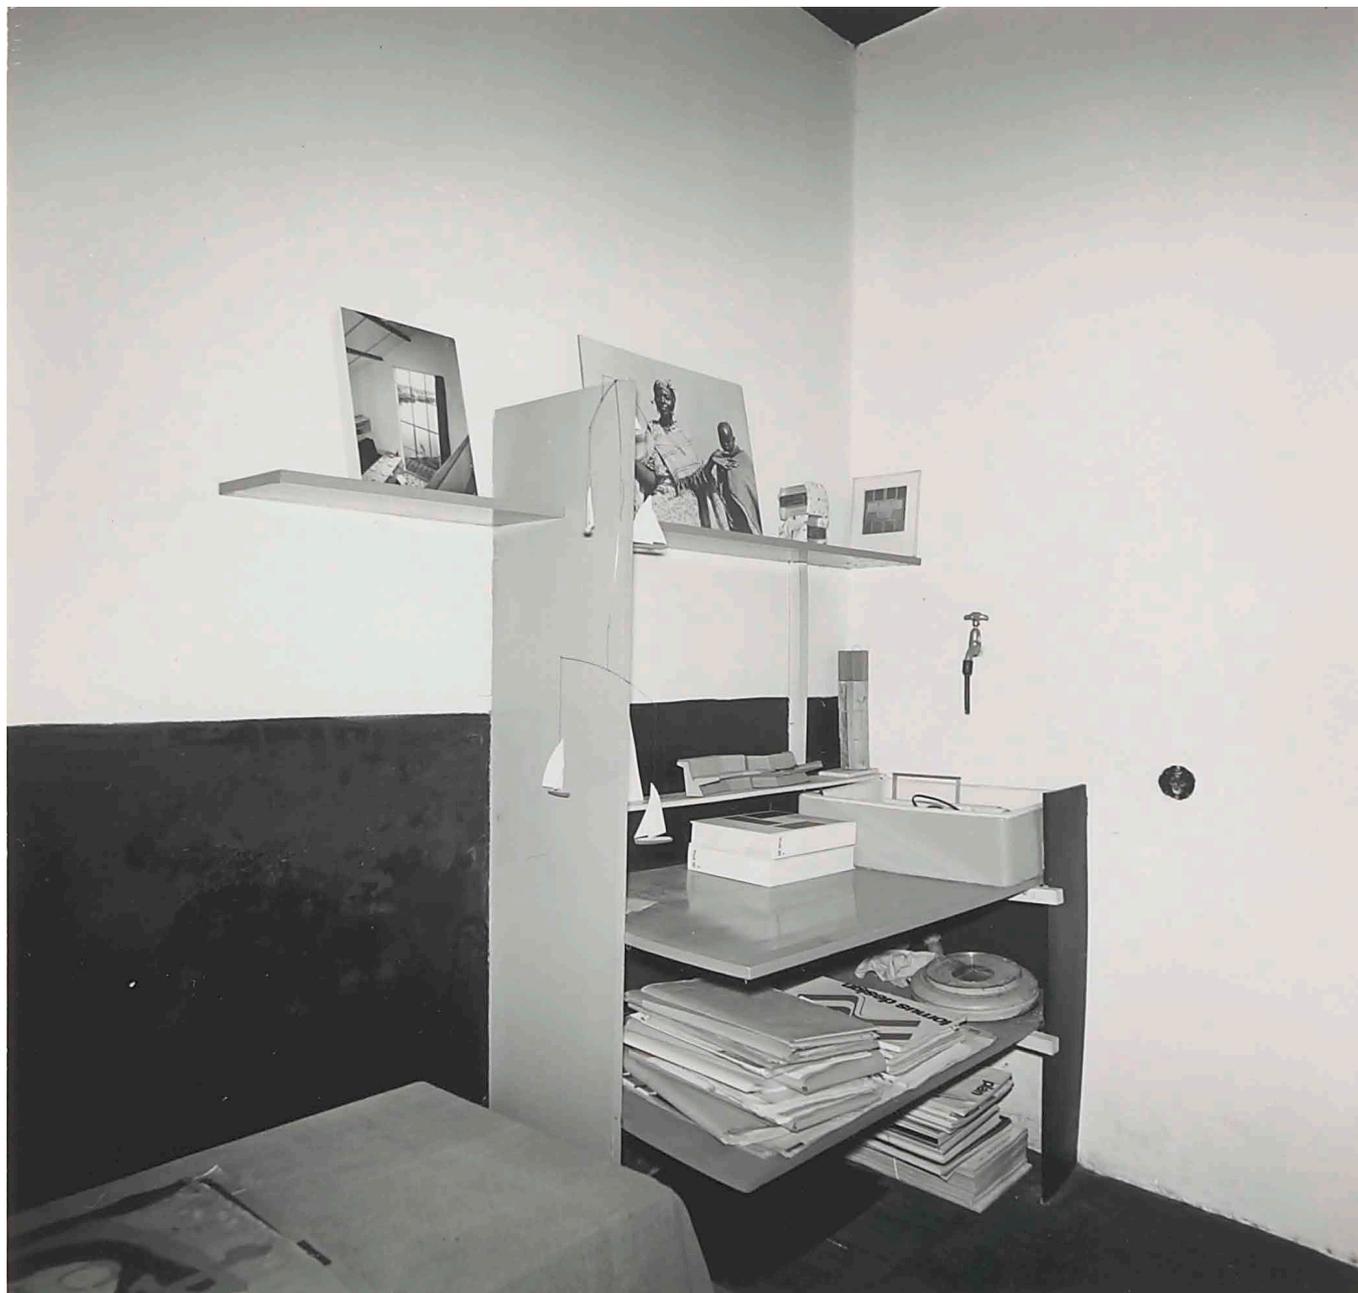
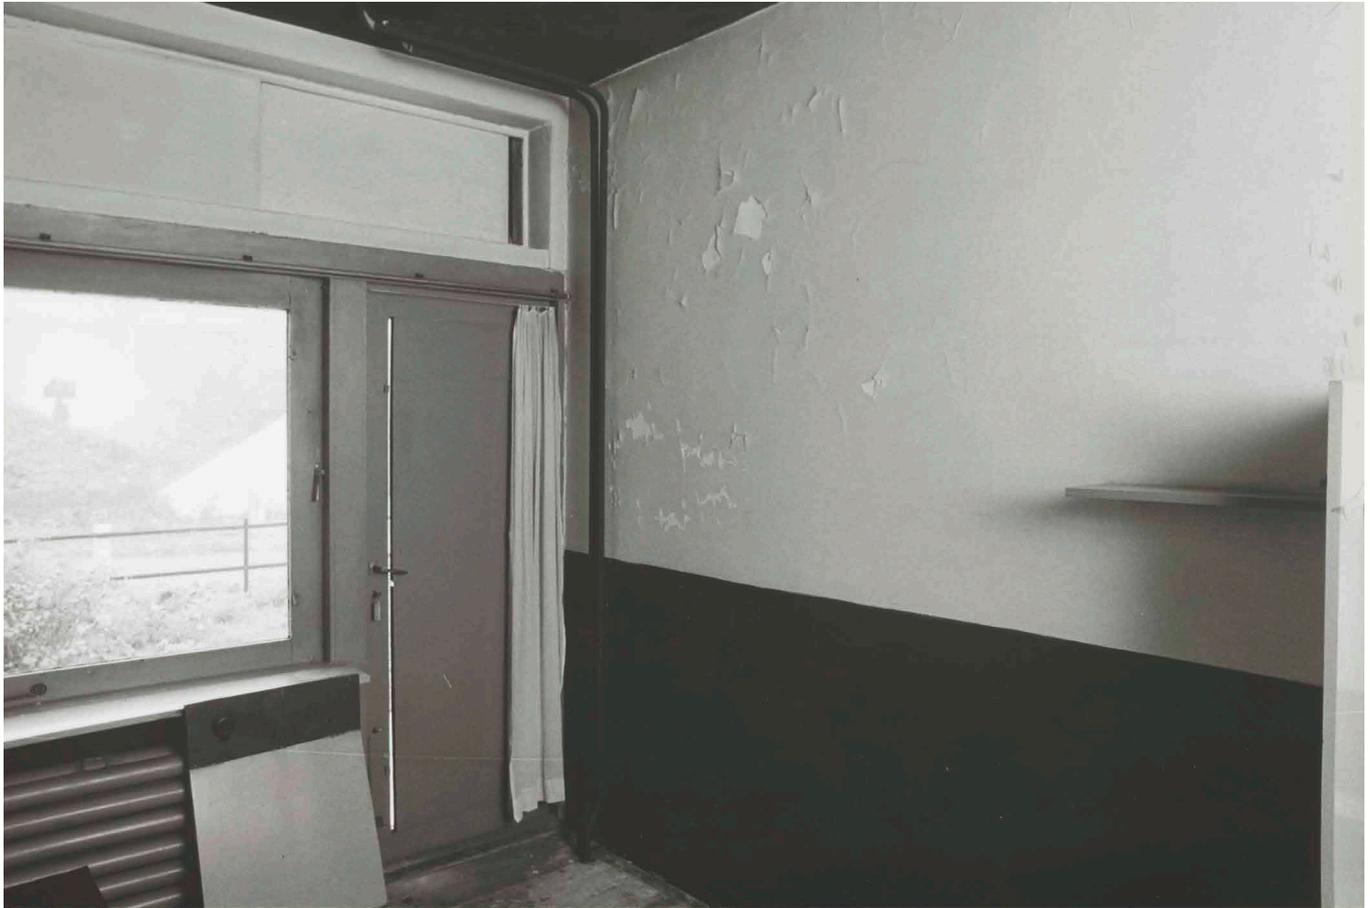
stripping away the plaster. The colour scheme of the adjoining study, in particular the greys, appeared to have changed little over the course of time, to the extent that this could be established based on historical photographs [FIG. 3.16/3.17]. Mulder recalled that the black ceiling in this room had looked pockmarked and had to be repainted. He had the other surfaces in this room repainted in the existing colours as well.

FIG. 3.16 The study painted in white, black and shades of grey, c. 1974

FIG. 3.17 Undated photograph of the study
