Root cause analysis of surface cracks in heavy steel plates during the hot rolling process

Root Cause Analysis of Surface Cracks in Heavy Steel Plates during the Hot Rolling Process

² Hormozgan Steel Company (HOSCO), Bandar Abbas, Iran

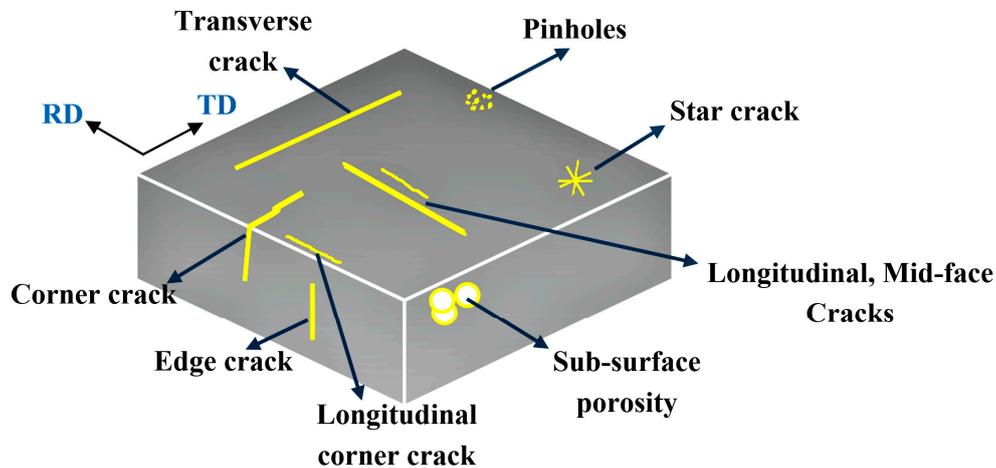
Figure 1. Schematic representation of typical surface defects in rolled products (RD: rolling direction, TD: transverse direction).
