Some learning cases in the Port of Rotterdam

De Gijt, J. G.; Brassinga, H. E.; Roubos, A. A.

IOP Conference Series: Materials Science and Engineering

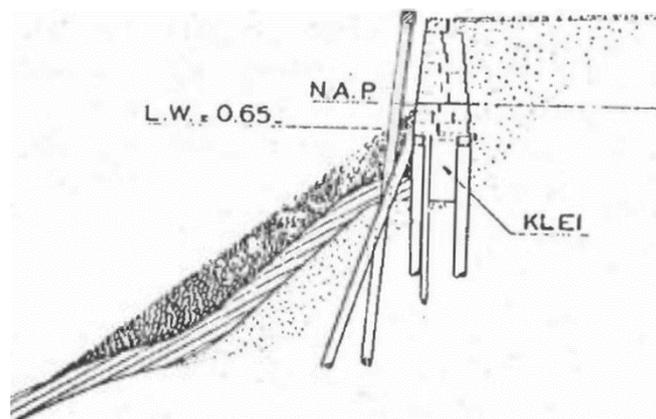
Figure 2. The reconstruction of the old Boompjes quay wall using batterpiles to increase horizontal stability.

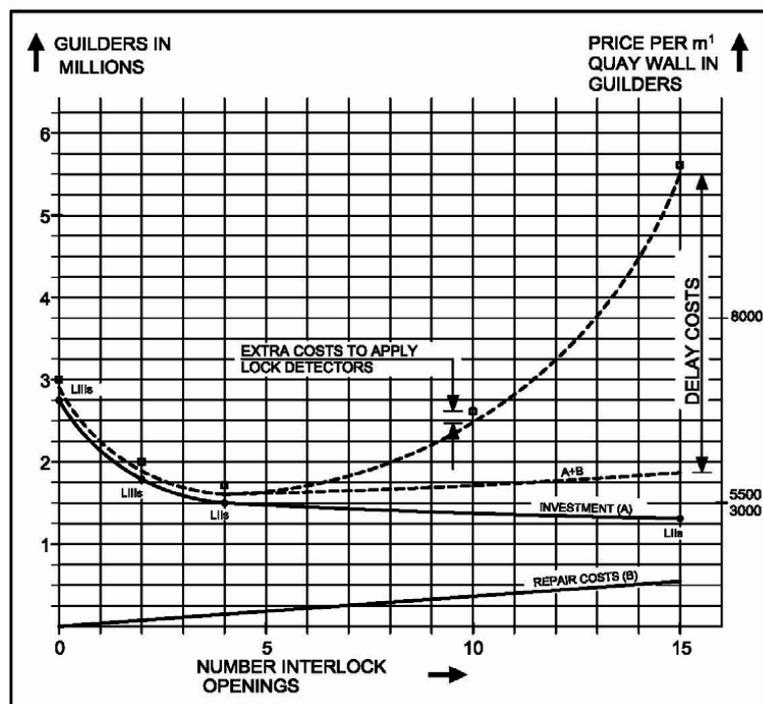
Since 1927 sheet pile elements are used to realize a retaining wall for quay walls up to a retaining height of 10 m [1]. Since 1950 the so called combi wall came into use and still is which consists of sheet pile elements with steel piles. One of the critical issues for building this type of walls is the challenge to prevent damage to the connection of the sheet pile elements and the piles. Today combined sheet piles are used for retaining heights of 30m. The evolution in time is presented in figure 10. In earlier days this wall was composed of sheet pile elements and Peiner profile sand since 1960 tubular piles are used as the main bearing element. Using this complex combi walls systems regularly interlock openings occurred.

The maximum interlock openings that occurred were with Amazone harbour quay walls 80 and with the ECT quay wall 180. Of course this raised the question could we continue with this type of structures. Therefore also other types of quay wall structures have been considered like fe caisson quay and jetties. Then in 1992 it was decided to improve the installation method which includes no driving on the sheet pile elements. These must be installed by vibrating and jetting at the same time. This of installation method appears to be a good method. In 2003 this method was further improved by drilling with bentonite.

Figure 10. Investment in risk to prevent interlock openings.

Within the study conducted it was concluded that 2 interlock openings per 500 m quay wall is acceptable. The cost of repair of an interlock opening is approximately 30000 euro for each interlock damage.
