# Wear Induced Failure of Automotive Disc Brakes—A Case Study

**Abstract:** This paper investigated a failure in a ventilated disc brake in an automobile. The failed brake disc had been in service for approximately 10 years. The observed failure was in the form of radial cracks that appeared to have initiated at the outer edge of the disc brake. The cracks were rather straight with no branching. Optical microscope, scanning electron microscope (SEM), and energy dispersive X-ray spectroscopy (EDS) were used to study the microstructure of the failed disc. Vickers microhardness test was also used to evaluate the hardness of the samples. Results showed that the root cause of crack formation, in this case, was related to the excessive wear in the brake disc. Different wear mechanisms, namely abrasive and adhesive wear, were recognized in the failed specimen. Moreover, the worn surface in some areas was covered with fine oxide particles. These particles appeared to have a significant contribution toward abrasion. To further understand the wear mechanisms, pin-on-disc experiments were also conducted on the samples. Results of the pin-on-disc experiments were compared and correlated to th

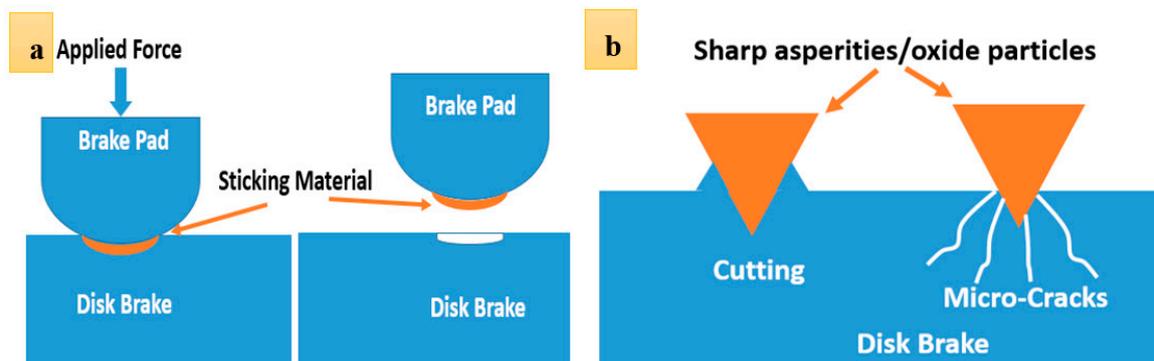
While plastic deformation and spallation are indications of an adhesive wear mechanism, plowing and cutting can be linked to the abrasive wear, inferring that both adhesive and abrasive wear mechanisms contribute to weight loss during wear test. The former wear mechanism has a relatively higher kinetics of weight loss. In severe conditions, contact points in-between sliding bodies can be severely damaged by adhesive wear. In case the surface has some minimum roughness and the applied load is high enough, metal-metal sticking on contact spots becomes inevitable. In case the so-called sticking layer is weakly bonded to the disc, it will eventually be detached from the surface. This is schematically shown in Figure 10a. In comparison to the adhesive wear, abrasive wear takes place when a hard particle/asperity is sliding over a surface. Hard particles/asperities can cause abrasion without having to induce any major plastic deformation on the surface. In case particles/asperities are sharp enough, they create surface cutting. However, their attributions are not limited to cutting, as they could also cause surface micro-fractures and grain pull-outs (see Figure 10b) [23]. Cutting and micro-cracks are essentially more dominant features on the fracture surface. Surface cutting results in the detachment of wear debris. Where the wear debris is hard and fragile, they will be fragmented and entrapped in between sliding bodies and inside surface grooves, and, in turn, contribute to the abrasion of the surface. The attribution of wear debris to the wear rate depends on the relative hardness of wear particles to that of the worn surface. Fast abrasion is expected to take place when the hardness of the matrix is less than 80% of the hardness of particles [23]. If the load at the contact points is high enough, the temperature at the contact points increases, and therefore, oxidation of the wear debris is also likely to take place. This appears to be the case in this failure (see Figure 7). Oxide particles are clearly hard and are expected to cause further abrasion. Both cutting and micro-cracks are less probable when the worn surface is ductile in nature. Results show that in this case, both adhesive wear and abrasion control the wear of the disc brake during service. Figure 11 shows the SEM images of debris after wear tests. Debris can primarily be categorized into large plate-like chips, with their sizes being in the range of a few ten micrometers, and fine agglomerated particles. EDS analysis shows that

Figure 10. Schematics of (a) adhesive wear and (b) abrasive wear mechanisms.
