Train Hunting Related Fast Degradation of a Railway Crossing—Condition Monitoring and Numerical Verification

Department of Engineering Structures, Delft University of Technology, 2628 CN Delft, The Netherlands

Abstract: This paper presents the investigation of the root causes of the fast degradation of a railway crossing. The dynamic performance of the crossing was assessed using the sensor-based crossing instrumentation, and the measurement results were verified using the multi-body system (MBS) vehicle-crossing model. Together with the field inspections, the measurement and simulation results indicate that the fast crossing degradation was caused by the high wheel-rail impact forces related to the hunting motion of the passing trains. Additionally, it was shown that the train hunting was activated by the track geometry misalignment in front of the crossing. The obtained results have not only explained the extreme values in the measured responses, but also shown that crossing degradation is not always caused by the problems in the crossing itself, but can also be caused by problems in the adjacent track structures. The findings of this study were implemented in the condition mon

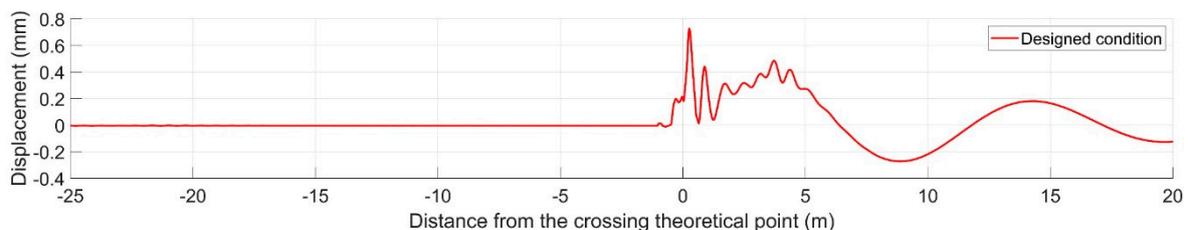
Figure 22. Wheel lateral displacement in the designed condition.

To understand how the track misalignment affects the wheel-rail interaction in the crossing, the relationship between the wheel lateral displacements and wheel-rail contact forces were analyzed. Before that, the wheel lateral displacement in the designed condition is presented in Figure 22. When the train enters the crossing panel, the varied rail geometry will lead to the lateral movement of the wheel. The maximum lateral displacement was around 0.7 mm.

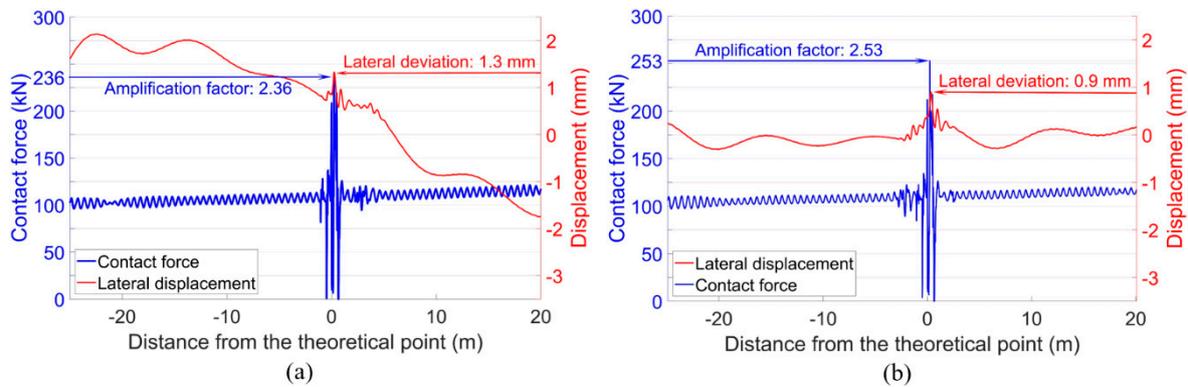
Figure 24. Wheel-rail contact forces and lateral wheel displacements. (a) Front wheel. (b) Rear wheel.

Considering the bridge-introduced lateral curve, the wheel-rail contact forces and the lateral wheel displacements were calculated, as presented in Figure 24. It can be seen that in the front wheel, the bridge-introduced curve mainly resulted in the lateral shift of the wheel trajectory due to the centripetal force. Such a shift was only 0.5 mm near the crossing nose when compared with the designed condition, and the effect on the wheel impact was limited. For the rear wheel, the combined effect of the curve and the motion of the front wheel resulted in the lateral deviation of 0.9 mm, which was quite close to that in the designed condition and had no significant influence on the wheel-rail impact.

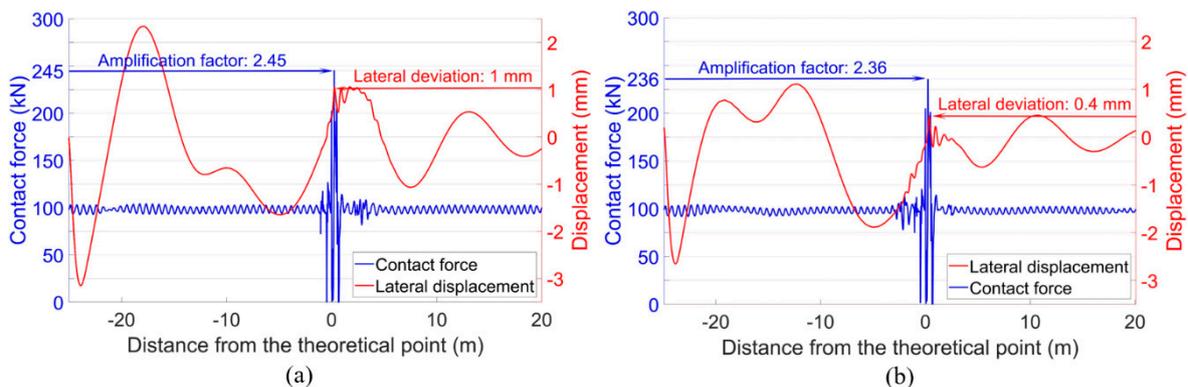
Figure 25. Wheel-rail contact forces and wheel lateral displacements. (a) Front wheel. (b) Rear wheel.

The effect of the track gauge deviation on the wheel-rail interaction is demonstrated in Figure 25. Different from the effect of the bridge-introduced curve, the deviated track gauge activated the hunting motion of the passing wheels. Still, the resulted lateral wheel displacements were not large enough to amplify the wheel-rail impact. The maximum displacements corresponding to the wheel impacts were 1 mm in the front wheel and 0.4 mm in the rear wheel, respectively.

Based on the above analysis, it can be concluded that the extremely high wheel-rail impacts in the monitored crossing were caused by the hunting oscillation of the passing trains. Such train hunting was the combined effect of the bridge-introduced curve in front of the crossing and the deviated track gauge along the turnout. When the maximum wheel lateral displacement reaches a certain level (e.g., 2.3 mm), the wheel-rail impact will be dramatically amplified.
