Re engineering history: Flight of the Phoenix, what can we learn from a movie crash?

AIAA SCITECH 2022 Forum

Michiel J. Schuurman*, Roeland De Breuker[†] and Christos Kassapoglou[‡]
Delft University of Technology, Faculty of Aerospace Engineering, Delft, 2629HS, The Netherlands

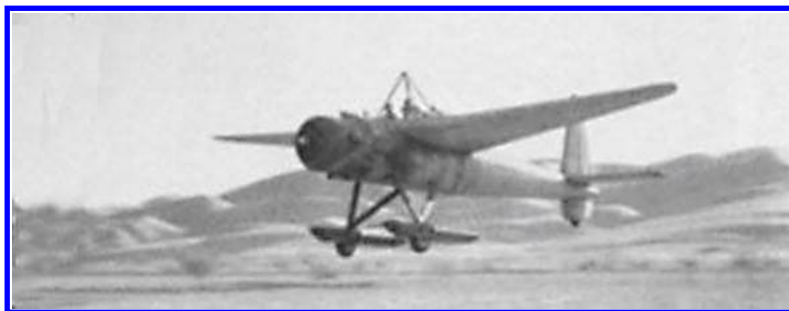
Fig. 2 Tallmantz P-1 flying for the Flight of the Phoenix movie sequence [23].

A final third pass was made in which the P-1 touched down on the sand. Bobby Rose escaped from the wreckage with a shoulder injury and Paul Mantz was fatally injured.
