## Re engineering history: Flight of the Phoenix, what can we learn from a movie crash?

AIAA SCITECH 2022 Forum

Michiel J. Schuurman\*, Roeland De Breuker<sup>†</sup> and Christos Kassapoglou<sup>‡</sup>

*Delft University of Technology, Faculty of Aerospace Engineering, Delft, 2629HS, The Netherlands*

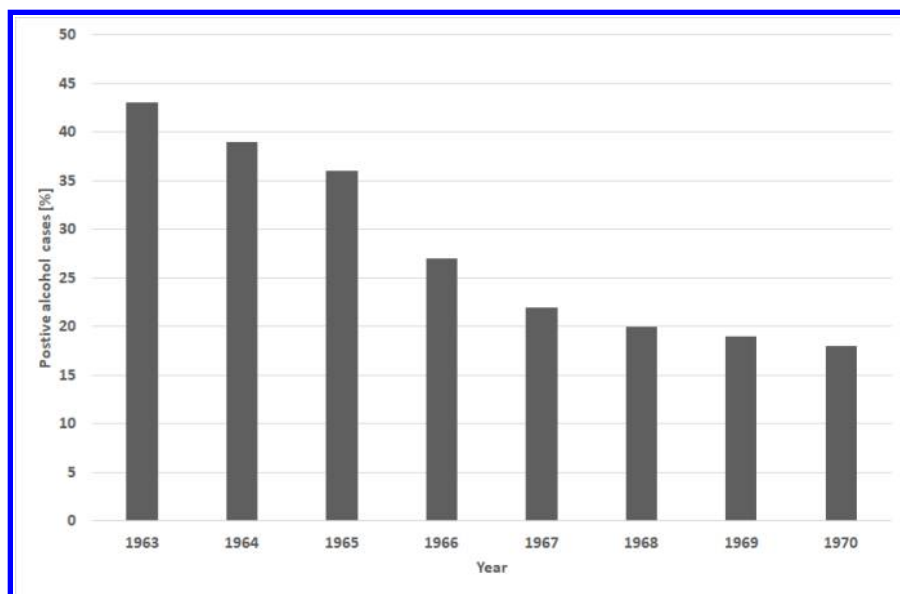
The NTSB determined that a contributing factor was alcohol impairment of efficiency or judgement. The NTSB considers alcohol to be a causal factor when a value of 50mg% or higher is found [27]. Studies have shown that pilot performance is degraded even when there is a small amounts of alcohol are consumed [28][29]. The level established by the NTSB for impairment of efficiency or judgement is substantiated.

**Fig. 6 General Aviation positive alcohol cases [%] [27]**

Reviewing the general aviation accidents from 1963-1970 it is evident that alcohol was present in many accidents, see Figure 6. In a 1963 study a total of 35.4% pilots involved in general aviation accidents had measurable level of alcohol in their blood at the time of their crash [30]. This study however did not account for contamination of the blood and putrefaction. Subsequent studies which accounted for contamination revealed lower values [31][32][33]. Especially in case of extensive (abdominal) trauma, which is very likely in aviation disasters (e.g. rupture of the viscera), interpretation of blood alcohol values in autopsy specimens from the pilot and crew is highly contentious [34]. In recent studies the main conclusion is that care must be taken to reach a valid conclusion related to blood alcohol levels.
