Shearography non-destructive testing of a composite ship hull section subjected to multiple impacts

Proceedings of the 20th European Conference on Composite Materials: Composites Meet Sustainability

Nan Tao^{a*}, Andrei G. Anisimov^a, Marcel Elenbaas^b, Roger M. Groves^a

a: TU Delft Structural Integrity & Composites b: Damen Shipyards *n.tao@tudelft.nl

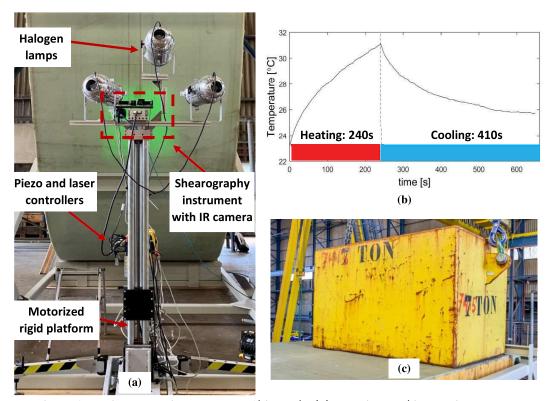
Figure 2 Testing campaign at Damen Shipyards: (a) Experimental inspection system. (b) Average temperature profile from thermal loading. (c) Applying mechanical loading.

The hull shell was illuminated with a Torus 532 laser source (optical power of 500 mW and wavelength of 532 nm) through a beam expander [Fig. 2(a)]. The formed speckle image was captured by a Pilot piA2400 camera with Linos MeVis-C 1.6/25 imaging lens and a Thorlabs bandpass filter through a Michelson interferometer. A piezo-electric actuator PSH 4z from Piezosystem Jena was used to enable temporal phase-shifting (three-step, 2.8 s per phase-shifting cycle). The shearing distance is about 9 mm (~34 pixels) in the vertical direction, which was determined experimentally to produce reliable phase maps for defect detection. During the testing, the shearography instrument was fixed on a motorized rigid platform. By adjusting the rigid platform, scanning in both horizontal and vertical directions can be achieved, enabling a large-area inspection.

Thermal loading was performed by three halogen lamps, each operating at full electrical power (1000W) [Fig. 2(a)]. During heating and cooling, the surface temperature of the hull shell was monitored with a FLIR A655 thermal infrared (IR) camera. The fields of view (FOVs) were inspected by repeating the same thermal loading [Fig. 2(b), 240s of heating], while the average temperature increase of the heated area was about 8 °C. Mechanical loading was done by

placing a 7-ton metal block on the structure [Fig.2(c)], which corresponds to the landing of a medium-sized helicopter.
