## Investigation of the formation of corrugation-induced rail squats based on extensive field monitoring

Deng, Xiangyun; Qian, Zhiwei; Li, Zili; Dollevoet, Rolf

Published in International Journal of Fatigue

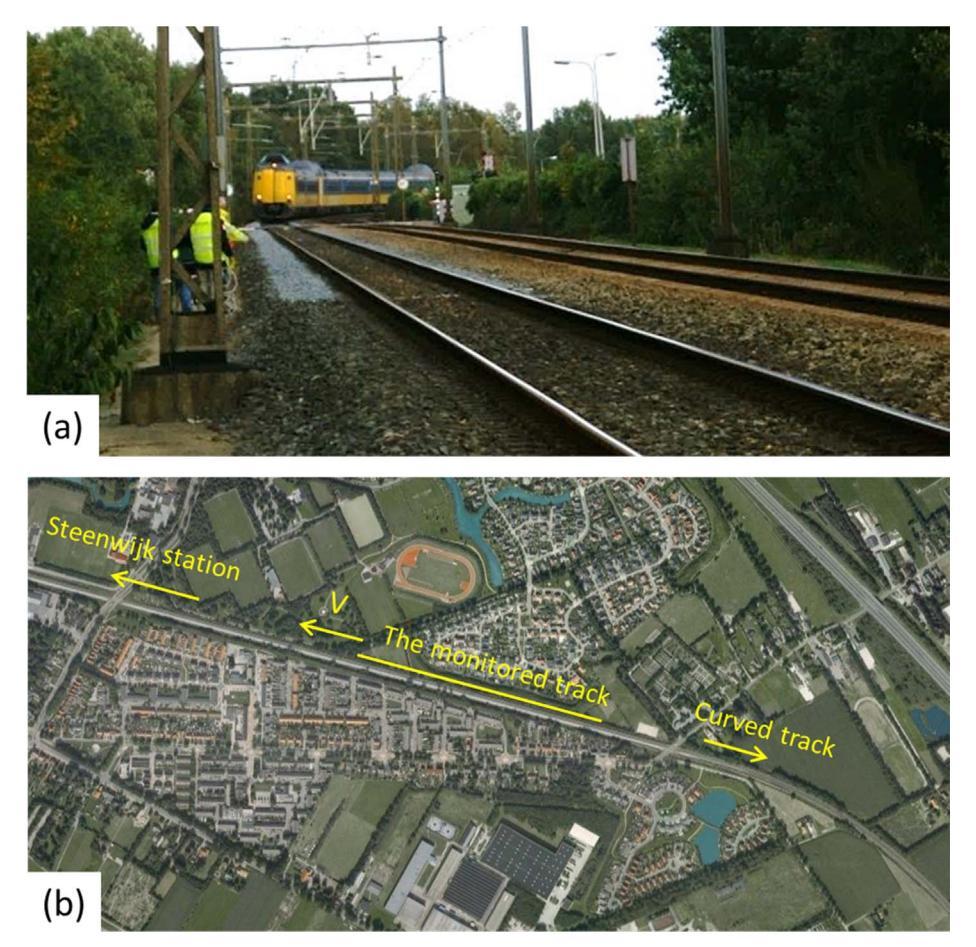
Fig. 2. Overview of the monitored straight track: (a) Monitored track looking in the direction of the curve against the traffic; (b) Google satellite view of the site.

A straight section of the Dutch railway network was selected for a five-year continual field monitoring of squat initiation and evolution. The monitored track was located in Steenwijk in the Netherlands, as shown in Fig. 2. During the period from 2007 to 2012, ten field observations were conducted at intervals of approximately 6 months. Two times of grinding were performed on the monitored track during the period of the monitoring. The first one was performed between the fifth monitoring observation (November 2009) and the sixth observation (June 2010) with a material removal of 1.1 mm (including natural wear by traffic because these 1.1 mm were derived from the profiles measured during the fifth and sixth observations); the second one was performed between the seventh observation (April 2010) and the eighth observation (August 2010) with a material removal of 0.3 mm (including natural wear). There was no grinding before the start of the monitoring. One-directional traffic ran on the track at a frequency of approximately 20 min per train during the day and no trains during the night. The majority of the traffic consisted of passenger trains. The maximum axle load of the trains was approximately 22 tons [19], and the annual traffic load was about 3.4 MGT. When trains were running on the straight section, they had just exited a curved track. The speed of the trains was 130 km/h and some traction was needed to maintain this speed. The rails were of the R260Mn grade with UIC54E1 as the nominal profile with a weight of 54 kg/m. They were installed in the track in 1989.

The section of track was selected for monitoring because of the following reasons. First, some corrugation and resulting squats of various severities were observed at the beginning of the monitoring, as shown in Fig. 3(a). In view of the active nature of corrugation-induced squats, it was predictable where new squats would initiate and grow from the developing corrugation. This makes a fruitful selection of monitoring locations possible. The second reason is that there were no visible defects or residual cracks in the rail surface other than the intended corrugation and squats. The third reason is that the rails had not been ground. To prove that any grinding was not performed before the start of the monitoring, the rail profiles measured during the monitoring at a number of defect-free locations were analyzed. It was found that the average rail head loss due to the natural wear was 0.07 mm/ year between the first and fifth observations, and the average rail head height loss was 0.06 mm/year between 1989 and 2007. The height loss of 0.06 mm/year would have not been possible if any corrective grinding had taken place. This was further confirmed by looking at the measured profiles, as shown in Fig. 3(c) and (d), where the measured profiles are aligned with the nominal profile (in black) on the field side (the left side). The measurements show good repeatability. The profile (in magenta) measured immediately after a corrective grinding at the sixth observation is as smooth as the other profiles on the gauge side. In contrast, the ground profile has a larger rail head height loss (see Fig. 3(d)) and a sharp turning point at the field side (indicated in Fig. 3(c)), apparently it is different from other profiles. If there was any

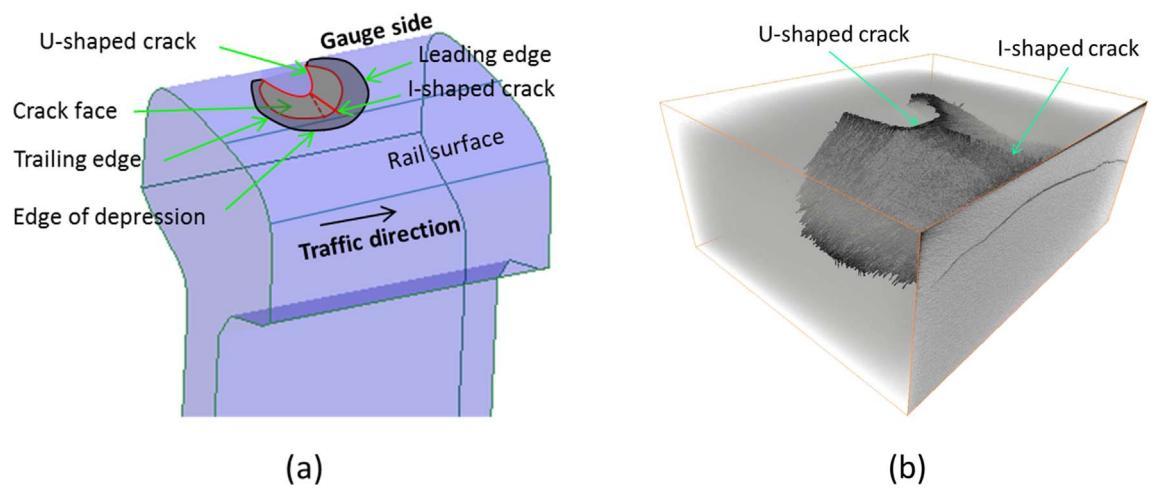
Fig. 8. 3D crack face in a two-lung-shaped squat: (a) Inferred from the surface-visible Y shape and the cracking angle  $\alpha$  of Fig. 7(c); (b) obtained from specimen 2b (squat caused by corrugation) from [20] with computed tomography, courtesy of Meysam Naeimi.

The U-shaped crack initiated at the bottom point of the U and then propagated toward the gauge side in both the traffic and opposite-traffic directions simultaneously, as illustrated in Fig. 8. The crack also propagated into the rail at an angle of approximately 20°. This cracking process was observed at more than 20 monitored squats, as shown above. Based on this finding, the shape of the crack was constructed and is shown in Fig. 8(a). This shape was verified with 3D computed tomography [20], as seen in Fig. 8(b).

In Fig. 8, the crack face encloses a peninsula-shaped part. The intersection of the peninsula-shaped part with the rail surface is a Ushaped crack. When the U-shaped crack grows, the two arms of the U extend toward the gauge side; this makes the peninsula-shaped part longer. At the same time, the crack propagates downward into the rail, i.e., the peninsula-shaped part extends deeper into the rail. Consequently, the depressed area grows with the peninsula-shaped part simultaneously in both the surface dimension and depth.

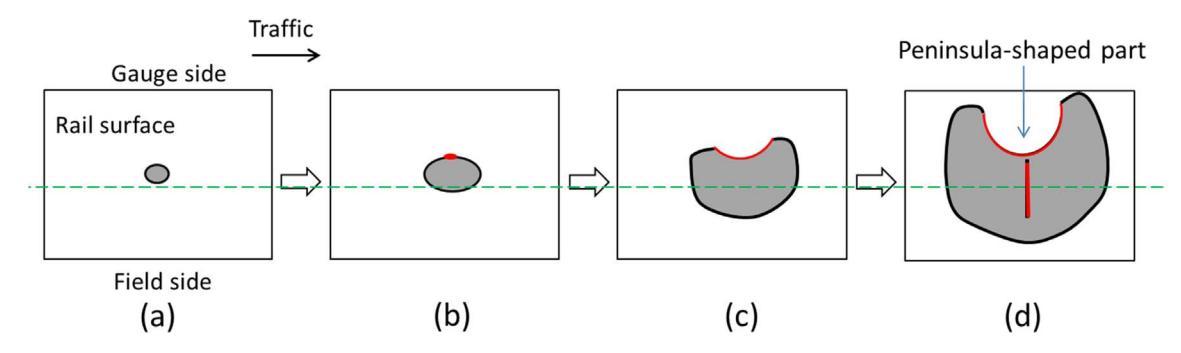
Fig. 11. Schematic diagram of the squat development process, including crack initiation and growth. The green line represents the rail centerline, the red line represents the cracks, and the gray area represents the squat/black depression with the black curved line representing its edge: (a) Elliptical small black depression; (b) crack initiation point, usually on the gauge side edge of the black depression; (c) U crack starts to form, causing the elliptical depression to become kidney shaped; crack propagates slightly more rapidly in the traffic direction due to traction force; (d) two-lung-shaped mature squat with a Y-shaped crack. (For interpretation of the references to color in this figure legend, the reader is referred to the web version of this article.)

Based on the observations and analyses described above, a squat development process is proposed. A schematic diagram of the process is shown in Fig. 11 to describe the squat evolution and cracking processes.

Initially, a small black depression is generated at a corrugation (Fig. 11(a)). The black depression results from microcracks due to plastic deformation and work hardening in the surface layer of the rail material, typically up to a depth of 1.1 mm, and it is caused by the cyclic wheel-rail impact forces excited by the corrugation. The black depression grows roughly in the shape of a complete ellipse until it reaches a critical size, and a primary macrocrack is initiated in/near the rail surface on the gauge side edge of the depression (Fig. 11(b)). Then, the shape of the black depression starts to change and follows the propagation of the crack, while the uncracking part remains elliptical. The surface crack propagates in a U shape toward the gauge side in both the traffic direction and the opposite-traffic direction (Fig. 11(c)). This process forms a U-shaped crack with the bottom point of the U being the initiation point of the primary crack. In this stage, the squat becomes a kidney-like shape with a concave part in the middle region bordered by the U-shaped crack. Moreover, the squat grows more rapidly in the traffic direction if the longitudinal contact force is tractive. It also propagates into the rail toward the field side at an angle of approximately 20°. When the squat grows to a certain stage, a ridge is

formed in the middle of the black depression, and an I-shaped crack can occur at this ridge. The combination of the U-shaped crack and I-shaped crack forms a Y-shaped crack (Fig. 11(d)). In this process, the U-shaped part grows into a peninsula-like shape around the time of the formation of the I-shaped crack. Eventually, this evolution process leads to a mature two-lung-shaped squat with a Y-shaped crack. The proposed development process is derived from and is valid for corrugation-induced squats, and it is elaborated in the next section.

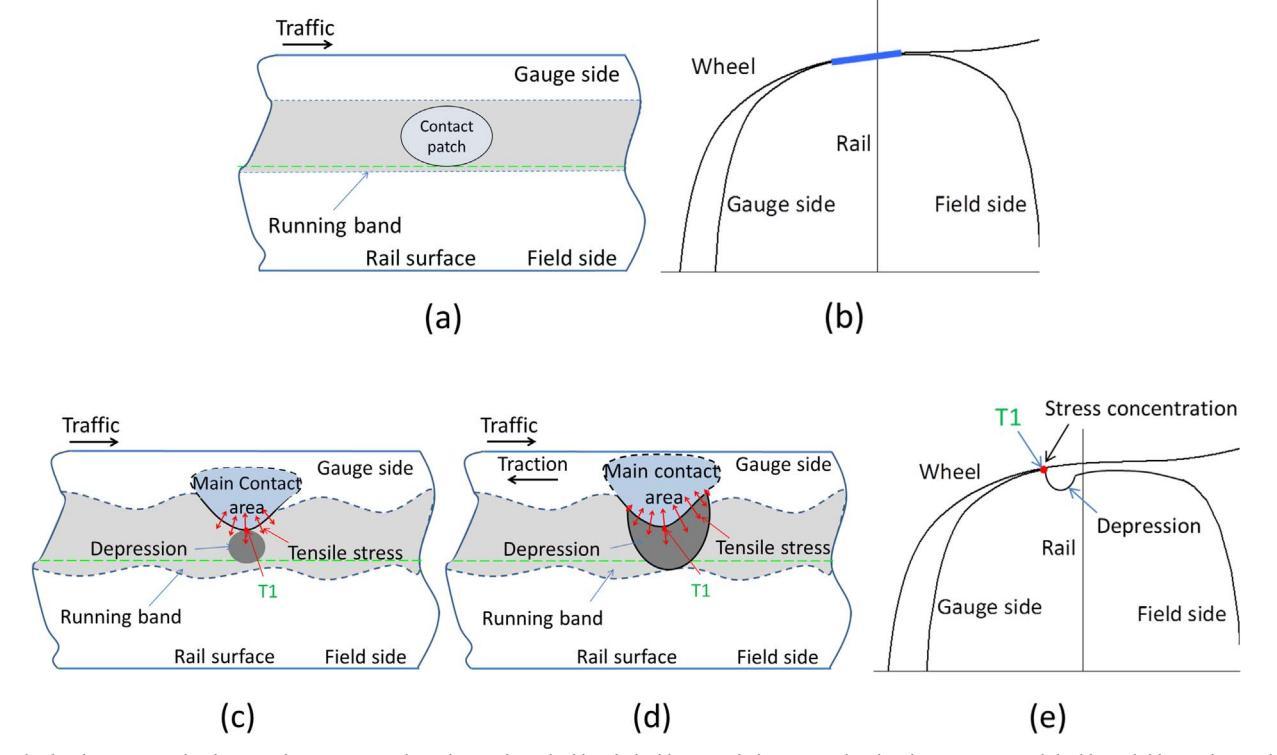
Fig. 12. Wheel-rail contact patch. The green line represents the rail centerline; the blue dashed lines mark the running band and corrugation; and the blue solid line indicates the main contact area: (a) and (b) When the rail is smooth; (c) and (e) when corrugation and a small black depression exist. The red arrows indicate tensile stress along the border of the main contact area; the length of the arrows is schematically proportional to the magnitude of the tensile stress. (c) corresponds to Fig. 11(b), and (d) corresponds to Fig. 11(c) and (d). (For interpretation of the references to color in this figure legend, the reader is referred to the web version of this article.)

When a small black depression grows to a certain size, it significantly changes the effective contact patch at the wheel-rail interface, as illustrated in Fig. 12. The contact patch can be approximated as elliptical when the rail surface is smooth, as shown in Figs. 12(a) and 10(b). However, its location and shape are different in the region when a small black depression exists. The main contact patch at the depression shifts to the gauge side, as shown in Fig. 12(c) and (d). The border of the main contact area at the edge of the depression exhibits a U shape with the opening of the U facing toward the gauge side. The U shape comes from the intersection of the wheel and the rail surfaces as a wheel is loaded onto a rail. This change in the contact patch is generalized and marked in Fig. 12(c) and (d). This main contact area is most clearly indicated by the brighter contact area bordered by the U-shaped crack at the monitored squats, such as those seen in Figs. 1, 4(d) and (e), 5, 6(d) and (e), 7, 9, 10, 15 and 17.

The region at the black depression sustains the impact from the wheels; the dynamic force is large. At the same time, the depression causes stress concentration at edge T1, as seen in Fig. 12(c), (d) and (e). The large contact force and stress concentration lead to stress that is much larger than elsewhere on the rail surface. According to the Hertz theory [25], tensile stress is present immediately outside the contact patch, and its value is maximal at the border of the contact. In the case of corrugation with surface depression, a tensile stress distribution arises along the border of the main contact area in a U shape, as indicated by the red arrows in Fig. 12(c). The tensile stress is the greatest at T1. Since the material at the depression is brittle, this greatest tensile stress results in a macrocrack at T1 by mode I fracture. This crack initiation phenomenon is analogous to the ring/cone crack formation of brittle materials under sphere contact [26] and the formation of crack

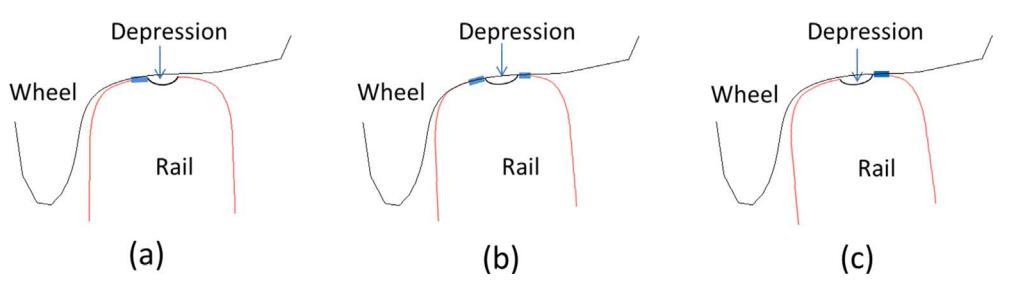
Fig. 13. Positions of the main contact areas (indicated by the blue line) that determine the locations of the primary cracks: (a) Rail inclination of 1/40; (b) a slight increase in the rail inclination; (c) a larger increase in the rail inclination. (For interpretation of the references to color in this figure legend, the reader is referred to the web version of this article.)

The case between the situations Fig. 13(a) and (c) is a slight increase in the rail inclination that slightly shifts the contact to the field side.
