## The Restoration of the Exterior

Colour, Form and Space

# 1 / THE RESTORATION OF THE EXTERIOR

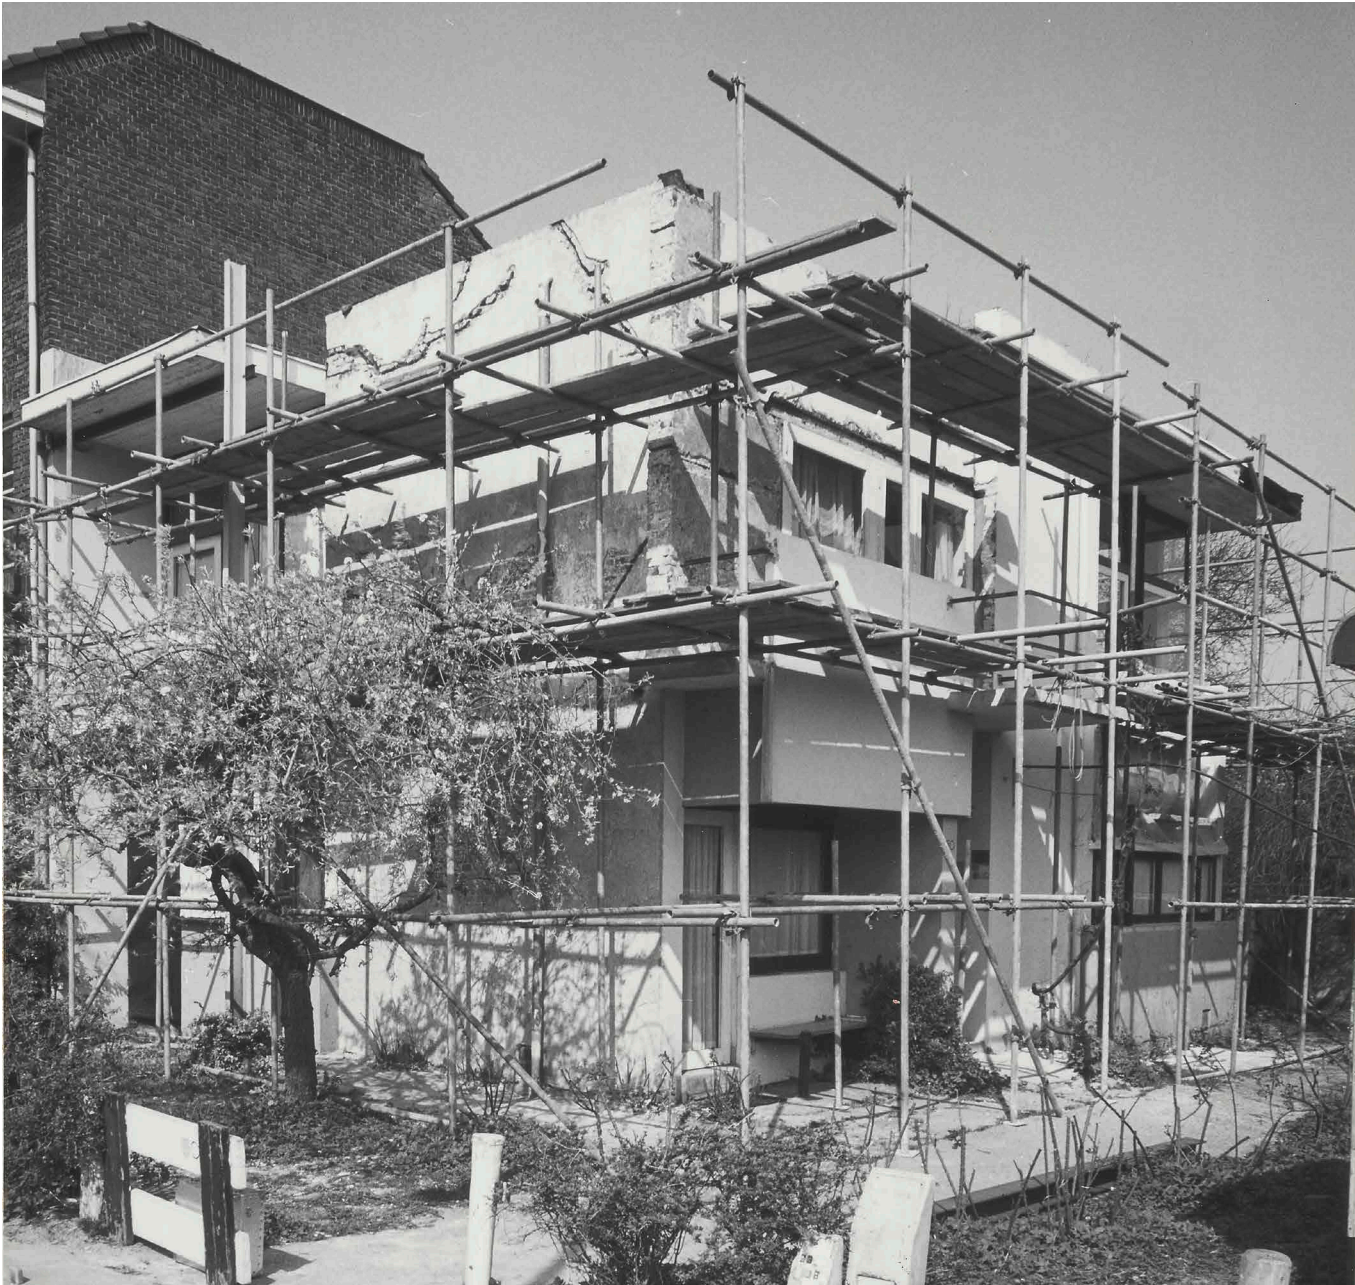
Once the house was surrounded with scaffolding, work could begin on the necessary repairs and replacements [FIG. 1.6]. The house had numerous defects and was not very stable.

FIG. 1.6 Scaffolded Rietveld Schröder House at the start of the restoration of the exterior, 1974

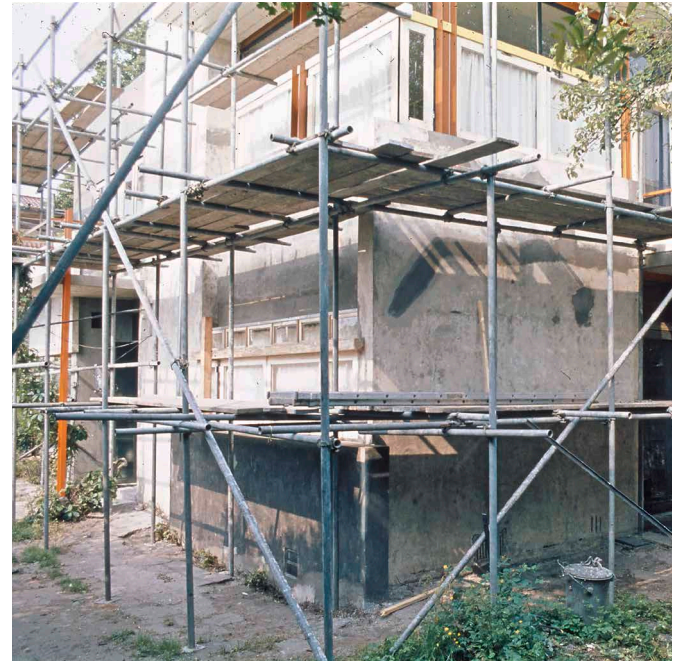
FIG. 1.8 Although the house was surrounded by scaffolding, Truus Schröder continued to live in it during the restoration of the exterior
