## Restoration of the Interior

van Thoor, M.-T. (2019). Restoration of the Interior. In M.-T. van Thoor (Ed.), *Colour, Form and Space: Rietveld Schröder House Challenging the Future* (pp. 34-53). Delft University of Technology.

# 3 / RESTORATION OF THE INTERIOR

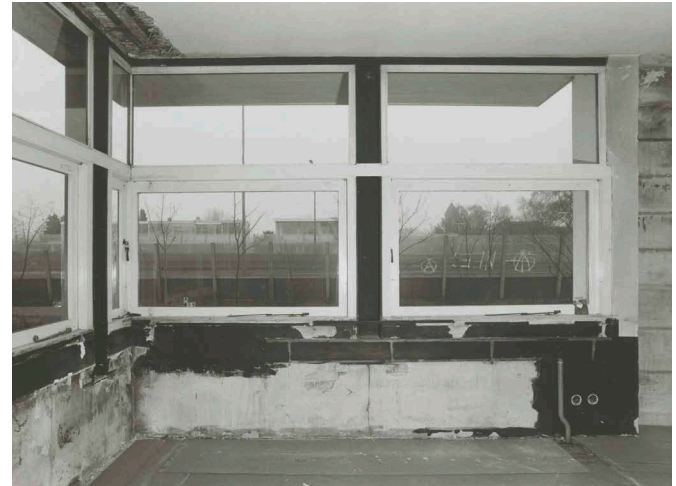
FIG. 3.4 The corner window during the restoration, with a view of the viaduct and the houses on Erasmuslaan

The most visible and radical aspect of the restoration of the upper floor was the stripping of the walls and ceiling, the elements that were so crucial to the spatial picture [FIG. 3.3/3.4]. Stripped back they revealed only 'bare brickwork' and a bare soffit [FIG. 3.5/3.6/3.7]. 'The f[oundation] and I were of the opinion that we would only be able to make the original spatial picture clearly and definitely tangible if the delimiting surfaces that determine that picture were once more of impeccable texture and colour,' Mulder later wrote. Even the possible withdrawal of the RDMZ's grant did not persuade the foundation to change its mind according to Mulder.<sup>23</sup> In 2016 Mulder still recalled a visit to his office by Ida van Zijl and Wim Denslagen. There was further discussion of the rigorous approach, which according to Denslagen did not correspond to what RDMZ was used to. Mulder explained once more that for him the original spatial experience went hand in hand with the restoration of space and surfaces. 'Denslagen disappeared, and that was the end of it'.<sup>24</sup> And so Mulder proceeded to reprise the reconstructive approach he had previously applied to the exterior.

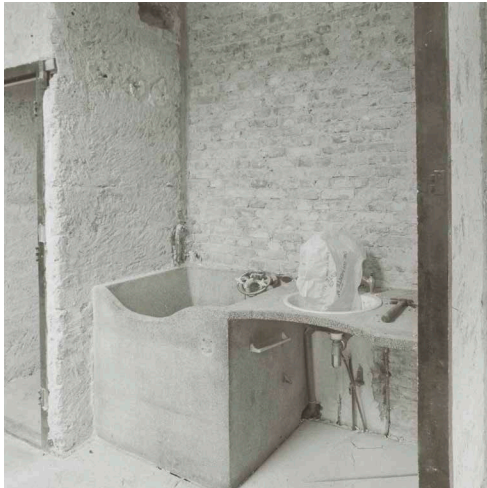
FIG. 3.7 Stripped bathroom with 'lavette'

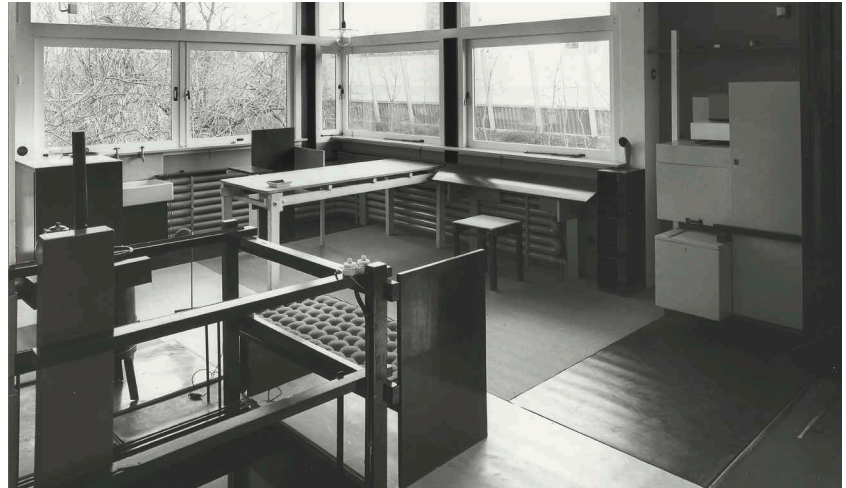
In the photographs taken in the 1970s and '80s, it is obvious that the plasterwork on the upper floor was at that moment painted white [FIG. 3.3/4.14/4.19/4.20]. The only exception was the chimney. The interior had been less frequently repainted than the exterior and significantly fewer different shades emerged when Mulder started to inspect and 'scrape' in search of underlying coats of paint. The greys were less bluish than those he had encountered on the exterior, while the red, blue and yellow were less vivid than on the exterior, especially the yellow, which was 'softer'.<sup>29</sup> On the plasterwork, and also on wooden and metal elements like the window seat in the living area, on cupboards, on the newel post, behind sliding walls, on the floor, on radiators and on the rails of the sliding walls, Mulder found the remains of what was very probably the original paintwork. These traces formed the basis for the new colour scheme in which the colours used to paint the plasterwork were white, yellow, blue and two shades of grey, while the woodwork and radiators were painted in white, black, red, yellow, yellowish green, blue and grey [FIG. 3.8].

FIG. 3.8 A black-and-white photograph of the upper floor after the restoration shows the new spatial composition and colour scheme

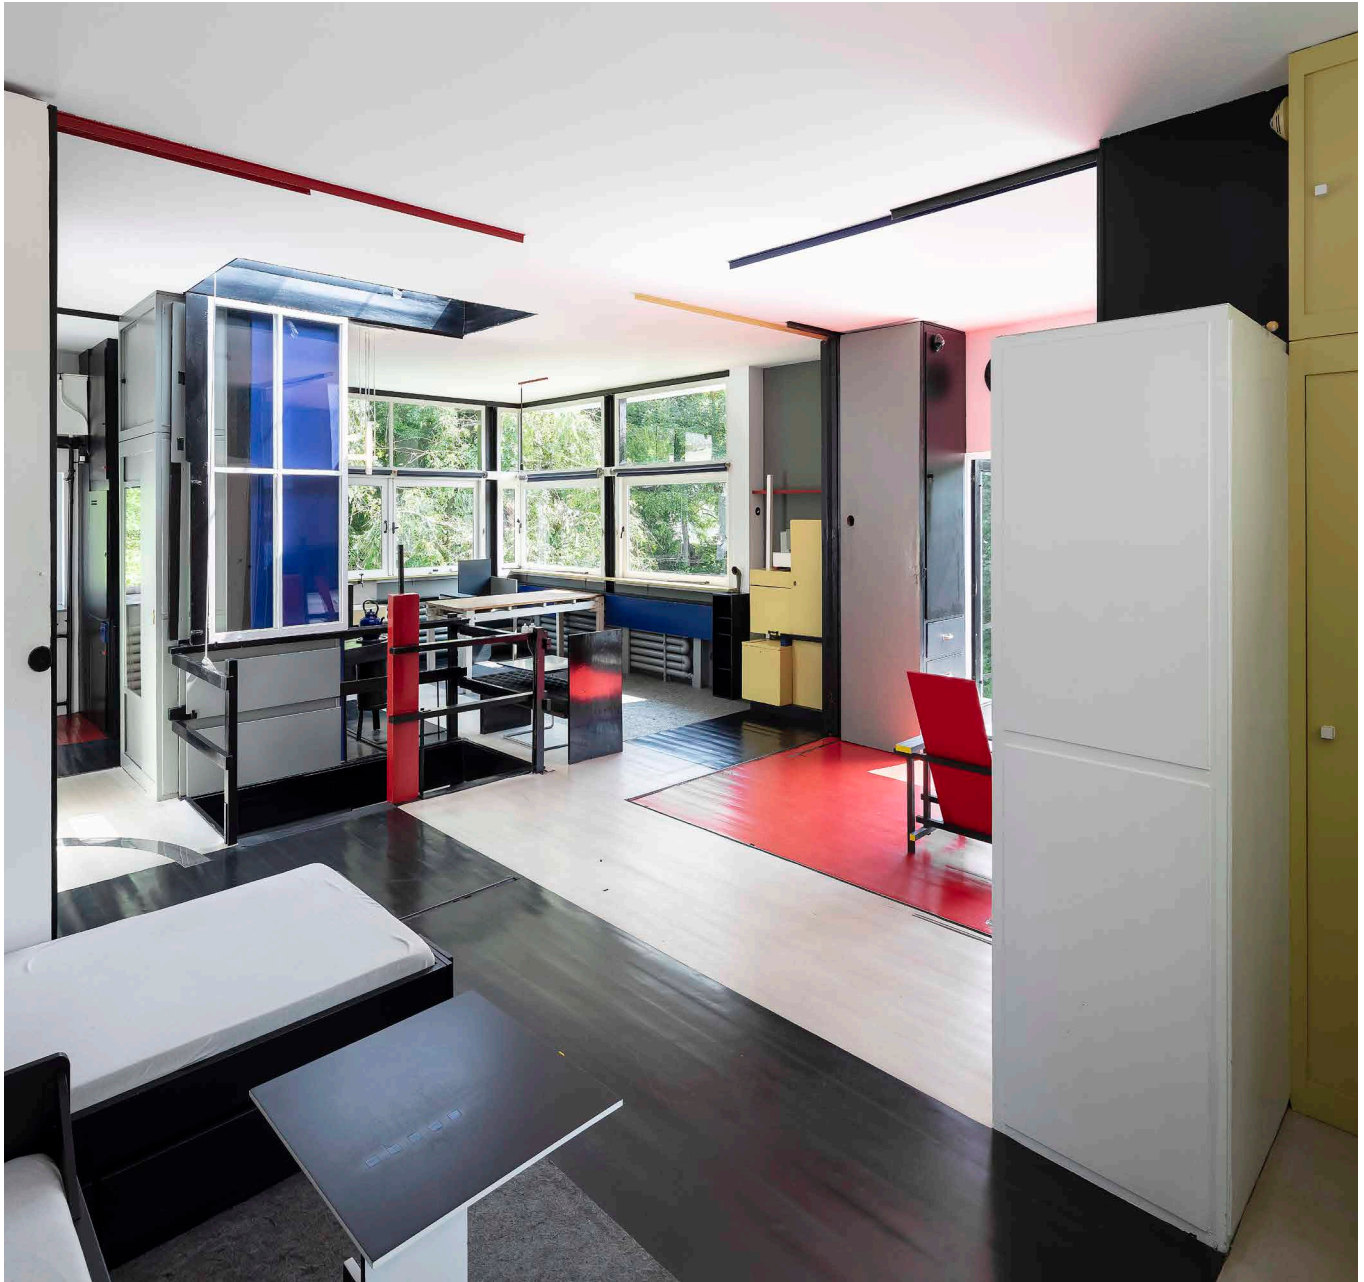
FIG. 3.10 The colour composition of the upper floor, 2018

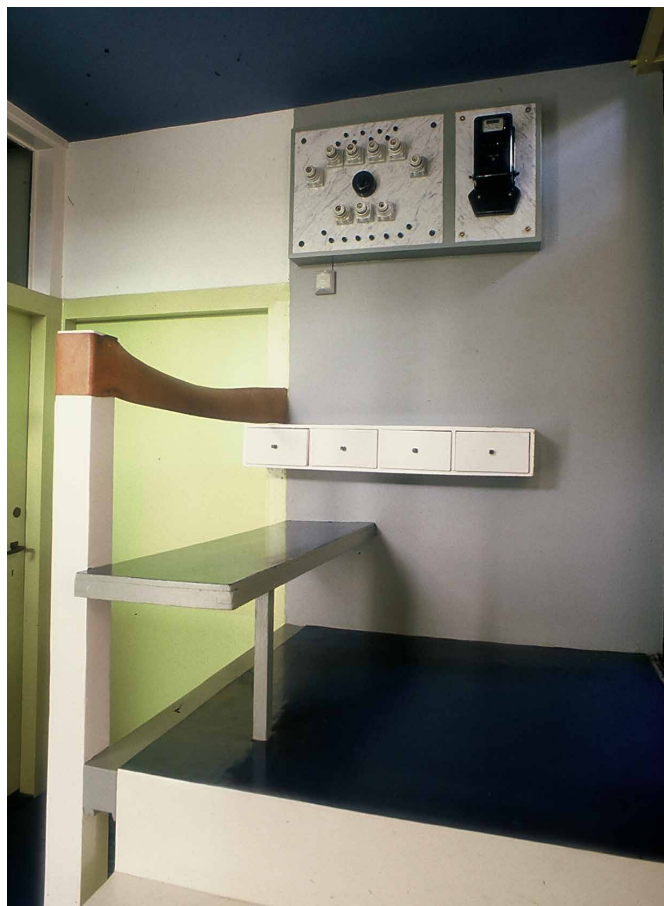
FIG. 3.11 Hall, 1985

Most of the illustrations in *Het Rietveld Schröderhuis* were of this floor, plus one or two photographs of the reconstructed kitchen or freshly painted hall on the ground floor. If we compare the hall in its current state with a photograph taken in 1985, immediately after Truus Schröder's death, the differences in colour are obvious [FIG. 3.11/3.12]. The architect repeatedly stressed that everything in the interior was created by him, that he had stripped the inner surface of the walls back to the structural shell, and

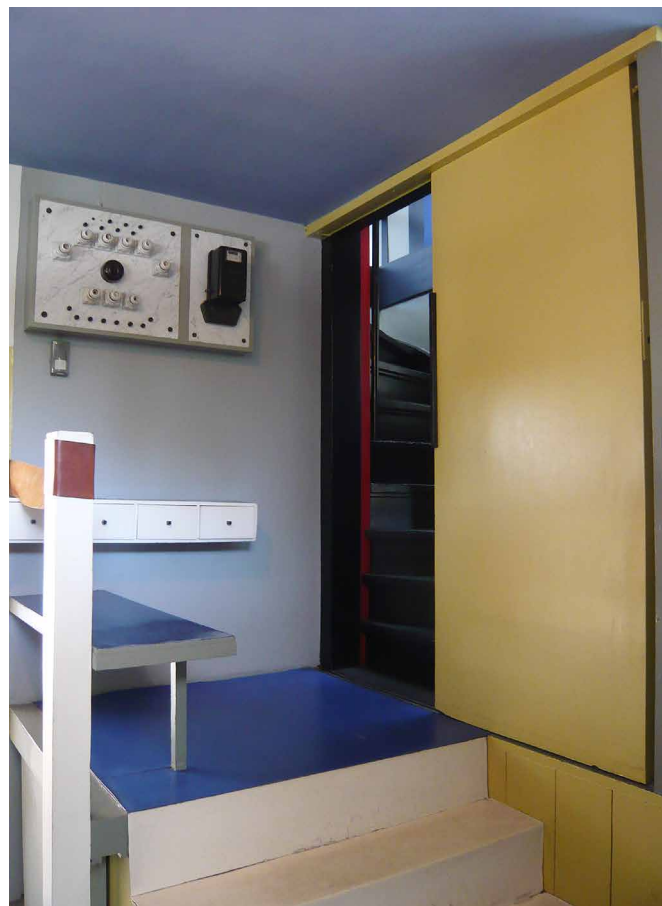
FIG. 3.12 Hall, 2015

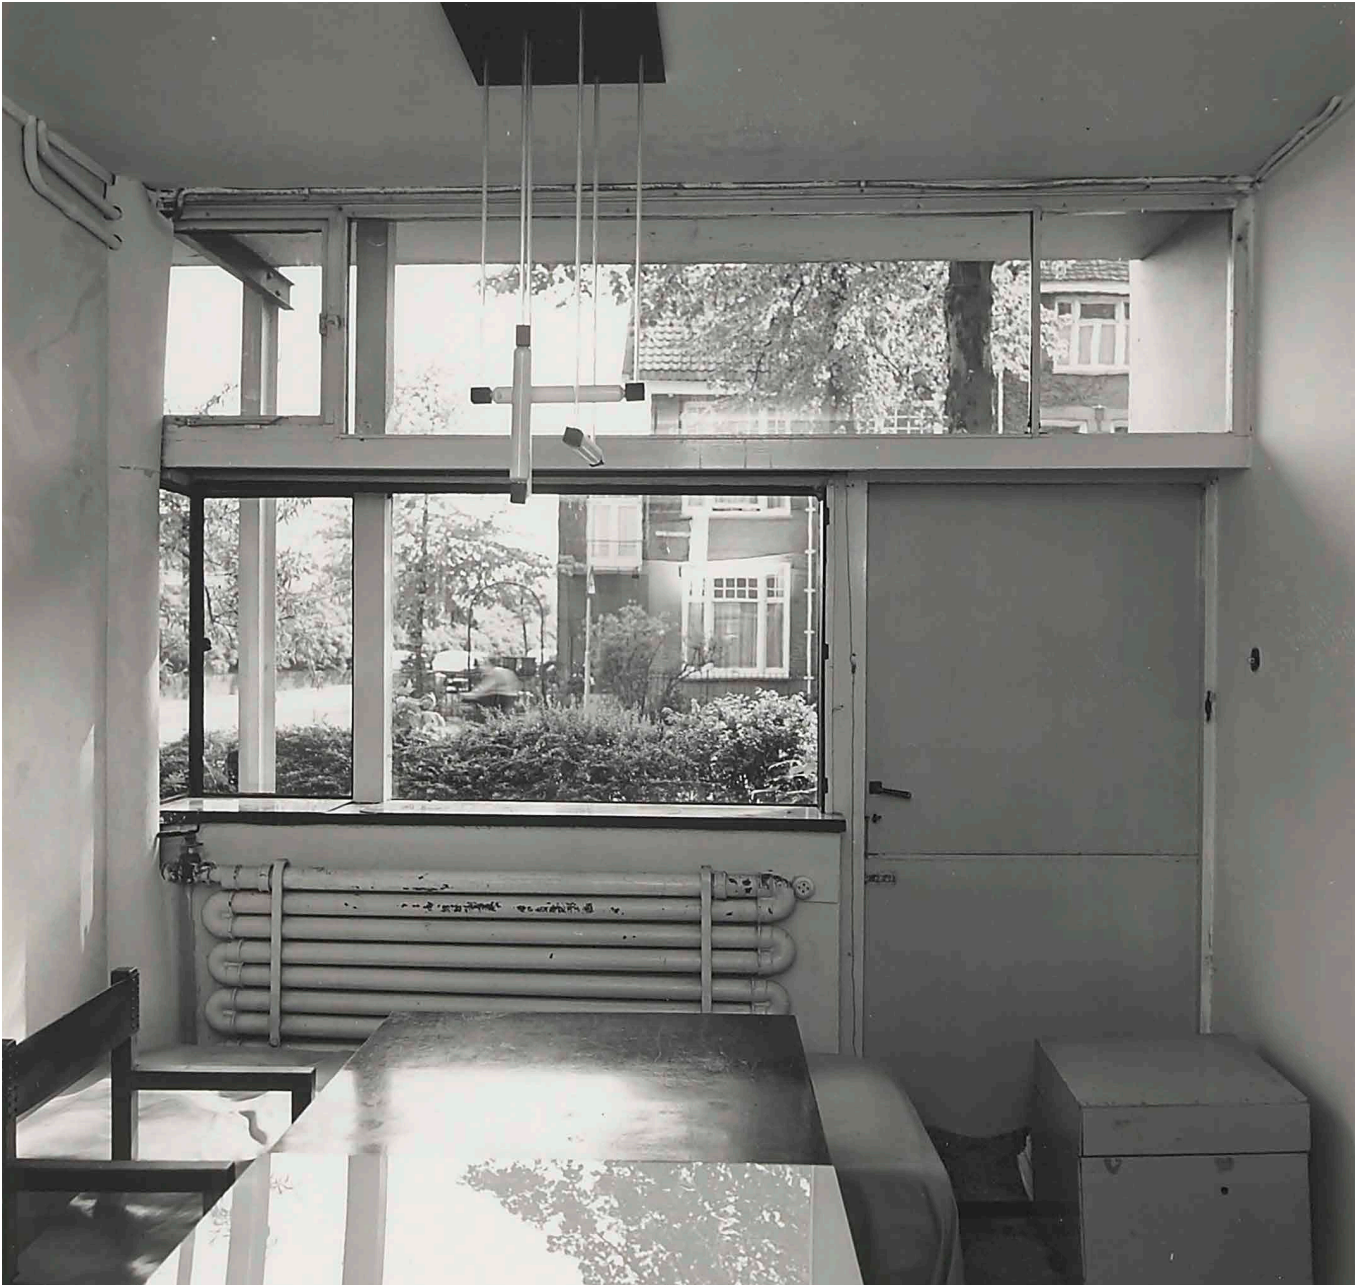
Armed with this information, we spoke again with the architect and took another look at the archival documents. We also obtained access to previously unavailable documents and photographs.<sup>39</sup> Given that the kitchen and adjoining daily help's room had been radically renovated, we focused on the study, next to the entrance, and on Rietveld's former studio, on the Prins Hendriklaan side. The latter was conceived as a garage, but was first used as studio and later served a number of different purposes. Various colour schemes can be gleaned from the historical photographs, all with an emphasis on white [FIG. 3.14].

FIG. 3.14 Undated photograph of the studio with view of Prins Hendriklaan; predominantly white colour scheme

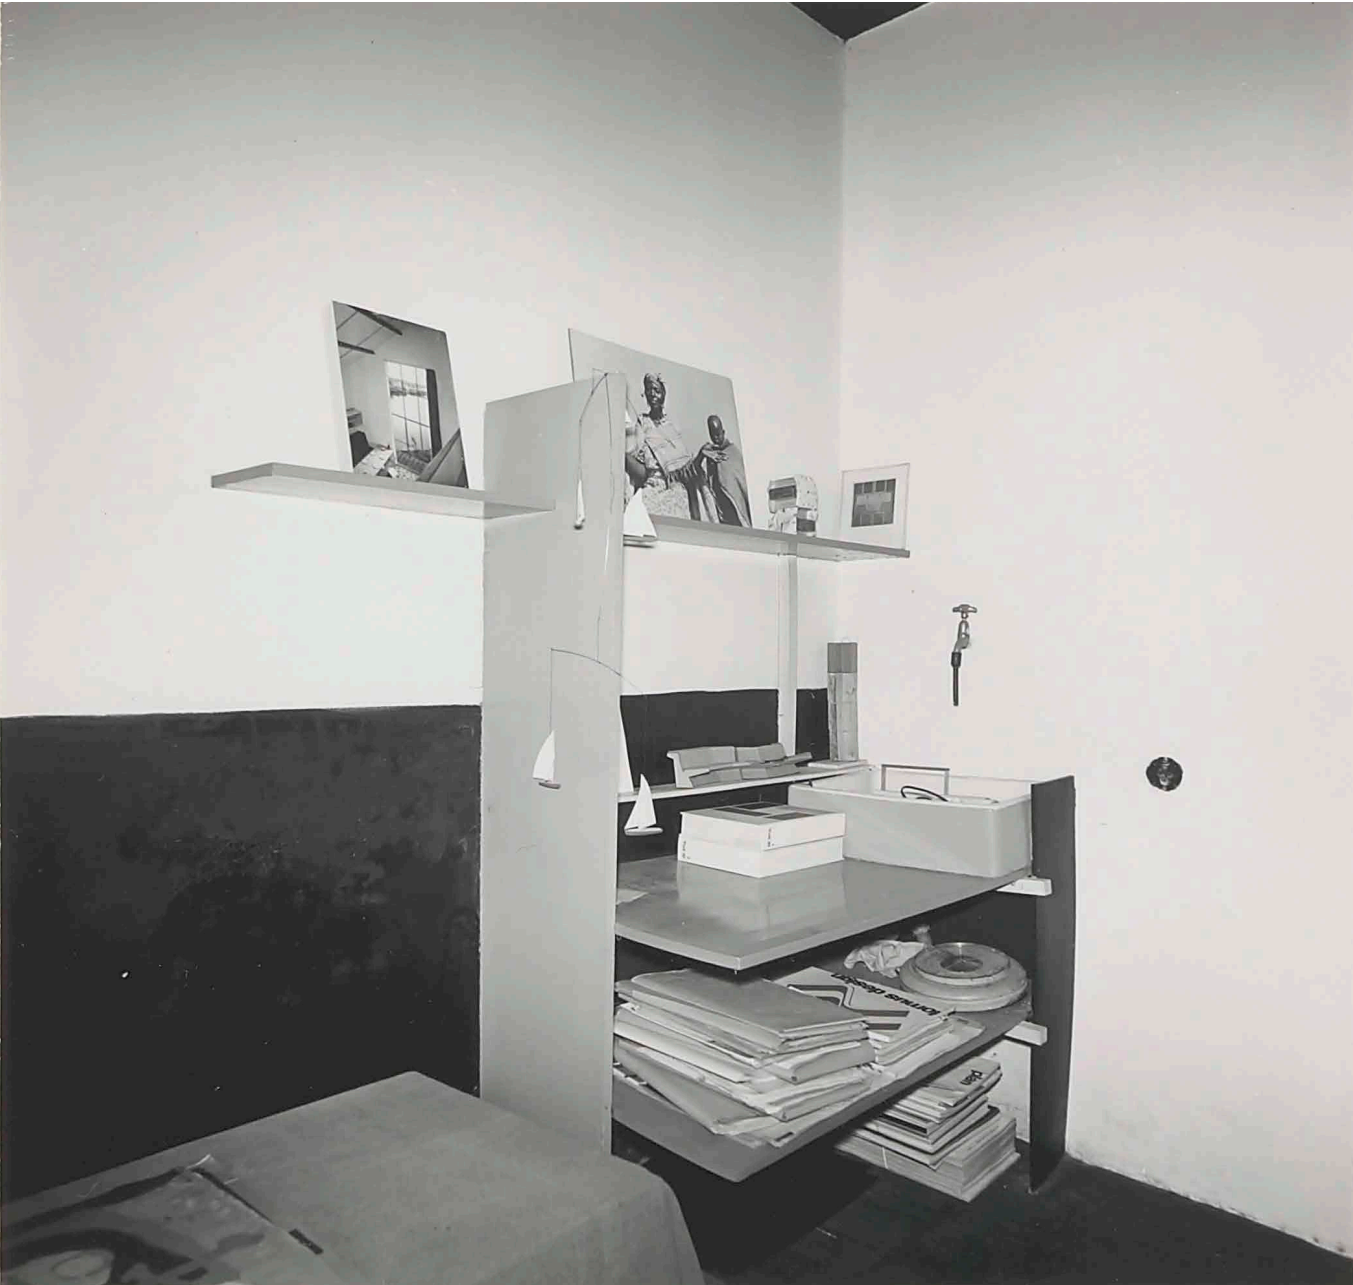
stripping away the plaster. The colour scheme of the adjoining study, in particular the greys, appeared to have changed little over the course of time, to the extent that this could be established based on historical photographs [FIG. 3.16/3.17]. Mulder recalled that the black ceiling in this room had looked pockmarked and had to be repainted. He had the other surfaces in this room repainted in the existing colours as well.

FIG. 3.16 The study painted in white, black and shades of grey, c. 1974

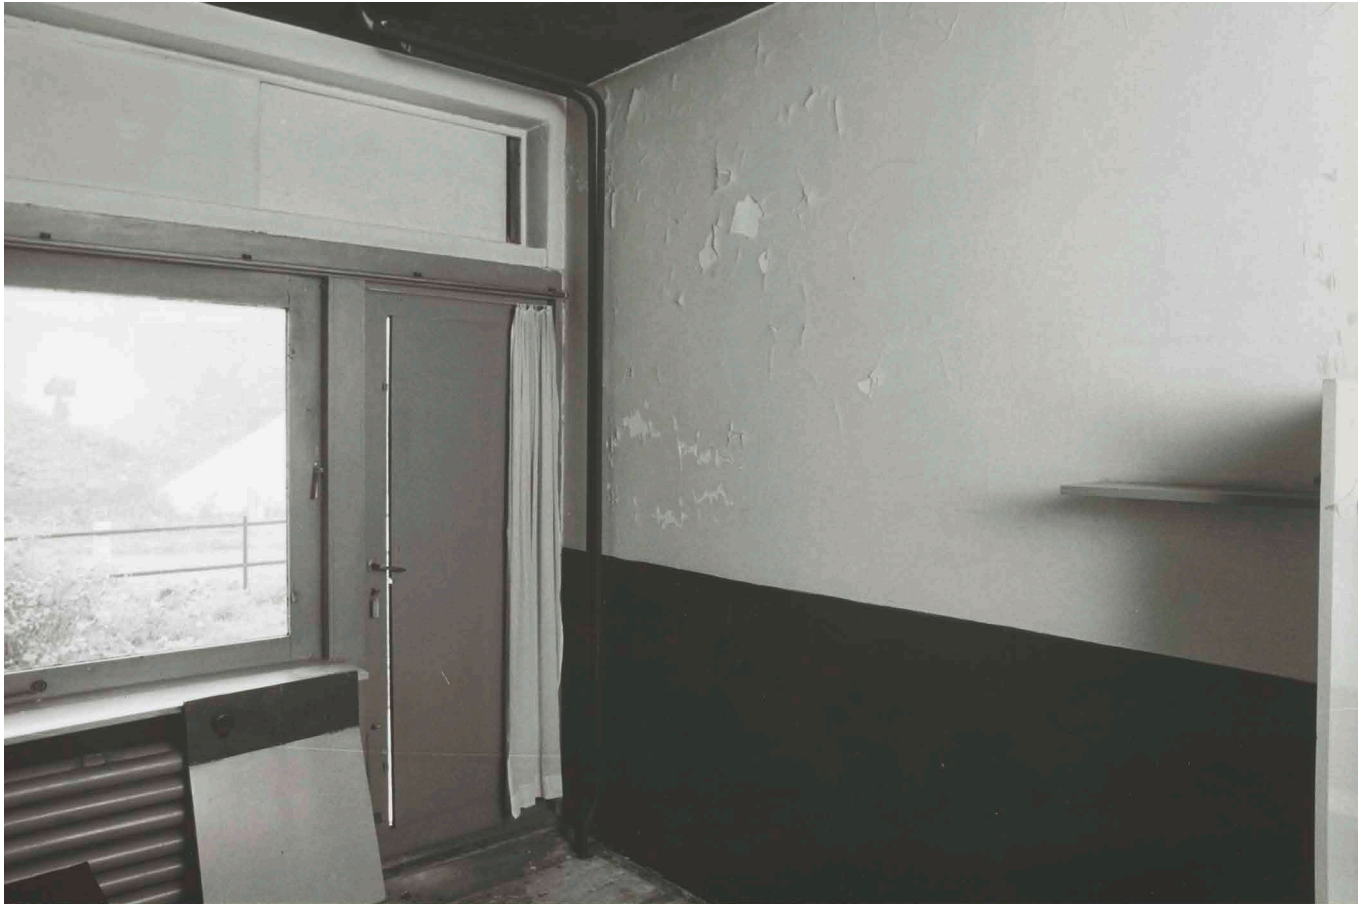
FIG. 3.17 Undated photograph of the study
