# Root Cause Analysis of Surface Cracks in Heavy Steel Plates during the Hot Rolling Process

<sup>2</sup> Hormozgan Steel Company (HOSCO), Bandar Abbas, Iran

**Abstract:** This paper investigates the root cause of the formation of surface cracks on hot-rolled C–Mn constructional steel heavy plates. Cracks are rather evenly distributed over the surface in the form of colonies of cracks. Samples were cut from the heavy plate. The microstructure of samples in the as-cast and hot-rolled states were studied using optical and electron microscopes as well as energy dispersive X-ray spectroscopy (EDS). Results show that cracks are heavily oxidized. De-carburized areas are also seen alongside cracks. The crack tip is in the form of a deer-horn, indicating that crack branching has taken place during deformation. The crack initiation sites are V-shaped grooves on the surface of as-cast slabs. Correlations between microstructures, processing parameters, and crack formation are discussed.

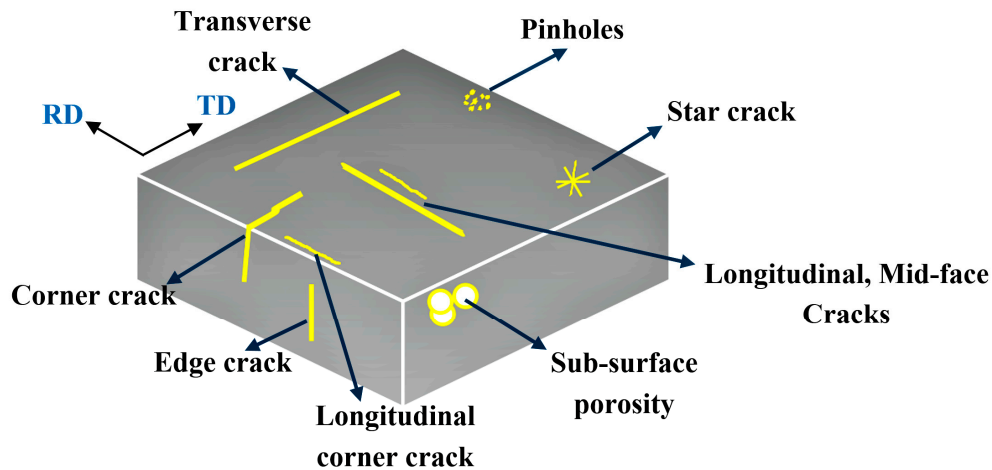
**Figure 1.** Schematic representation of typical surface defects in rolled products (RD: rolling direction, TD: transverse direction).
