**Structural behaviour of a calcium silicate brick masonry assemblage
Quasi-static cyclic pushover and dynamic identification test (C31B60-7)**

<i>Project number</i>	C31B60
<i>File reference</i>	C31B60-7
<i>Date</i>	21 October 2016
<i>Corresponding author</i>	Geert Ravenshorst (g.j.p.ravenshorst@tudelft.nl) Rita Esposito (r.esposito@tudelft.nl)

STRUCTURAL BEHAVIOUR OF A CALCIUM SILICATE BRICK MASONRY ASSEMBLAGE: QUASI-STATIC CYCLIC PUSHOVER AND DYNAMIC IDENTIFICATION TEST

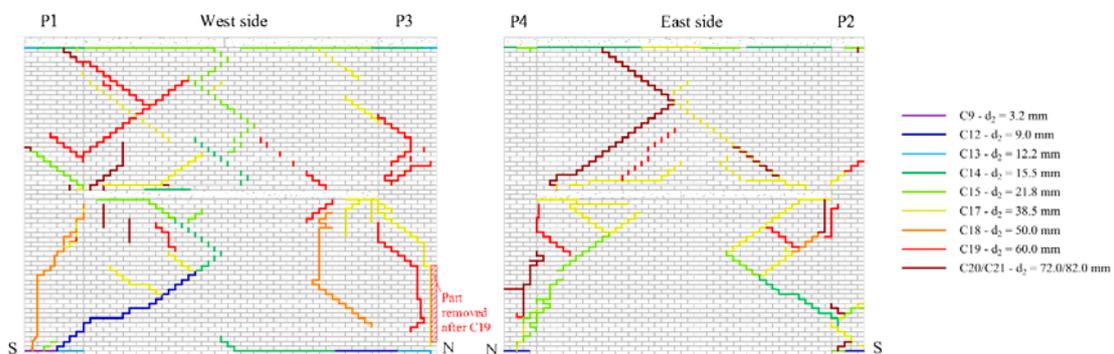
Figure 4.6 – Crack pattern defined on the base of visual inspection (see also Figure 4.5).

In this phase, horizontal cracks with a maximum opening of approximately 0.7 mm were measured at the level of the floors (Figure 4.9, Figure 4.10). These cracks could not be detected by the visual inspection until the pre-peak phase (Figure 4.6). Figure 4.9 shows in a schematic way the maximum crack opening measured at the floor-to-wall connections for the western wall and the pier P1, while Figure 4.10 shows the measured crack opening as a function of the displacement at the second floor for both the south-western and south-eastern corner. In both figures, the symmetry lines are used to indicate the geometrical symmetry of the structure. Please note that at the ground floor level the instrument is located between two courses of masonry, being the first one glued on the steel beam foundation. For both the western and eastern wall, the horizontal cracks developed mainly at the second floor level at the corner with the southern façade (WROTO2 and EROTO2 in Figure 4.10c and Figure 4.10d, respectively). Limited cracking was measured for the other wall-to-floor connections on the transversal walls. Horizontal cracks were measured also at the top and bottom of the southern piers P1 (western side) and P2 (eastern side), as reported in Figure 4.10c and Figure 4.10d, respectively. In both cases, the larger horizontal cracks at the floor-to-pier connection were recorded at the second floor level in correspondence of the corner with the transversal wall (SH4R01 and SH4R06) and at the ground floor level in correspondence of the free side of the pier (SH0R04 and SH0R07). Due to the different size of the piers, a larger opening was recorded for the western pier P1.

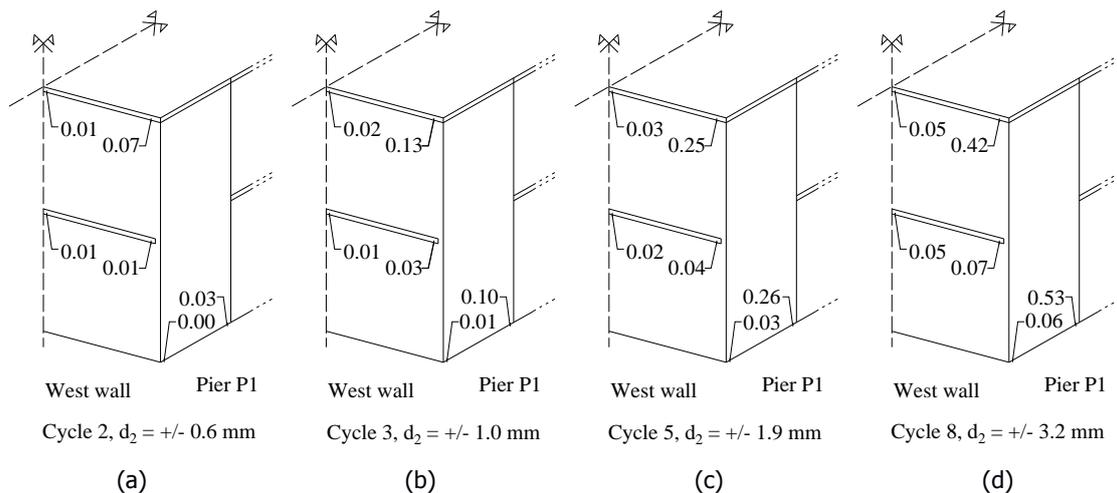
Figure 4.9 – Maximum opening of horizontal cracks at the floor-to-wall connection (western wall) and at the bottom of the pier P1, measured on the outside of the assemblage during the initial phase (unit: mm).

- The first observed stiffness degradation is caused by the formation of cracks at the floor-to-wall connection along the transversal walls (Figure 4.9, Figure 4.10). Because part of the transversal walls act as a flange for the piers in the loading direction, this cracking gives a stiffness reduction in the loading direction. Subsequently, the rocking mechanism of the wide piers plays an important role on the stiffness degradation in the pre-peak phase (Figure 6.2).

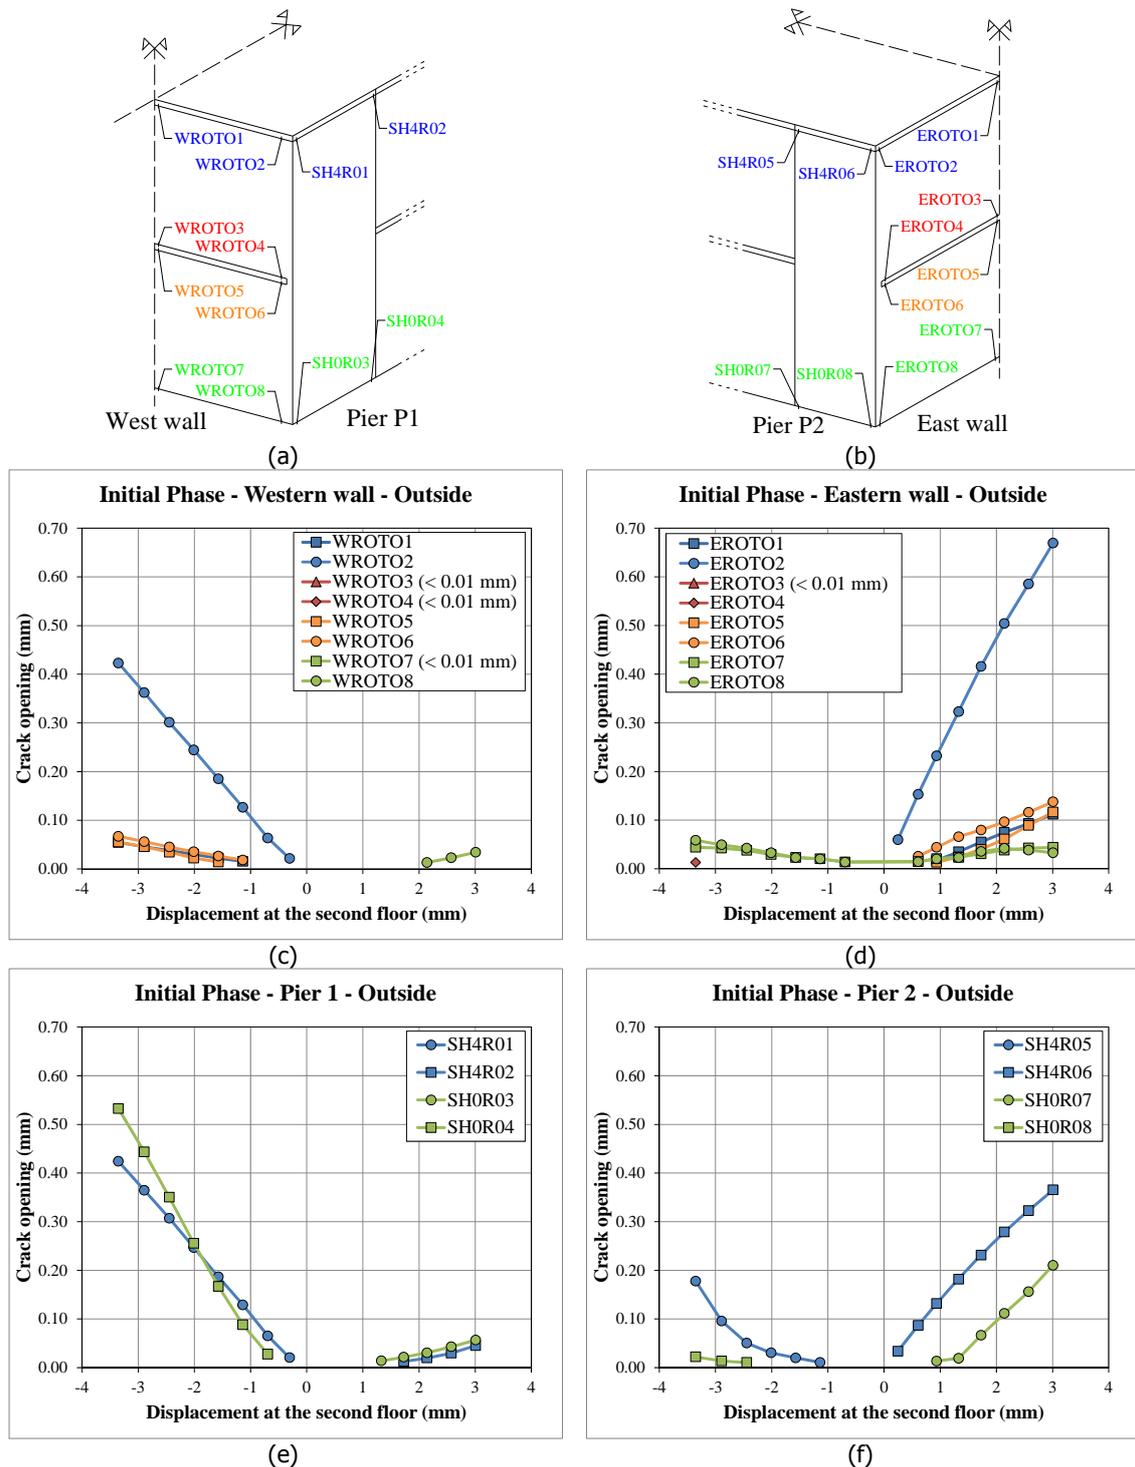
Figure 4.10 – Opening of horizontal cracks recorded during the initial phase: (a)-(b) Location of the sensors; (c)-(d) Cracks between floor and transversal wall on the western and eastern side; (e)-(f) Cracks at the bottom of the southern piers (P1 and 2). Crack opening lower than 0.01 mm have been not reported in the graphs for clarity sake.

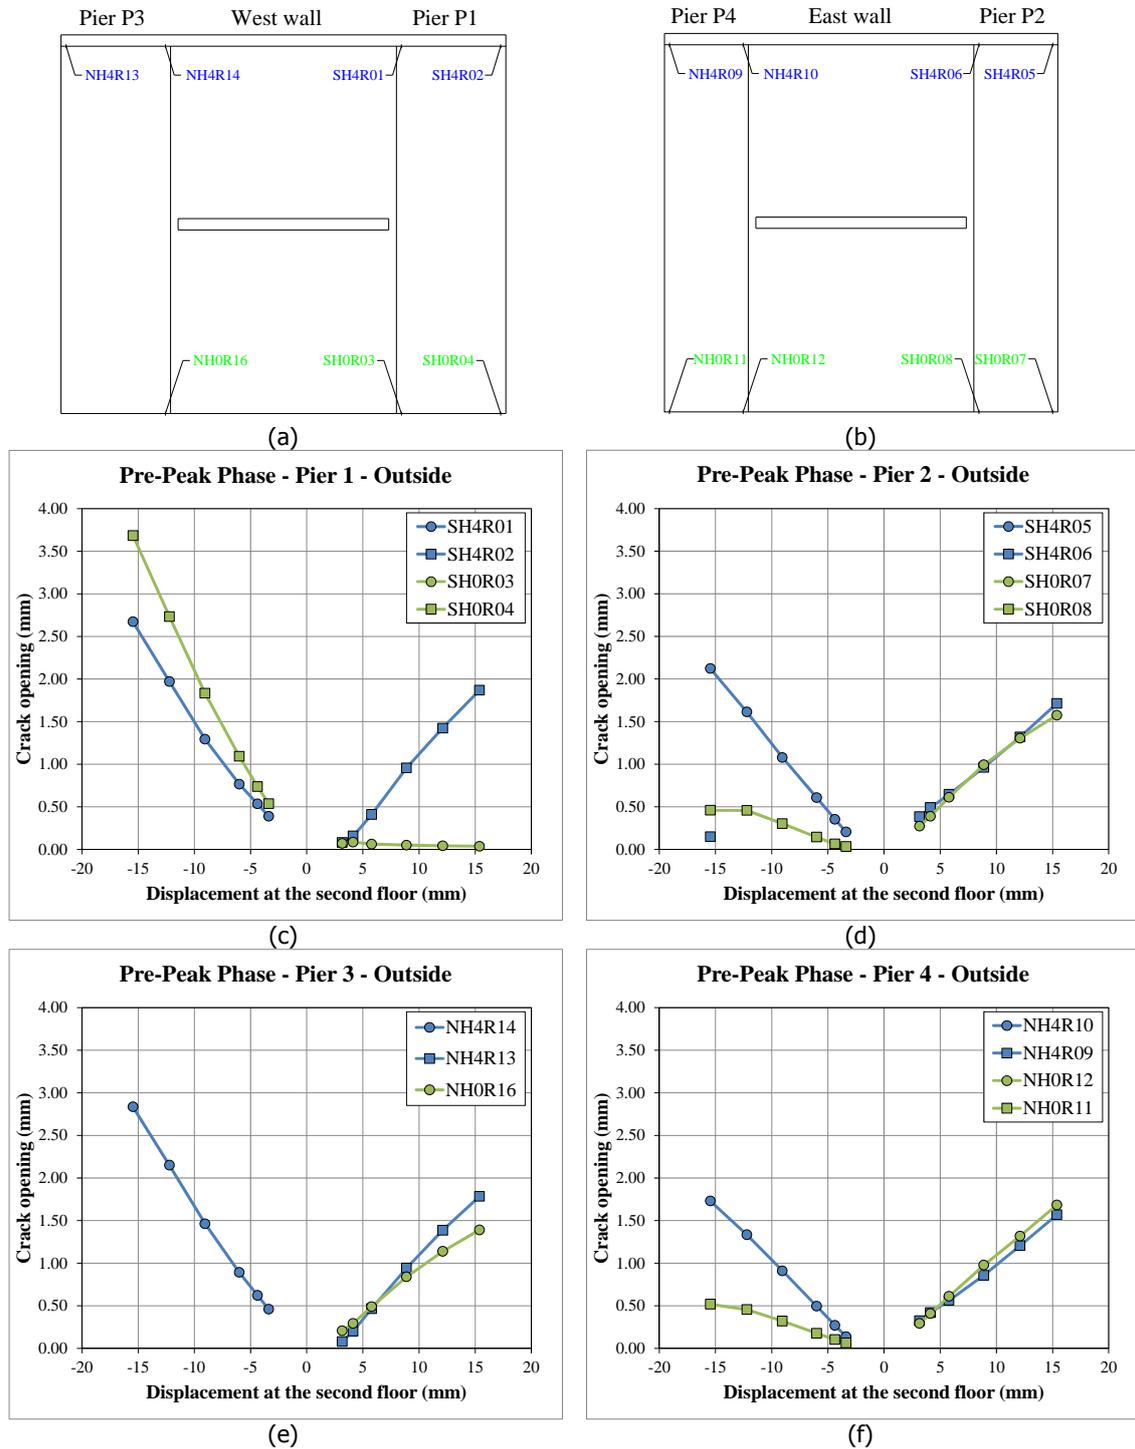
In this phase, the horizontal cracks in the piers at the ground floor level, which were previously measured in the initial phase (Figure 4.10), were detected both by the measurements (Figure 4.12) and during the visual inspection. During cycle 9 ($d_2 = \pm 3.2$ mm), the first crack visible at necked eyed was observed at the bottom of pier P1 (Figure 4.13) on the free side of the pier. During cycle 12 ($d_2 = \pm 9.0$ mm), all the other piers showed a similar crack pattern (Figure 4.14). Due to the limited thickness of the glue at the free bottom side of pier P3, the horizontal crack undesirable occurred in the glue rather than in the first mortar joint (Figure 4.15d, Figure E.7). This crack only developed for a length of half a brick (Figure 4.15b), thus the mechanism can be considered locally and with a limited impact on the structural behaviour. Consequently the measurement of sensor NH0R15 have been excluded (Figure 4.12e) and an additional sensor (NH0R15A) has been mounted between the steel beam foundation and the first course of brick prior to the post-peak phase.

The horizontal cracks at the first and second floor level were detected during the visual inspection only after cycle 13 ($d_2 = \pm 12.2$ mm, Figure 4.15 and Figure 4.16) and cycle 14 ($d_2 = \pm 15.5$ mm, Figure 4.17 and Figure 4.18). However, by analysing the response of the sensors in Figure 4.12, it is possible to note that for the majority of the piers horizontal cracks with similar crack opening are observed both at the ground and second floor level. This difference can be input to the difference in accessibility of the two locations.

Figure 4.12 – Opening of horizontal cracks recorded during the pre-peak phase: (a)-(b) Location of the sensors; (c) Pier P1; (b) Pier P2; (e) Pier P3; (f) Pier P4. Crack opening lower than 0.01 mm have been not reported in the graphs for clarity sake.

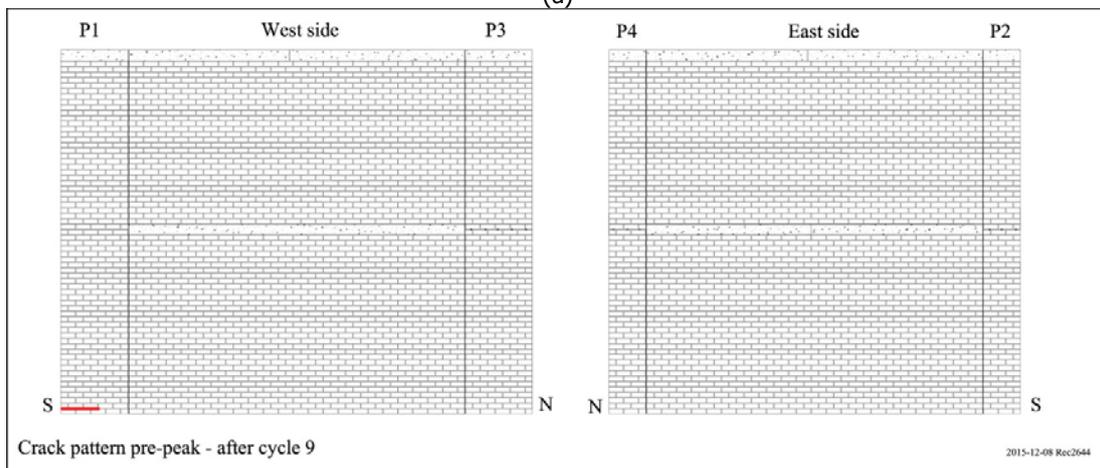
Figure 4.13 – Visual inspection after **cycle 9**: (a) Backbone curve; (b) Crack pattern (existing cracks in black, new cracks in red); (c) Crack at the bottom of pier P1 (1_C9-GF-P1). See also Figure E.2.

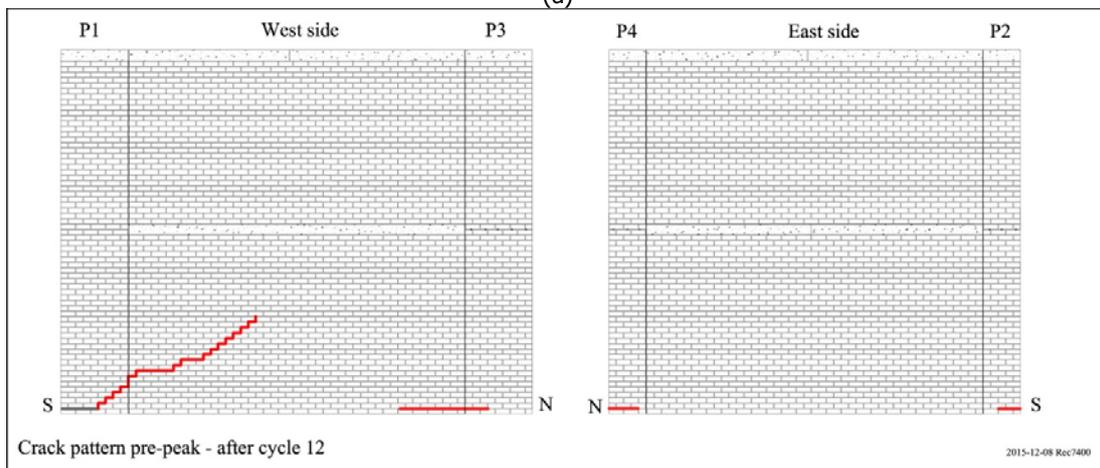
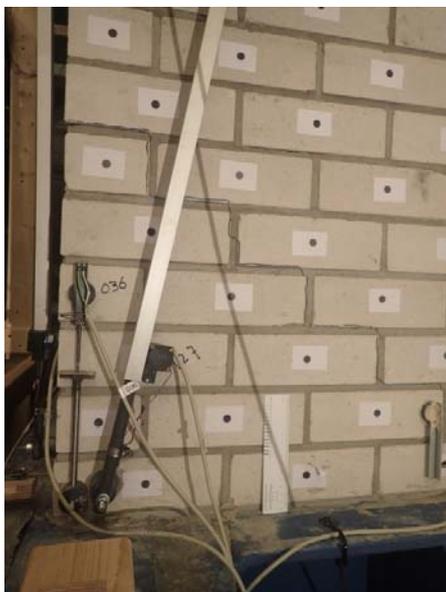
During the pre-peak phase the first diagonal cracks appeared on the transversal walls. After cycle 12 ($d_2 = \pm 9.0$ mm, Figure 4.14), a diagonal crack was observed on the western wall. This crack developed first at the bottom of pier P1, as an extension of the horizontal crack previously formed, and it run around the corner to finally develop as a diagonal stepwise crack on the southern side of the western wall. After cycle 14 ($d_2 = \pm 15.5$ mm, Figure 4.17), a similar crack was observed on the eastern wall at the corner with the southern pier P2. Cracks in some head joint were observed at the central part of the western wall at the first floor (Figure 4.17).

Figure 4.14 – Visual inspection after cycle 12: (a) Backbone curve; (b) Crack pattern (existing cracks in black, new cracks in red); (c) Crack at the bottom of pier P1 (2_C12-GF-P1); (d) Crack at the bottom of pier P2 (4_C12-GF-P1). See also from Figure E.3 to Figure E.5.

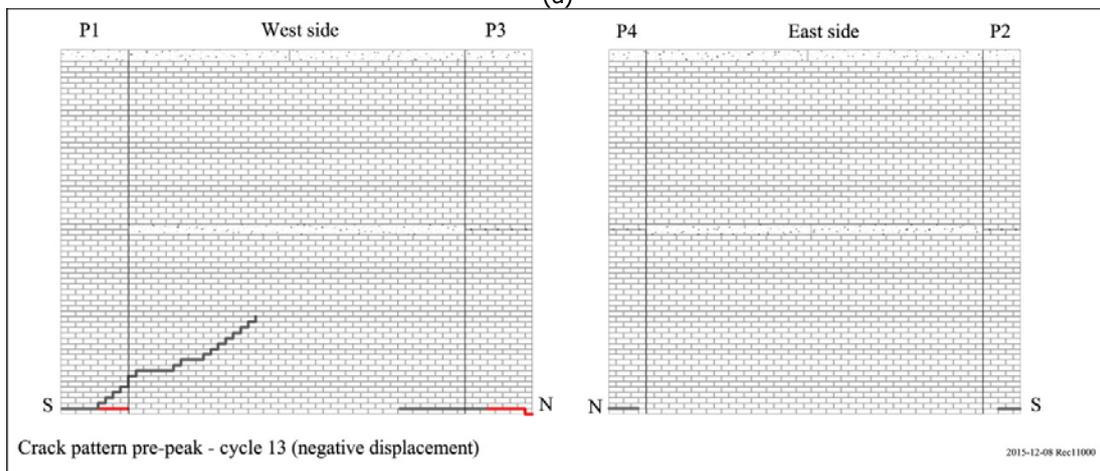
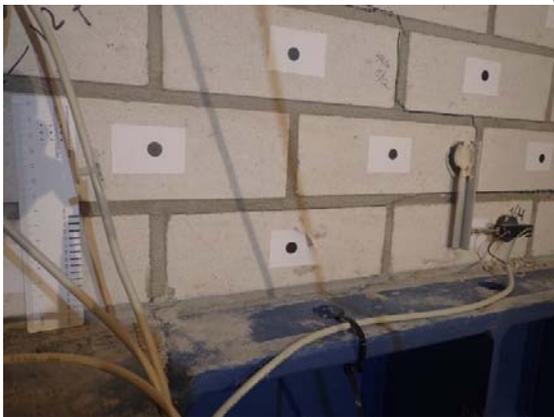
Figure 4.15 – Visual inspection after cycle 13 (last negative displacement): (a) Backbone curve; (b) Crack pattern (existing cracks in black, new cracks in red); (c) Crack at the bottom of pier P1 (7_C13-GF-P1); (d) Crack at the bottom of pier P3 (8_C13-GF-P3). See also Figure E.6.

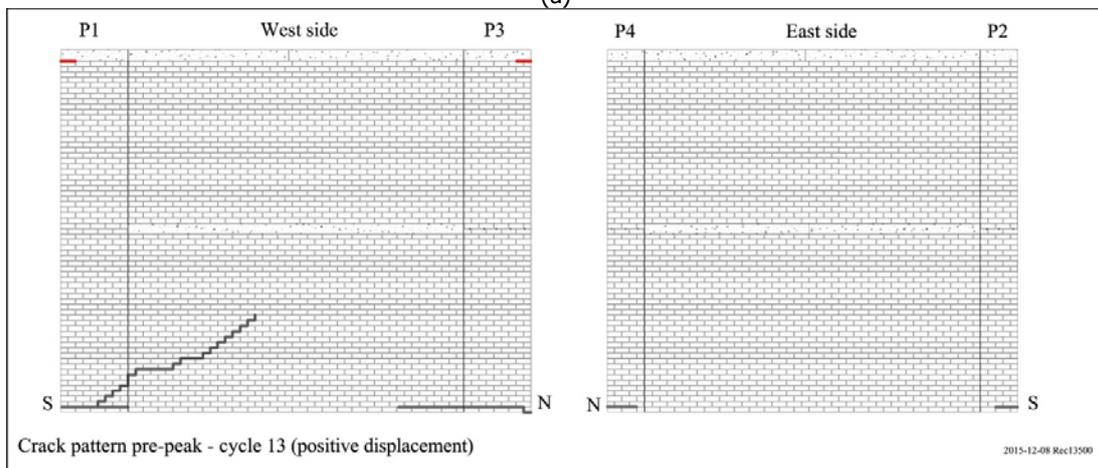
Figure 4.16 – Visual inspection after **cycle 13 (last positive displacement)**: (a) Backbone curve; (b) Crack pattern (existing cracks in black, new cracks in red)

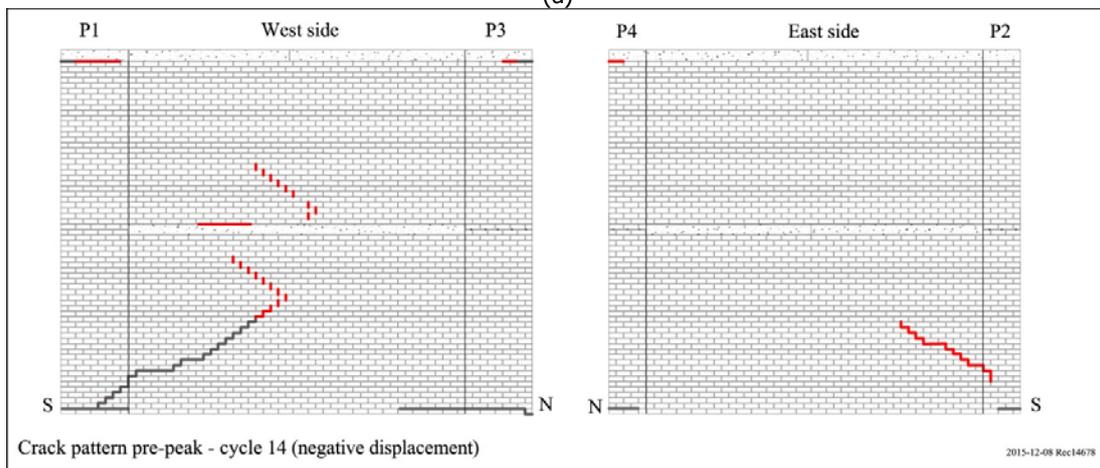
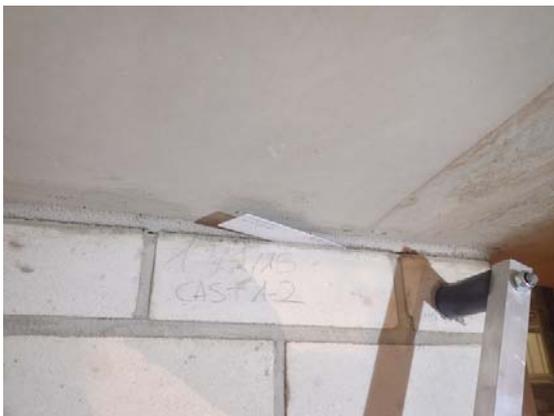
Figure 4.17 – Visual inspection after **cycle 14 (last negative displacement)**: (a) Backbone curve; (b) Crack pattern (existing cracks in black, new cracks in red); (c) Crack between second floor slab and pier P3 (15_C14-FF-P3); (d) Crack in pier P2 (12_C14-GF-P2). See also from Figure E.7 to Figure E.10.

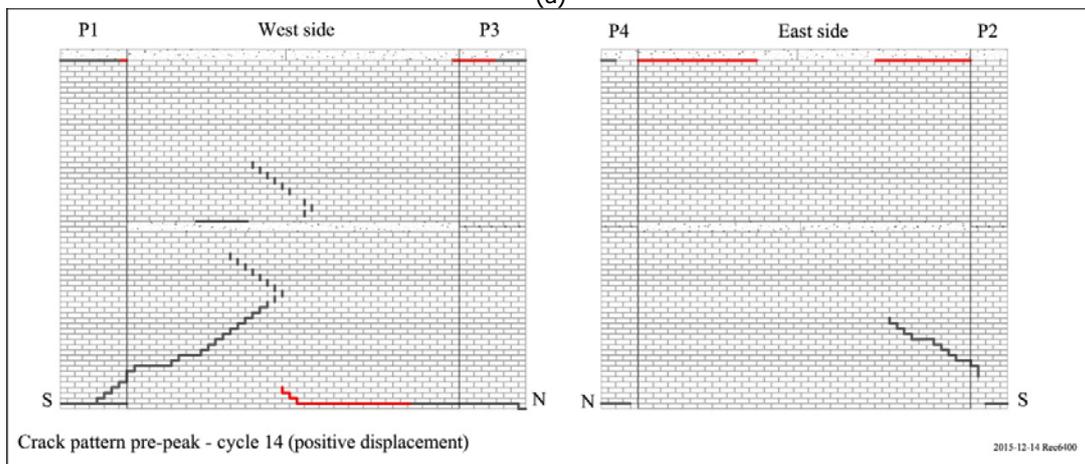
Figure 4.18 – Visual inspection after **cycle 14 (last positive displacement)**: (a) Backbone curve; (b) Crack pattern (existing cracks in black, new cracks in red); (c) Diagonal cracks on west wall (outside) at the first floor (16_C14-FF-W). See also Figure E.11.

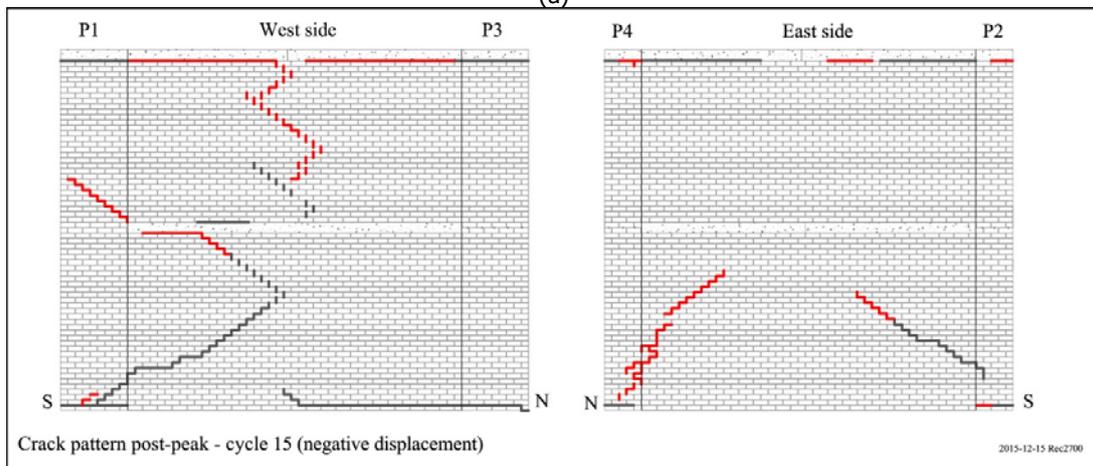
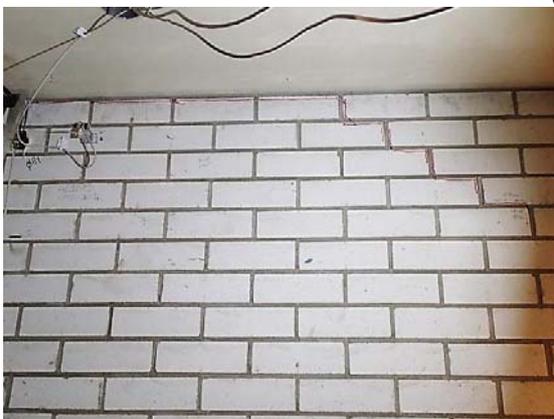
The structure presented an asymmetrical behaviour for loading in the positive (from west to east side) and negative (from east to west side) direction. The maximum capacity was first reached for positive displacements. During cycle 15 ($d_2 = \pm 21.8$ mm), the maximum base shear force of 47.3 kN was reached for positive displacement, while for negative displacement approximately 97% of the maximum capacity was reached. During this cycle, the previously observed horizontal and diagonal cracks on the transversal walls further extended (Figure 4.18, Figure 4.20, Figure 4.21).

Figure 4.20 – Visual inspection after **cycle 15 (last negative displacement)**: (a) Backbone curve; (b) Crack pattern (existing cracks in black, new cracks in red); (c) Crack between first floor slab and west wall at corner with pier P1 (18_C15-GF-WP1); (d) Crack between second floor slab and pier P1 (outside) (23_C15-FF-P1). See also from Figure E.12 to Figure E.16.

1. It is conservatively assumed that the connection between the masonry walls and the concrete floor is an hinged connection. This assumption is justified by the horizontal cracks developed at the second and at the ground floor level after cycle 15 (Figure 4.20 and Figure 4.21), in which the maximum base shear force is reached for positive loading.

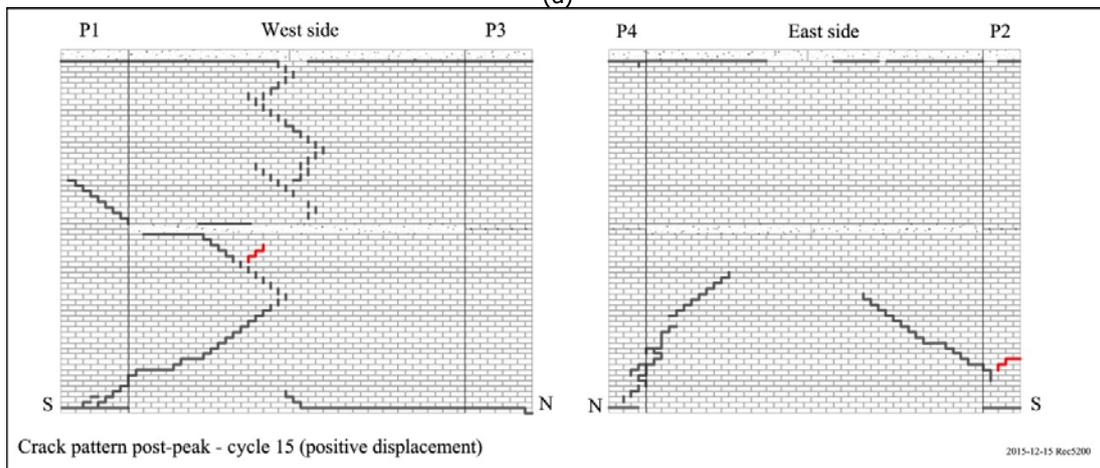
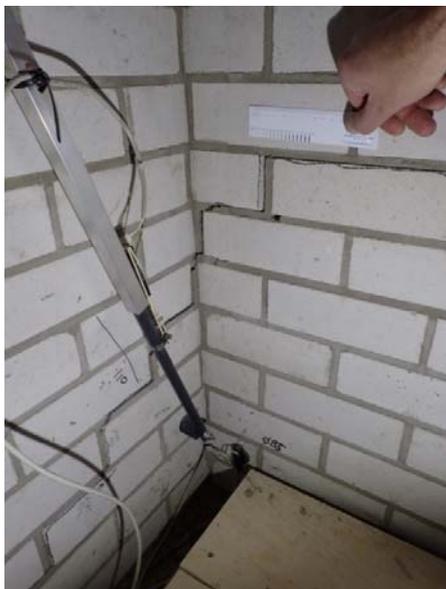
Figure 4.21 – Visual inspection after **cycle 15 (last positive displacement)**: (a) Backbone curve; (b) Crack pattern (existing cracks in black, new cracks in red); (c) Crack at the corner between west wall and pier P1 (30_C14-GF-P1W); (d) Crack between second floor slab pier P2 (28_C15-FF-P2). See also from Figure E.17 to Figure E.18.

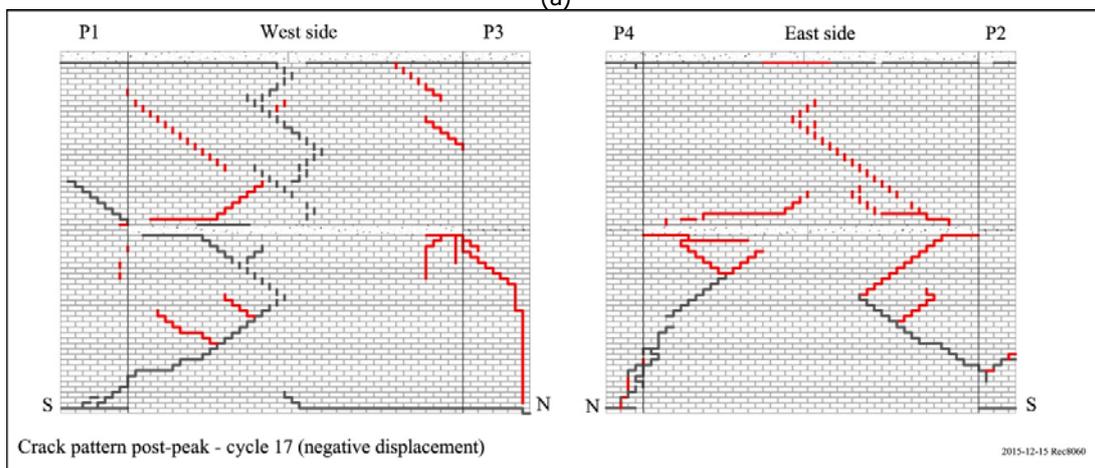
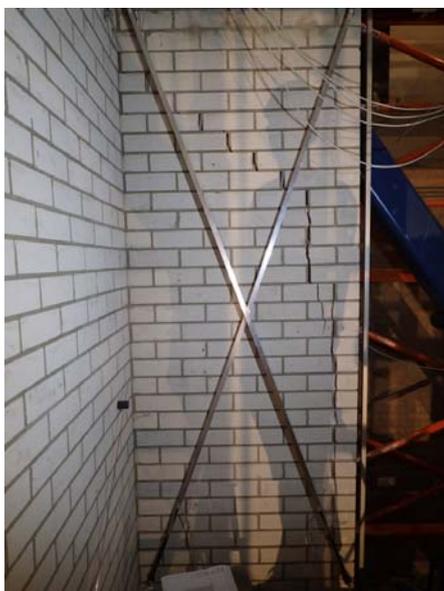
After the peak, the capacity and stiffness substantially reduced for positive displacements. This phenomenon was mainly governed by the diagonal/vertical cracks occurring first in pier P3 during cycle 17 ($d_2 = \pm 38.5$ mm, Figure 4.22) and subsequently in pier P1 during cycle 18 ($d_2 = \pm 50.0$ mm, Figure 4.24). Due to the extensive cracking of these piers, part of pier P3 was removed for safety reasons after cycle 19 ($d_2 = \pm 60.0$ mm, Figure 4.25). For negative displacements, the maximum base shear force of 41.6 kN was reached in cycle 19 for displacement of $d_2 = -60$ mm. This event corresponded to the formation of a secondary diagonal/vertical crack in pier P3 (Figure 4.25).

Figure 4.22 – Visual inspection after cycle 17 (last negative displacement): (a) Backbone curve; (b) Crack pattern (existing cracks in black, new cracks in red); (c) Crack on pier P3 at the ground floor (31_C17-GF-P3); (d) Cracks on pier P4 at the corner with east wall (35_C17_GF_P4E). See also from Figure E.19 to Figure E.24.

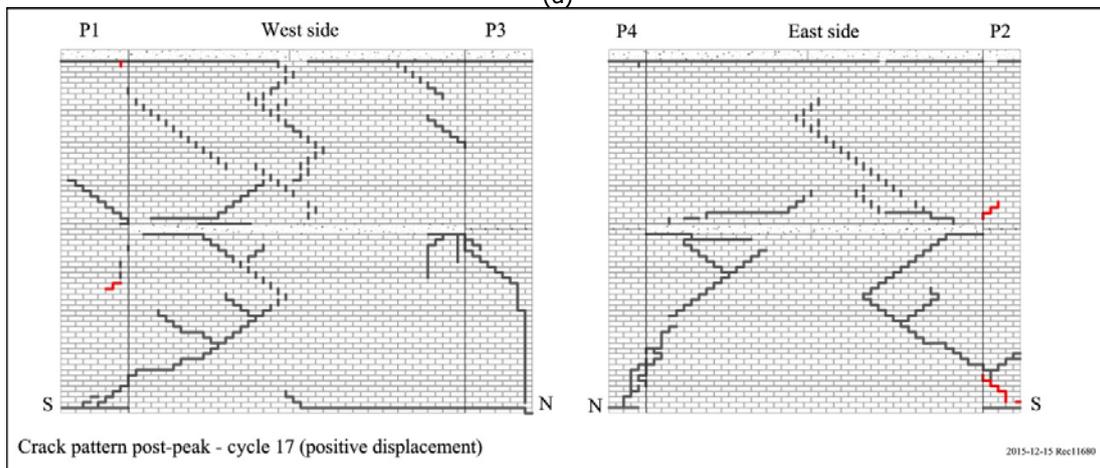
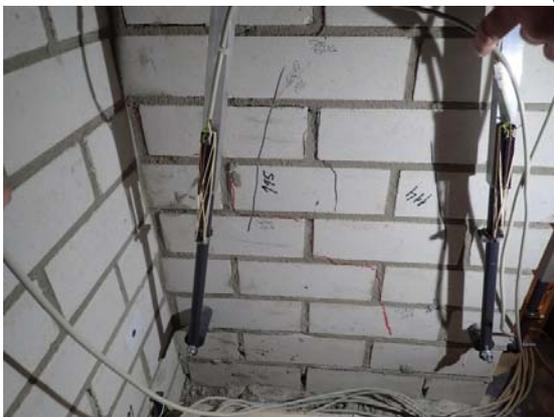
Figure 4.23 – Visual inspection after **cycle 17 (last positive displacement)**: (a) Backbone curve; (b) Crack pattern (existing cracks in black, new cracks in red); (c) Diagonal crack at the bottom of pier P2 at the ground floor (41_C17-GF-P2); (d) Crack on pier P3 at the side with west wall (42_C17-GF-P3). See also Figure E.25.

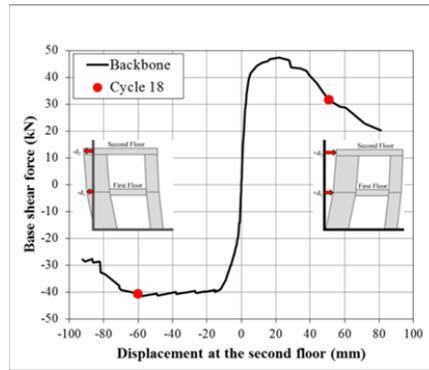
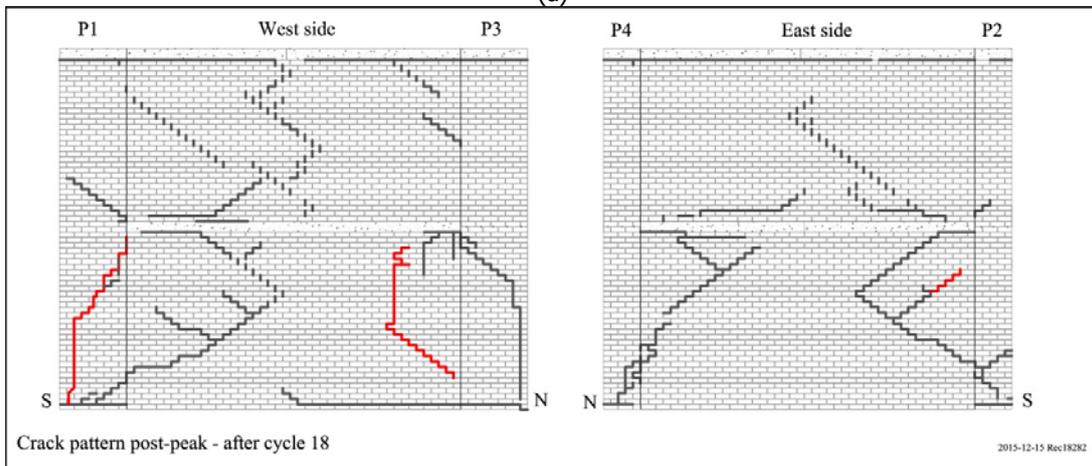
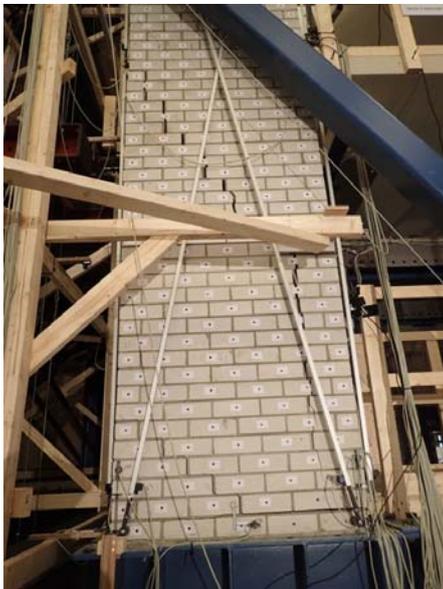
Figure 4.24 – Visual inspection after cycle 18: (a) Backbone curve; (b) Crack pattern (existing cracks in black, new cracks in red); (c) Diagonal crack on pier P1 at the ground floor (a): Outside (43_C18-GF-P1); (d) Diagonal crack on pier P3 at the ground floor (outside): (a) Bottom part (45_C18-GF-P3). See also from Figure E.27 to Figure E.29.

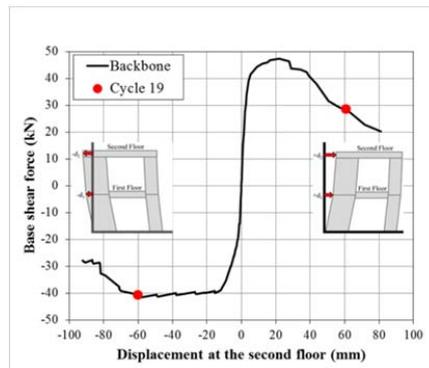
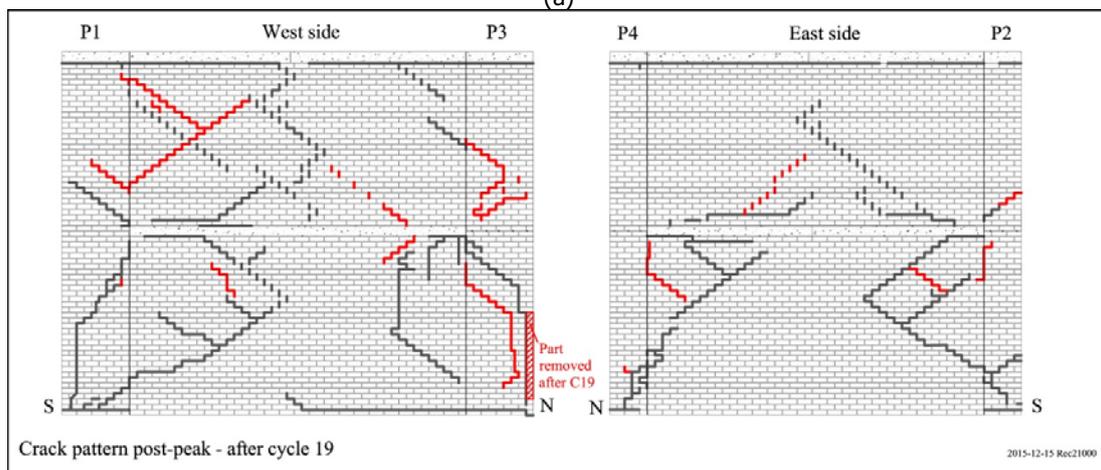
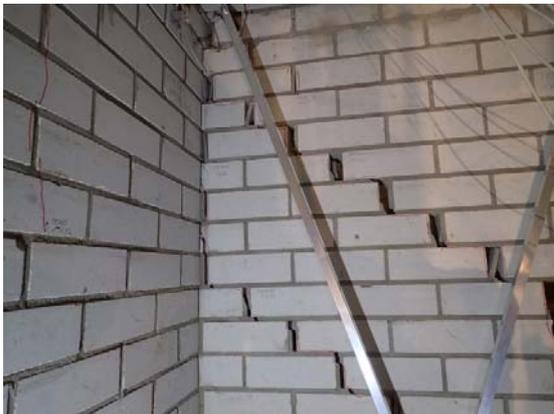
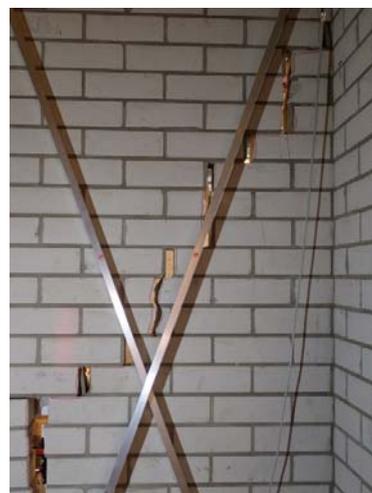
Extensive cracking in the narrow piers P2 and P4 only occurred during cycle 19 ($d_2 = \pm 60.0$ mm, Figure 4.25). Prior to this cycle, the narrow piers only presented limited damage at the bottom and in the floor-to-pier connection at the second floor level. During cycle 19, both pier P2 and P4 show vertical cracks at the ground floor in correspondence of the interlocked connection with the transversal wall. Its crack width reached 20 mm for the northern pier P4 during cycle 20 (GF-E in Table 4.3 and in Figure 4.27). After cycle 20 ($d_2 = \pm 72.0$ mm, Figure 4.26), a vertical crack formed within the central part of the northern pier P4 at the ground floor.

Figure 4.25 – Visual inspection after cycle 19: (a) Backbone curve; (b) Crack pattern (existing cracks in black, new cracks in red); (c) Upper part of the diagonal/vertical crack on pier P3 at the ground floor (54_C19-GF-P3); (d) Central part of the diagonal/vertical on pier P1 at ground floor (49_C19-GF-P1). See also from Figure E.31 to Figure E.34.

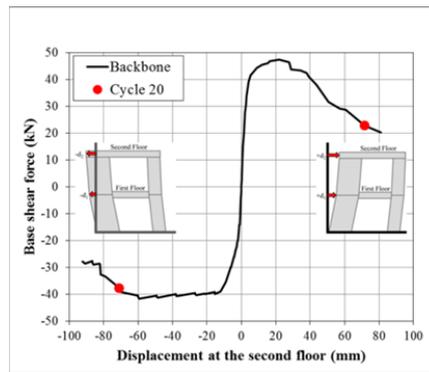
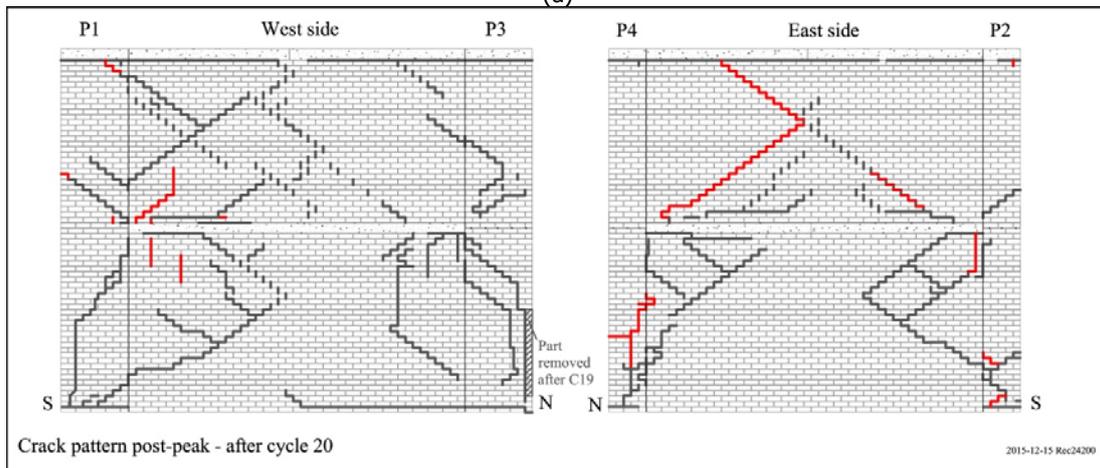
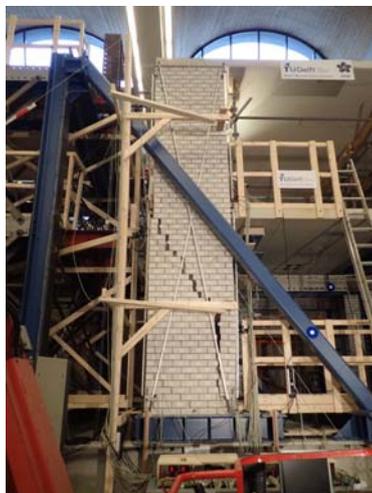
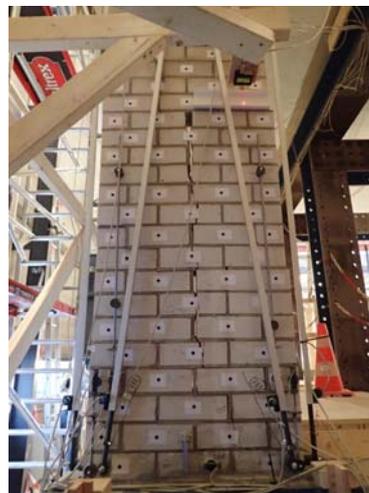
Figure 4.26 – Visual inspection after cycle 20: (a) Backbone curve; (b) Crack pattern (existing cracks in black, new cracks in red); (c) Diagonal/vertical crack on pier P1 (57_C20-P1); (d) Crack on pier P4 (60_C20-GF-P4). See also from Figure E.36 to Figure E.39.

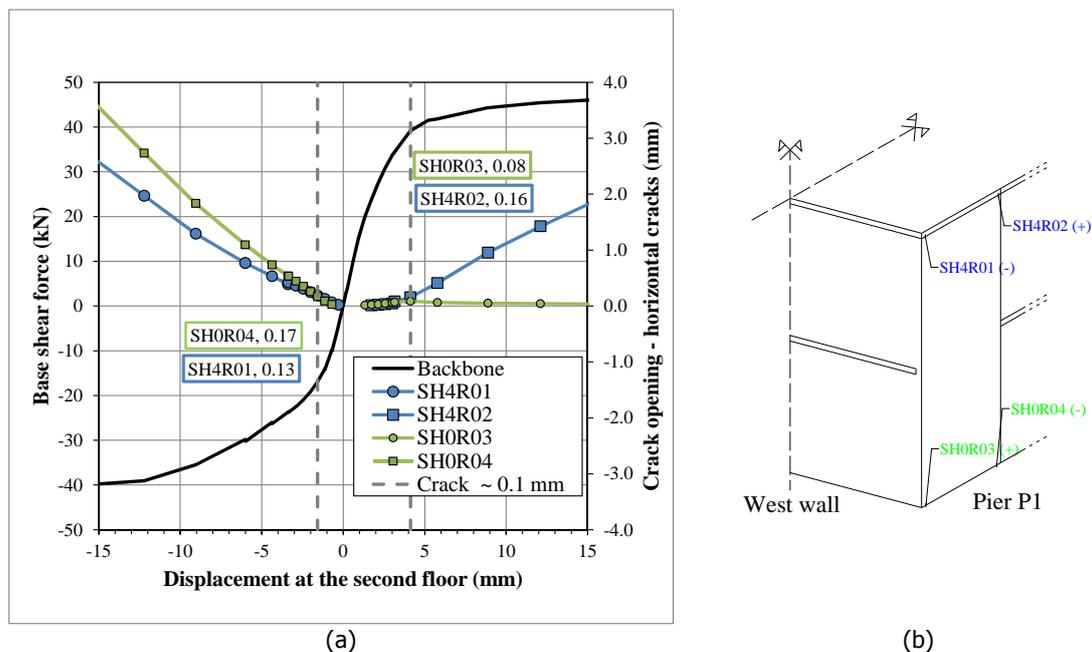
In order to show this correlation, the development of the horizontal cracks at the bottom and top of the wide pier P1 for the pre-peak phase is compared with the capacity curve (Figure 6.2); a similar trend in terms of crack width was observed for pier P3. The sensors at the bottom corner (SH0R03) and at the top free side of the pier (SH4R02) are activated for positive displacement of the assembled structure, while the sensors on the bottom free side (SH4R01) and at the top corner (SH0R04) are activated for negative displacement of the assembled structure (Figure 6.2b). The dashed line indicates the displacement at which the horizontal cracks reach approximately 0.1 mm (the exact data of each sensor is reported in the dedicated labels). Comparing the positive and negative loading direction, it is possible to correlate the asymmetric behaviour of the structure in the pre-peak phase to the crack opening. A crack opening of approximately 0.1 mm is first reached for negative loading at a displacement $d_2 = -1.2$ mm (cycle 4) corresponding to a base shear force of approximately -17 kN. Subsequently, the same crack opening is reached for positive loading at displacement $d_2 = +4.3$ mm (cycle 10) corresponding to a base shear force of approximately +39 kN.

Figure 6.2 – Analysis of pre-peak behaviour: (a) Comparison between the capacity curve and the development of the horizontal cracks at the bottom and top of pier P1; (b) Location of the sensor with indication of loading direction (+ or -) which activate them. Crack opening lower than 0.01 mm have been not reported in the graph for clarity sake. See also Figure 4.10 and Figure 4.12.

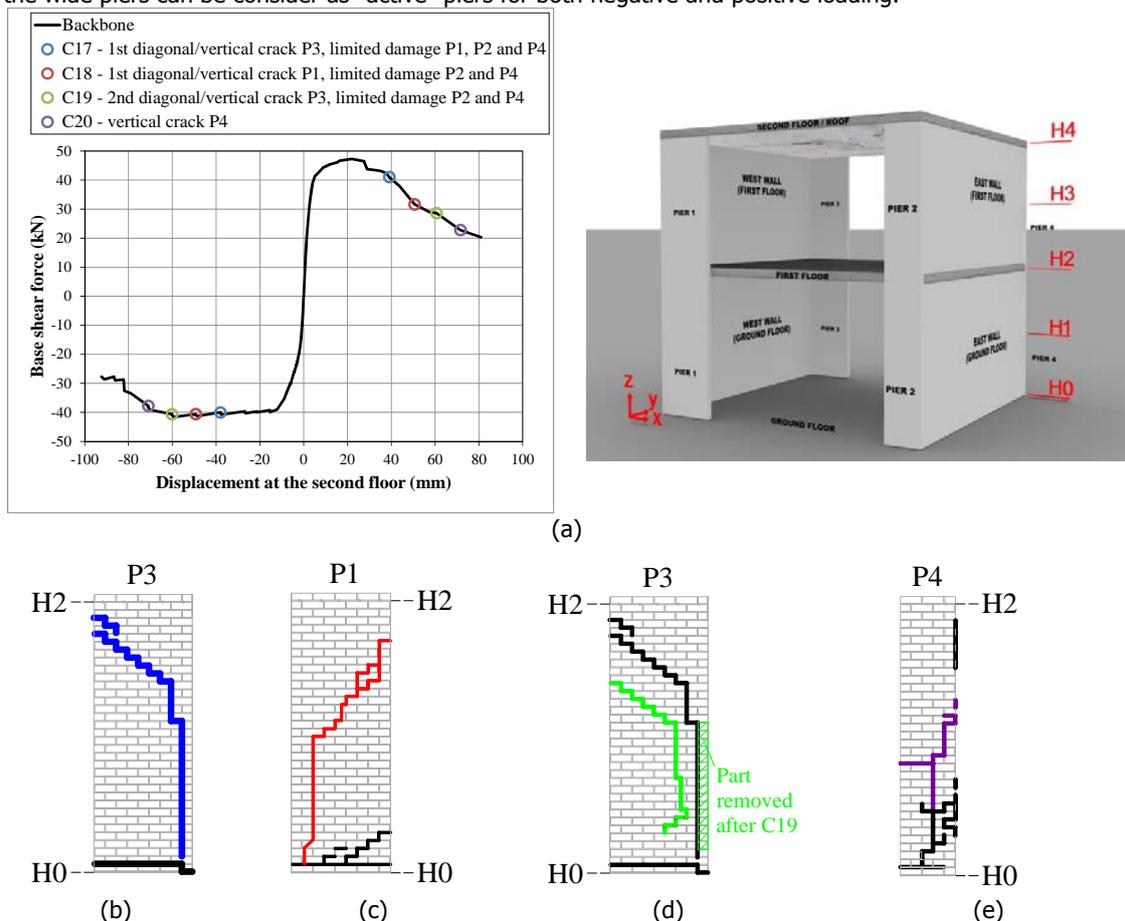
The softening behaviour observed during the post peak phase can be correlated to the formation of diagonal/vertical cracks within the wide piers (P1 and P3). Figure 6.3 shows this analysis for the post-peak. A degradation in base shear force is first observed in the positive loading direction during cycle 17 ($d_2 = \pm 38.5$ mm), which corresponds to the formation of the first vertical/diagonal crack in the wide pier P3. Immediately afterwards, the same failure mechanism is observed for the wide pier P1 during cycle 18 ($d_2 = \pm 50$ mm). During this cycles the capacity of the structure for negative displacement remains nearly constant until cycle 19 ($d_2 = \pm 60$ mm). During cycle 19, the formation of a secondary diagonal/vertical crack in the

wide pier P3 leads to the degradation in base shear force for negative loading. Considering that an extensive crack of the narrow pier P2 and P4 only occurs during cycle 20 ($d_2 = \pm 72$ mm), it is possible to establish the correlation between the diagonal/vertical cracks in the wide piers (P1 and P3) and the softening behaviour.

Figure 6.3 – Analysis of post-peak behaviour: (a) Backbone curve with indication of main cracks; (b) First diagonal/vertical crack in the wide pier P3; (c) Second diagonal/vertical crack in the wide pier P1; (d) First diagonal/vertical crack in the wide pier P1; (e) Vertical crack in the narrow pier P4. For complete crack

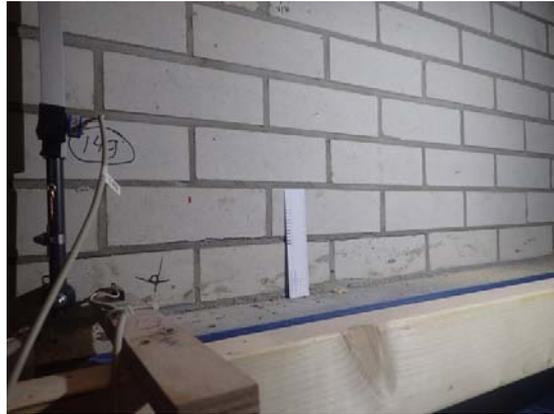
Figure E.5 – Pre-peak phase **cycle 12** – ground floor: Crack at the bottom of west wall (6_C12-GF-W).

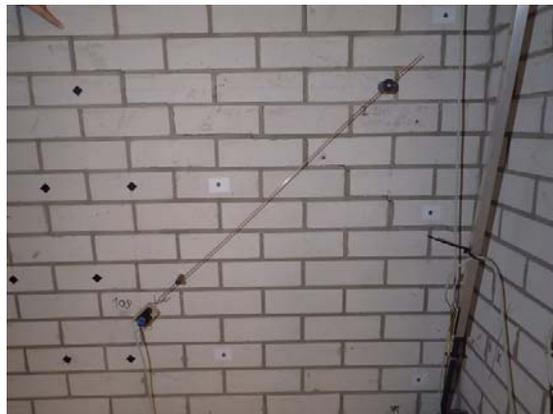
Figure E.9 – Pre-peak phase **cycle 14 (negative displacement)** – ground floor: Diagonal crack on the east wall at the ground floor (13_C14-GF-W).

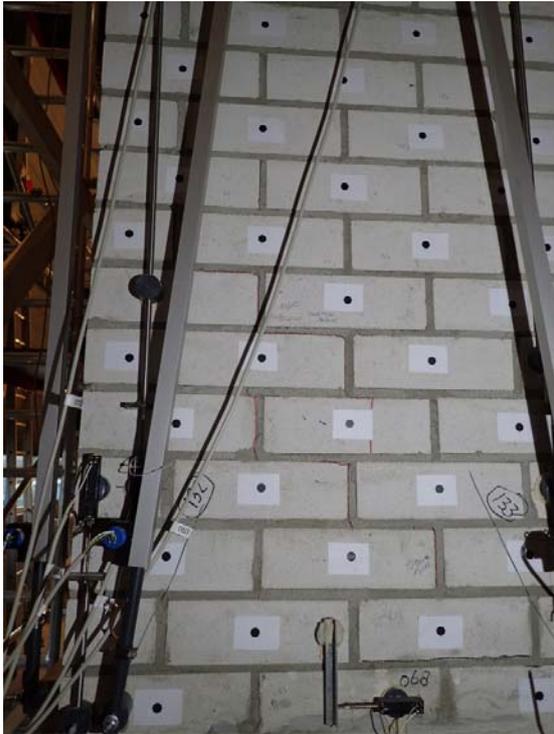
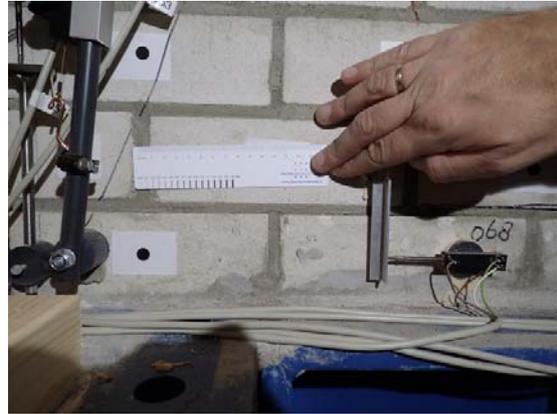
Figure E.13 – Post-peak phase cycle 15 (negative displacement) – ground floor: (a) Diagonal cracks on pier P1 (outside) at the ground floor (19_C15-GF-P2); (b) Detail of picture (a) (20_C15-GF-P2). Compare with Figure E.7(a).

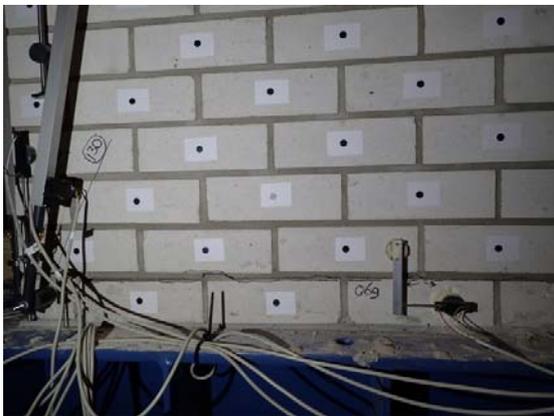
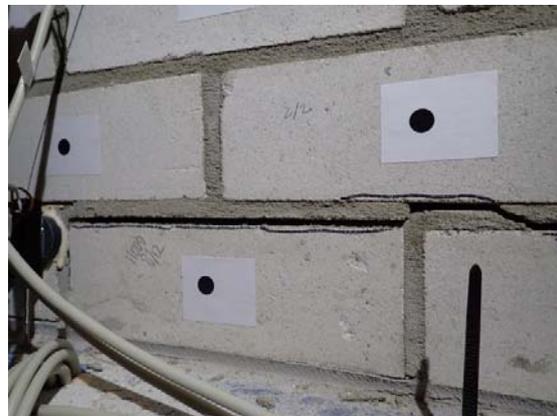
Figure E.14 – Post-peak phase cycle 15 (negative displacement) – ground floor: (a) Crack at the bottom of pier P3 (outside) (21_C15-GF-P3); (b) Detail of picture (a) (22_C15-GF-P3). Compare with Figure E.7(b).

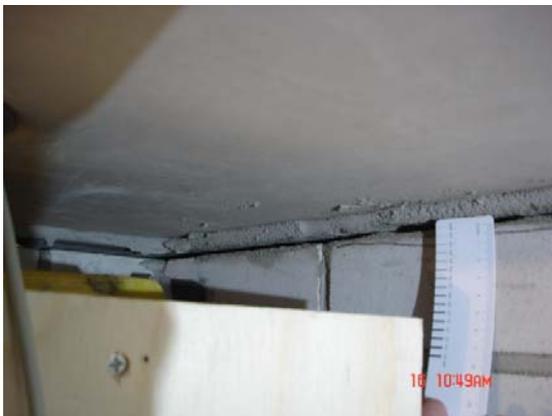
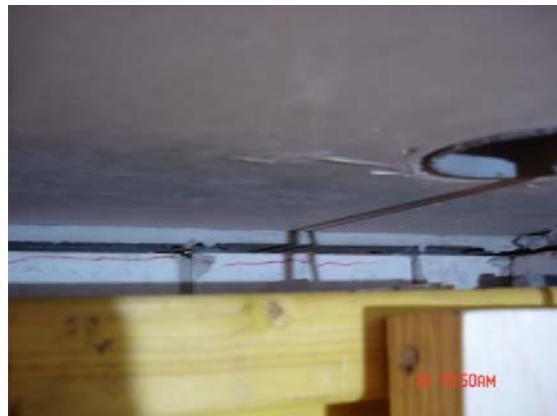
Figure E.22 – Post-peak phase **cycle 17 (negative displacement)** – first floor: (a) Crack between second floor slab and pier P3 (36_C17-FF-P3); (b) Crack between second floor slab and west wall (37_C17-FF-W). Compare with Figure E.16.

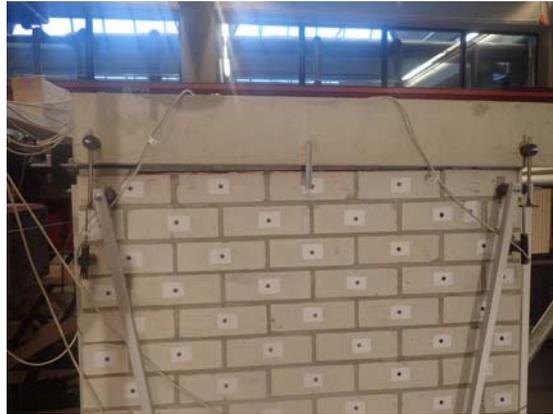
Figure E.23 – Post-peak phase **cycle 17 (negative displacement)** – first floor: (a) Crack between second floor slab and pier P1 (38_C17-FF-P1). Compare with Figure E.15.
