**Structural behaviour of a calcium silicate brick masonry assemblage
Quasi-static cyclic pushover and dynamic identification test (C31B60-7)**

<i>Project number</i>	C31B60
<i>File reference</i>	C31B60-7
<i>Date</i>	21 October 2016
<i>Corresponding author</i>	Geert Ravenshorst (g.j.p.ravenshorst@tudelft.nl) Rita Esposito (r.esposito@tudelft.nl)

STRUCTURAL BEHAVIOUR OF A CALCIUM SILICATE BRICK MASONRY ASSEMBLAGE: QUASI-STATIC CYCLIC PUSHOVER AND DYNAMIC IDENTIFICATION TEST

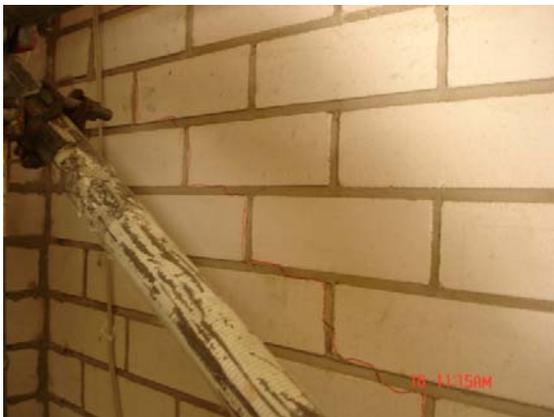
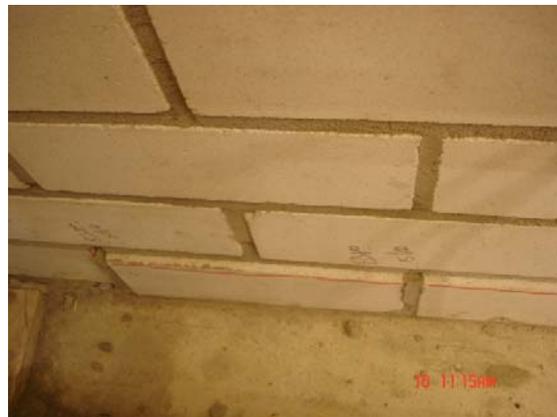
Figure E.24 – Post-peak phase **cycle 17 (negative displacement)** – first floor: (a) Diagonal crack on west wall on the side of pier P1 at the first floor (39_C17-FF-P3); (b) Crack between first floor slab and west wall at the centre (40_C17-FF-W).

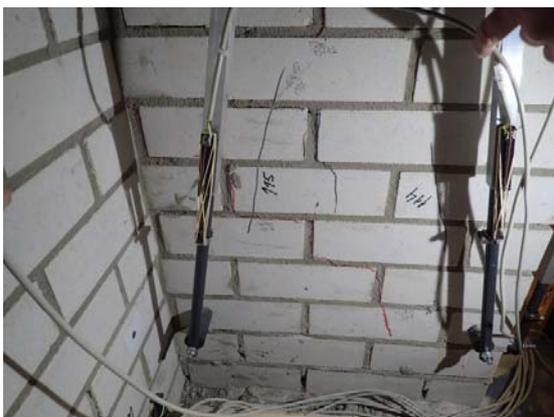
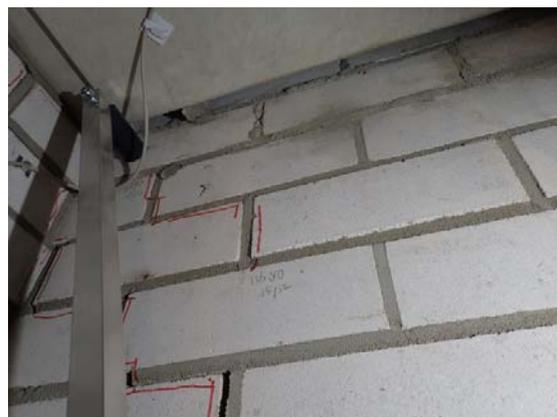
Figure E.25 – Post-peak phase **cycle 17 (positive displacement)** – ground floor: (a) Diagonal crack at the bottom of pier P2 at the ground floor (41_C17-GF-P2); (b) Crack on pier P3 at the side with west wall (42_C17-GF-P3).

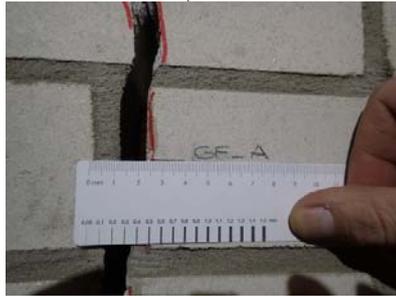
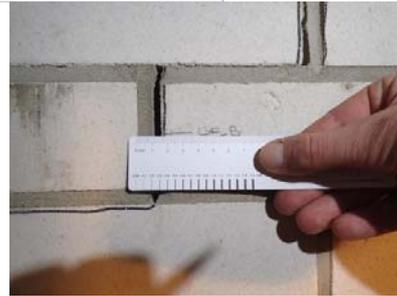
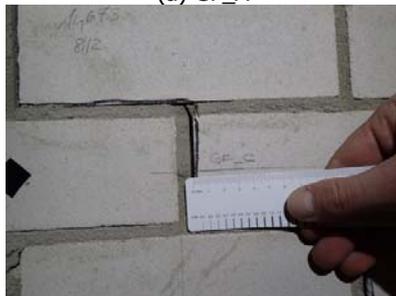
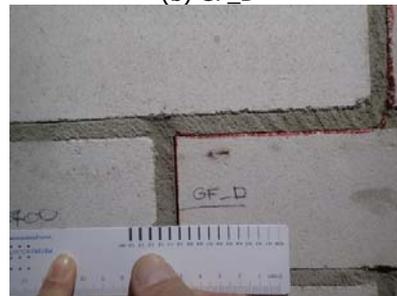
Figure E.26 – Post-peak phase cycle 17 (positive displacement) – Crack width.

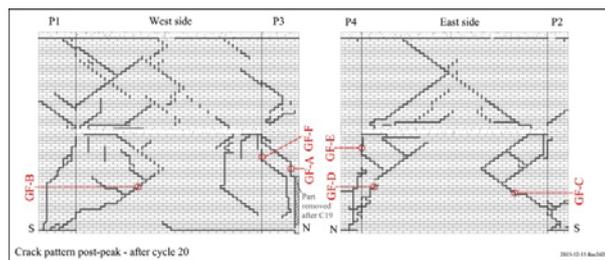
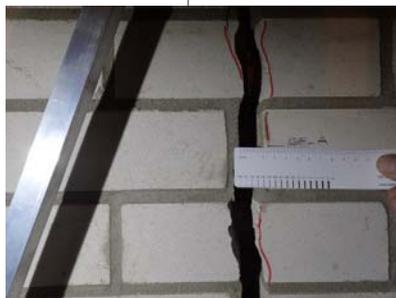
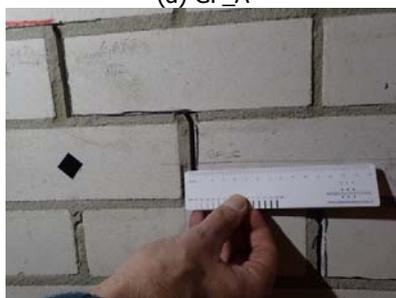
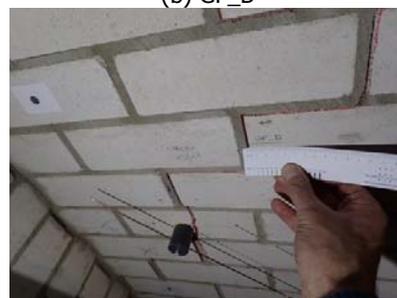
Figure E.30 – Post-peak phase cycle 18 – Crack width. Compare with Figure E.26.

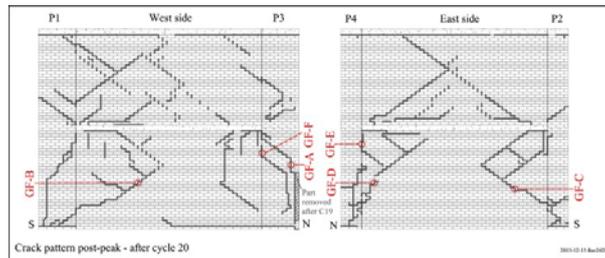
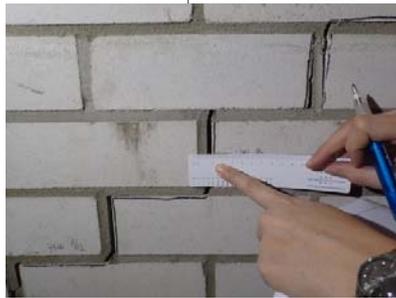
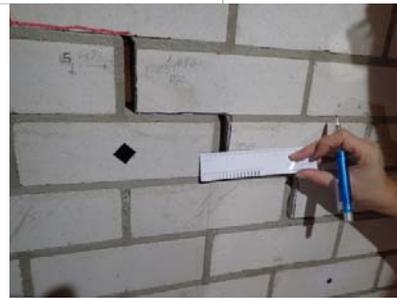
Figure E.35 – Post-peak phase **cycle 19** – Crack width. Compare with Figure E.30..

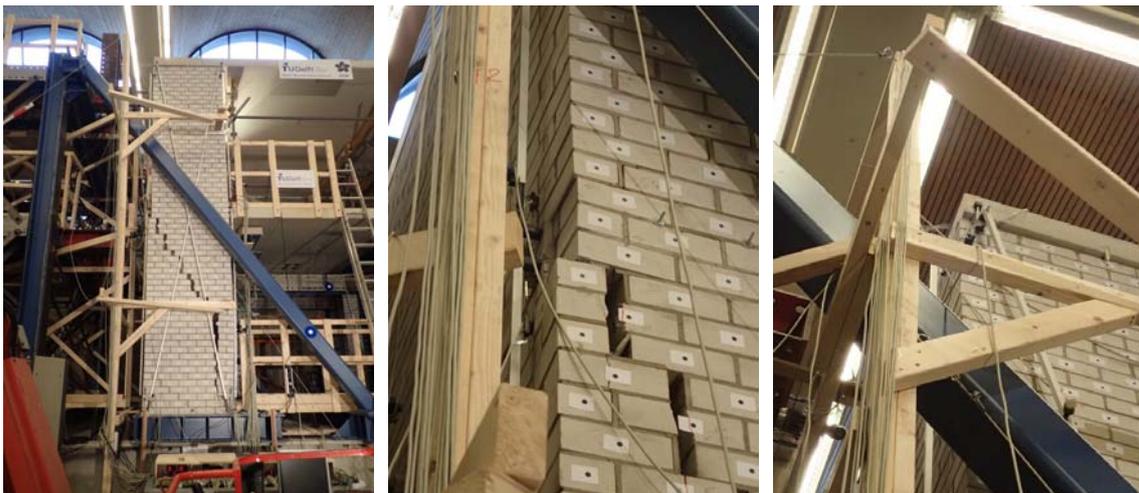
Figure E.36 – Post-peak phase **cycle 20** – Vertical/diagonal crack on pier P1 (outside): (a) Overview (57_C20-P1); (b) Detail at the first floor slab (58_C20-GF-P1); (c) Detail at the second floor slab (59_C20-FF-P1). Compare with Figure E.31.

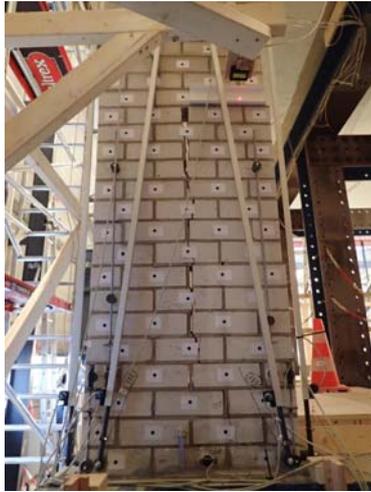
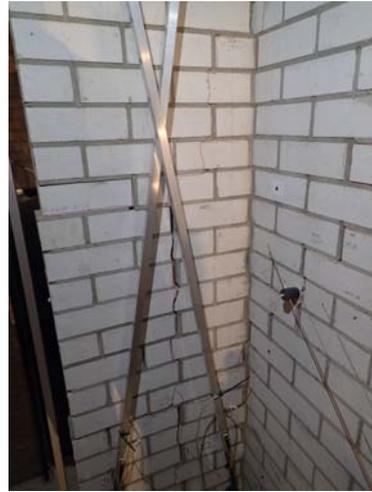
Figure E.37 – Post-peak phase **cycle 20** - Crack on pier P4: (a) Outside (60_C20-GF-P4); (b) Inside (61_C20-GF-P4). Compare with Figure E.21.

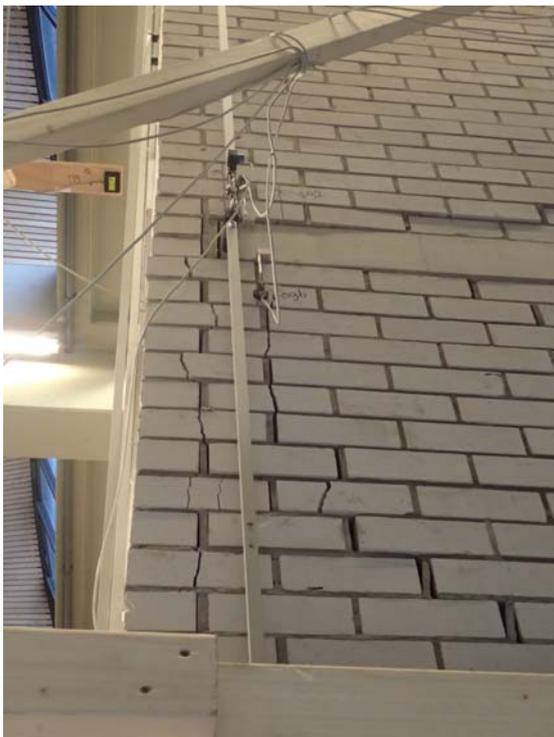
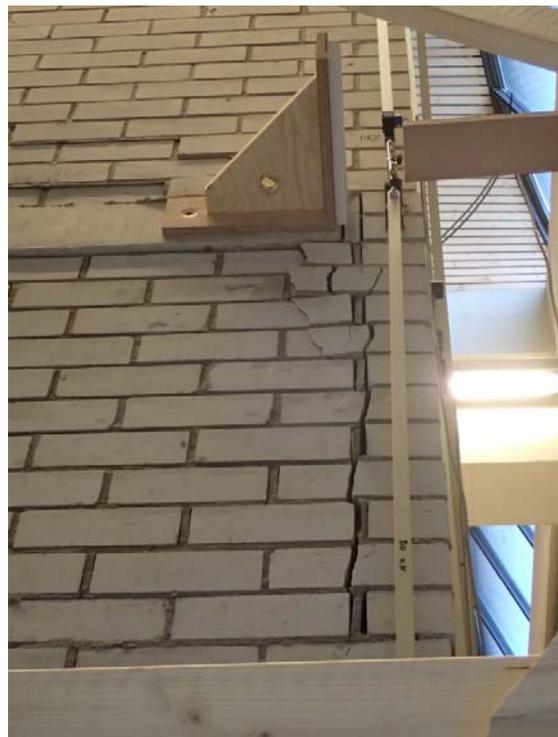
Figure E.38 – Post-peak phase **cycle 20** - Crack on east wall (outside): (a) At the side with pier P2 (62_C20-GF-EP2); (b) At the side with pier P4 (63_C20-GF-EP4).
