**On the morphological evolution of restored banks  
Case study of the Meuse river**

# On the morphological evolution of restored banks: Case study of the Meuse river

<sup>1</sup> Department of Hydraulic Engineering, Delft University of Technology, 2628CN Delft, the Netherlands

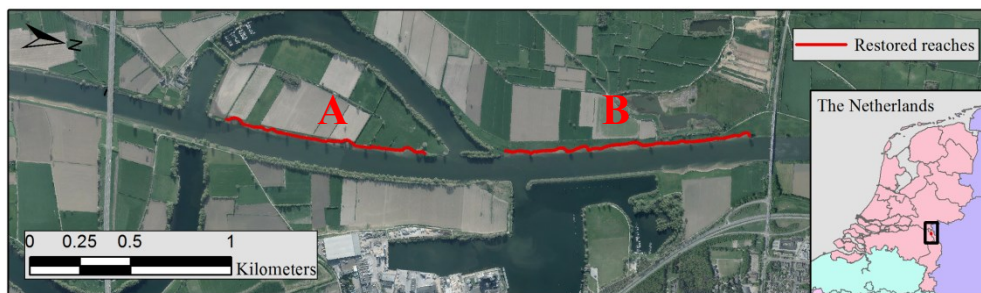
**Fig. 1.** Location of restored reaches under analysis

The Meuse River is a highly regulated river, with a series of weirs that keep minimum water levels, bend cut-offs, and protections that prevented banks from eroding. During the first phase of restorations after the WFD, 750 m of reach A (Figure 1) had the left-bank rip-rap removed in 2008. In 2010, the remaining 250 m of reach A and 1.2 km of reach B followed the same path (Figure 1).

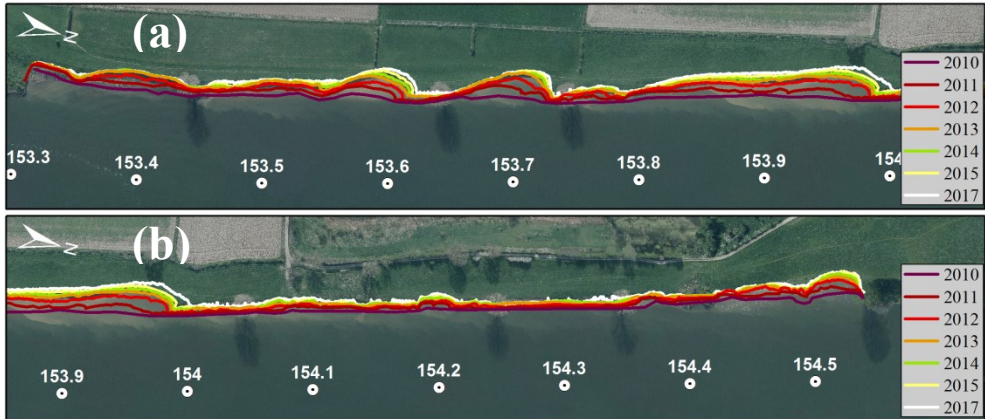
**Fig. 4.** Bankline migration at reach “B” over 7 years for upstream (a) and downstream (b) sub-reaches

The banks after seven-to-nine years of restoration present two distinct patterns in both reaches under analysis: uniform retreat and embayments (Figures 3-4). This difference is clearly evident for reach A, which has long reaches with barely any erosion and three ~30 m deep isolated embayments (Figure 3a-b). On the other hand, reach B shows two sub-reaches: the first with a series of rather continuous embayments (Figure 4a), and the second with a uniform type of erosion until the last 100 m (Figure 4b).

Factors influencing the bank resistance may then also be playing a role. For instance, the presence of trees next to the bankline sometimes appear to create strong points of relative low retreat (e.g., Figure 3a, km. 152.1), but in other places it seems not to have influenced bank erosion rates (e.g., Figure 4a, km. 153.94, where there used to be a tree that was dislodged). In addition, bank material characteristics may change bank erosion rates [e.g., 7], which would require further investigations.

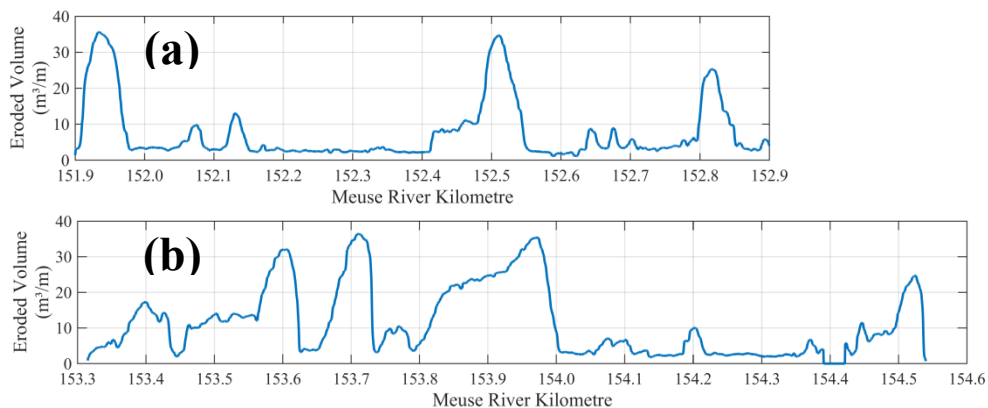
**Fig. 5.** Eroded volumes of reach “A” (a, top) and reach “B” (b, bottom) until January 2017

Figure 5 presents the eroded volumes per metre of river length for reaches A and B. A huge variability of sediment yield is evident in both reaches, whose maximum amplitudes are similar but frequencies differ. The minimum eroded volume per metre is located where uniform retreat occurred, with an average value of 2.5 m<sup>3</sup>/m. The maximum eroded volume happened at embayments, with peak values of 36 m<sup>3</sup>/m. Finally, the average for reach A was 7.6 m<sup>3</sup>/m whereas for reach B was 11.4 m<sup>3</sup>/m.
