Interlaminar adhesion assessment of carbon-epoxy laminates under salt water ageing using peel tests

Moreira Arouche, Marcio; Budhe, Sandip; Banea, Mariana D.; Teixeira De Freitas, Sofia; de Barros, Silvio

Institution of Mechanical Engineers. Proceedings. Part L: Journal of Materials: Design and Applications

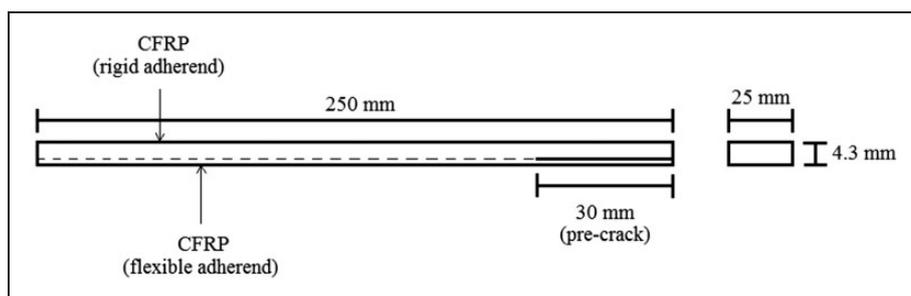
Figure 1. Specimen geometry.

The laminate plate consists of a rigid part with a layup of $[\pm 45]_6$, and a flexible part with a layup of [0/90], with [90] as the outer ply and the [0] as the contact ply with the rigid adherend. Finally, peel test specimens were cut from the laminate. The geometry is shown in Figure 1. Specimens were 25 mm in width and 250 mm long with a total thickness of 4.3 mm. The mechanical properties of the composite were determined in a previous work³⁰ by conducting tensile tests according to ASTM D 3039 standard.³²

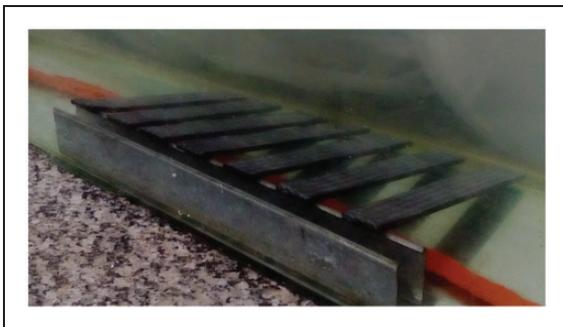
Figure 2. Specimens inside the salt water tank.

environmental exposure on the joint. Specimens were kept inside the salt water tank (5% NaCl) at room temperature for 60 days. The ageing process simulates the effect of environmental conditions wherein the materials are exposed to marine environment. Three reference specimens were tested without any ageing. Figure 2 shows the specimens inside the salt water tank.

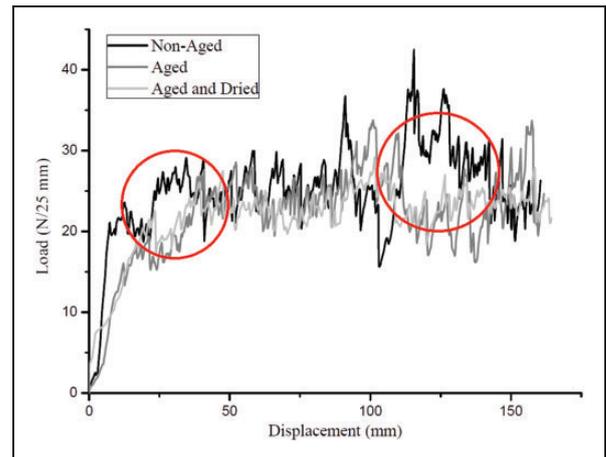
Figure 4. Representative load–displacement curves of the peel tests.

Specimens were tested in three different conditions: (1) non-aged; (2) immediately after 60 days ageing; and (3) after 60 days ageing and subsequent 280 days drying. Figure 4 shows the representative load–displacement curves of each test condition. Significant differences on the peel load are noted in the highlighted areas. This suggests a consequence of the ageing process. Previous work³⁰ showed that water ingress from the edge towards the centre of the interface and it has an irregular pattern. However, no relevant change on the peel strength is observed as consequence of the drying process.

The average peel loads (F_{ave}) were determined along 100 mm length, discarding the first 25 mm of the test. One result of aged and dried condition was discarded in order to have an equal number of results for each test condition. Values are shown in Table 2.

It is observed a reduction of 22.4% on the average peel loads as consequence of the ageing process. No significant distinction is perceived on the peel loads after drying. This indicates that the damage caused by salt water ageing on the laminate interface is essentially irreversible.

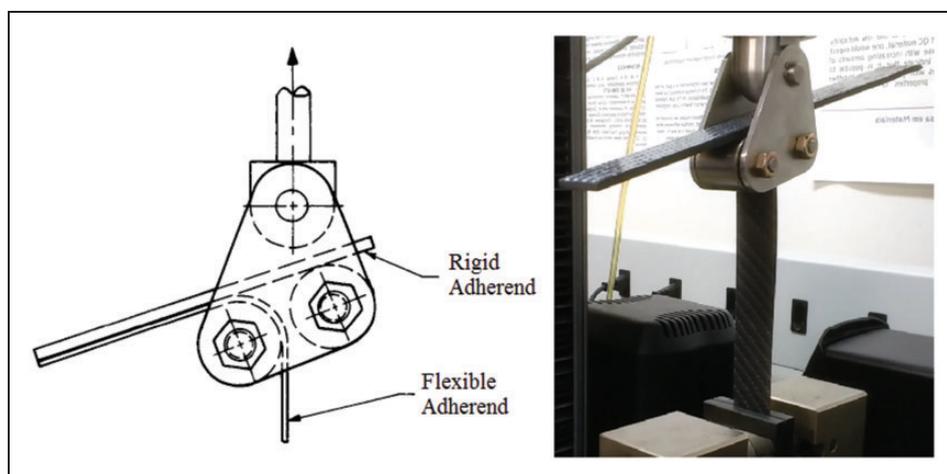
Figure 3. Floating roller peel test setup.

Figure 3 shows the test set up. The initial crack of the specimens was too short for clamping on the machine grips and had to be manually increased by pre-loading to enable testing. Load–displacement curves were recorded during testing. Three specimens were tested for each condition.

The floating roller peel test allows determining the peel strength between a rigid and a flexible adherend. Tests were performed on the specimens at room conditions, by means of an electro mechanic Instron machine (Series 5966) with a maximum capacity of 20 kN, coupled with a load cell of 1 kN. The testing speed was 125 mm/min, in accordance with the Composite Peel Test.²⁸ During the test, the flexible adherend is peeled off from the rigid adherend.

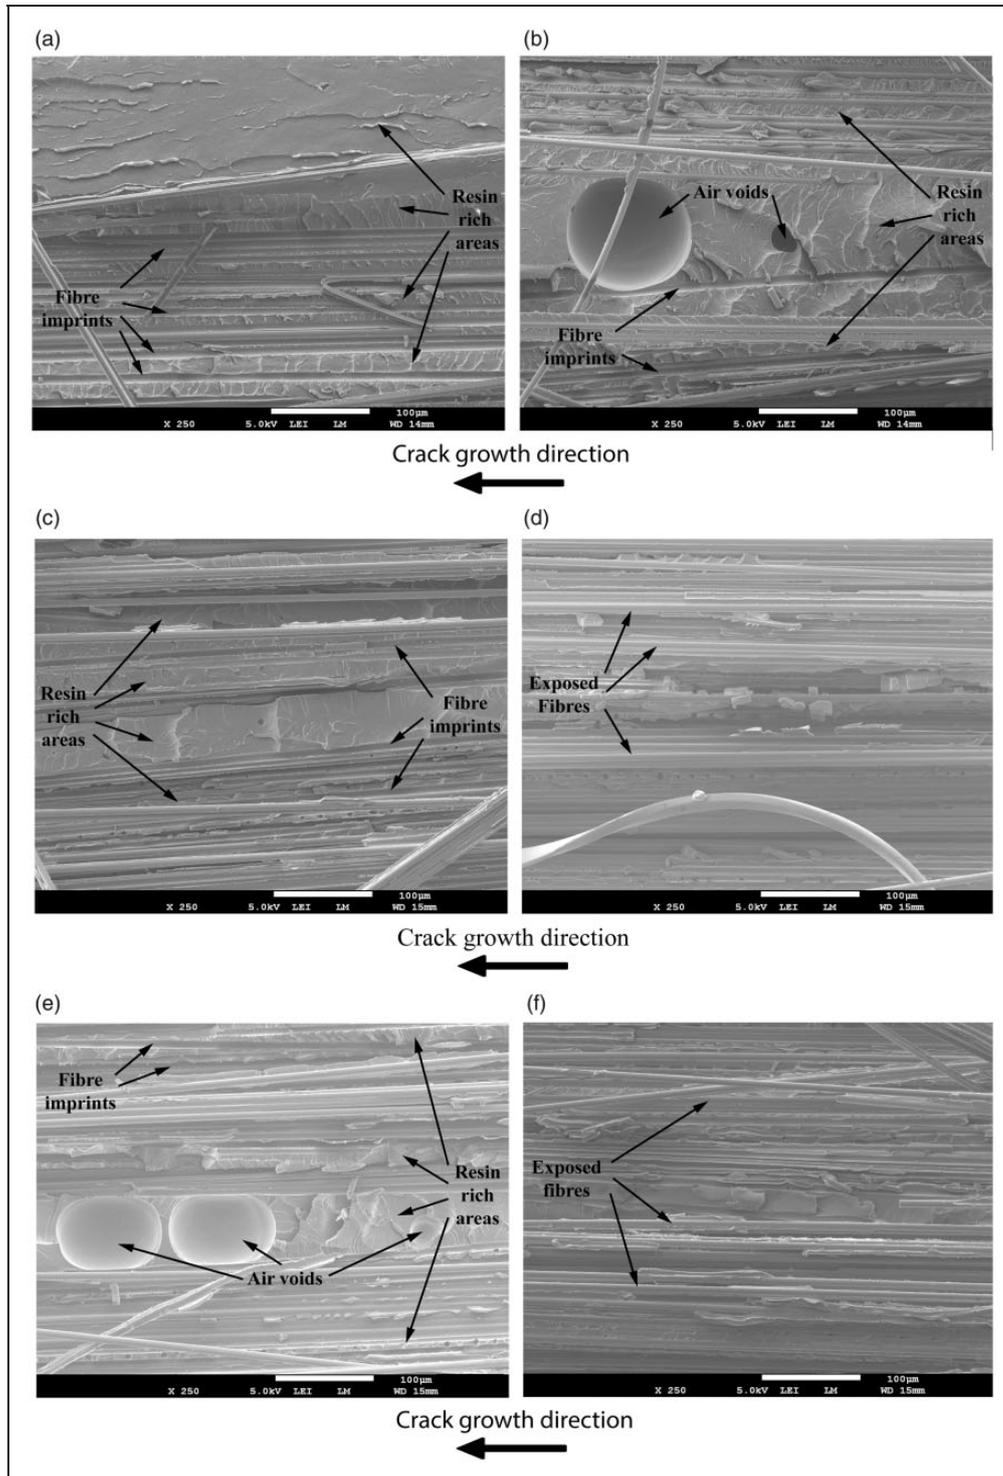
Figure 5. Fracture surfaces in low magnification: (a) non-aged – centre, (b) non-aged – edge, (c) aged – centre, (d) aged – edge, (e) aged and dried – centre, (f) aged and dried – edge.

Figure 5 shows the typical SEM fracture surfaces of samples taken from the rigid adherend in low magnification ($\times 250$, low-angle secondary electron image – LEI, 5.0 kV). The crack growth occurred from right to left direction of the images. Overall, the fracture surfaces show both resin-rich areas and exposed 0°

Considering the fracture surfaces of the non-aged specimens in Figure 5(a) and (b), significant resin rich areas are observed both at the centre (Figure 5(a)) of the specimens and at the edge (Figure 5(b)). The presence of considerable areas of resin together with the exposed fibres indicates that the failure occurred partially cohesive within the matrix and partially adhesive at the fibre/matrix interface.

Figure 5(c) to (f) shows the fracture surfaces of the aged specimens. The fracture surfaces at the centre locations (Figure 5(c) aged and Figure 5(e) aged and

dried) show similar features as for the non-aged specimens: a mixed of matrix failure (resin rich areas) and fibre/matrix interface failure (exposed fibres). However, at the edge of the conditioned specimens (Figure 5(d) aged and Figure 5(f) aged and dried), the resin rich areas disappear and the dominant fracture feature is the exposed carbon fibres, both at the aged specimens (Figure 5(d)) and aged and dried specimens (Figure 5(f)). The corrugated shape of the fracture surfaces typical of these areas indicates a poor fibre/matrix adhesion.

Results show that fracture mechanisms at the centre of the aged specimens remained unaffected by ageing, since at these areas the fracture surfaces are similar to the non-aged specimens. The typical fracture mechanism in this case is a mixture of matrix cohesive failure and fibre/matrix interface failure. These results indicate that the edges of the fracture surfaces were affected by ageing. In these cases, the prevailing fracture mechanism is fibre/matrix interface failure. According to the literature,^{16,20} this is the governing damage mechanism in polymer composites exposed to environmental ageing.

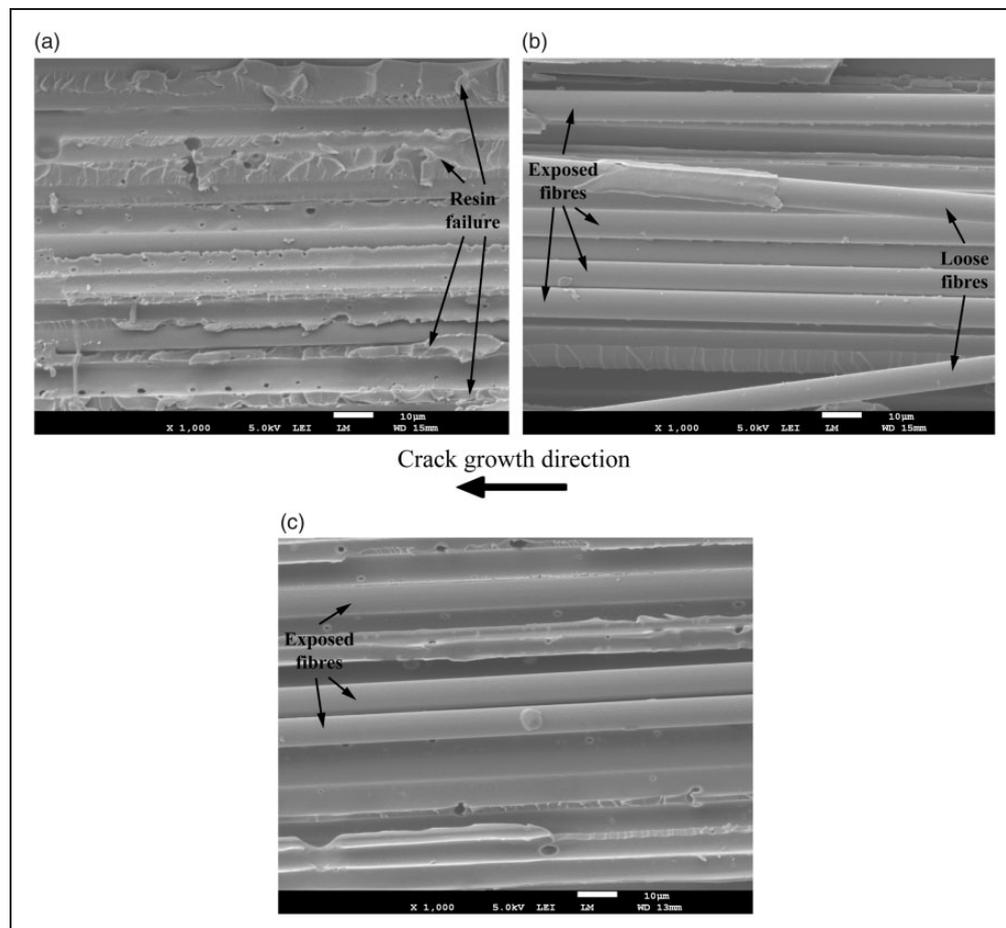
Figure 6. Fracture surfaces in high magnification: (a) non-aged, (b) aged, (c) aged and dried.

Figure 6 shows the fracture surfaces obtained from the rigid adherend in high magnification ($\times 1000$, LEI, 5.0 kV). Images were taken from regions near the edge of the specimen where the effect of ageing is noted. The crack growth occurred from right to left direction of the images. Non-aged specimen (Figure 6(a)) presented a substantial amount of matrix around fibres. It indicates a strong fibre/matrix interface adhesion. In the aged specimen (Figure 6(b)), the exposed fibres are predominant. It shows that the fibre/matrix interface became the major failure mode rather than the matrix failure. A similar fracture surface is observed in the aged and dried specimen (Figure 6(c)). This confirms that the ageing process produced an unrecoverable damage in the composite interlaminar adhesion.

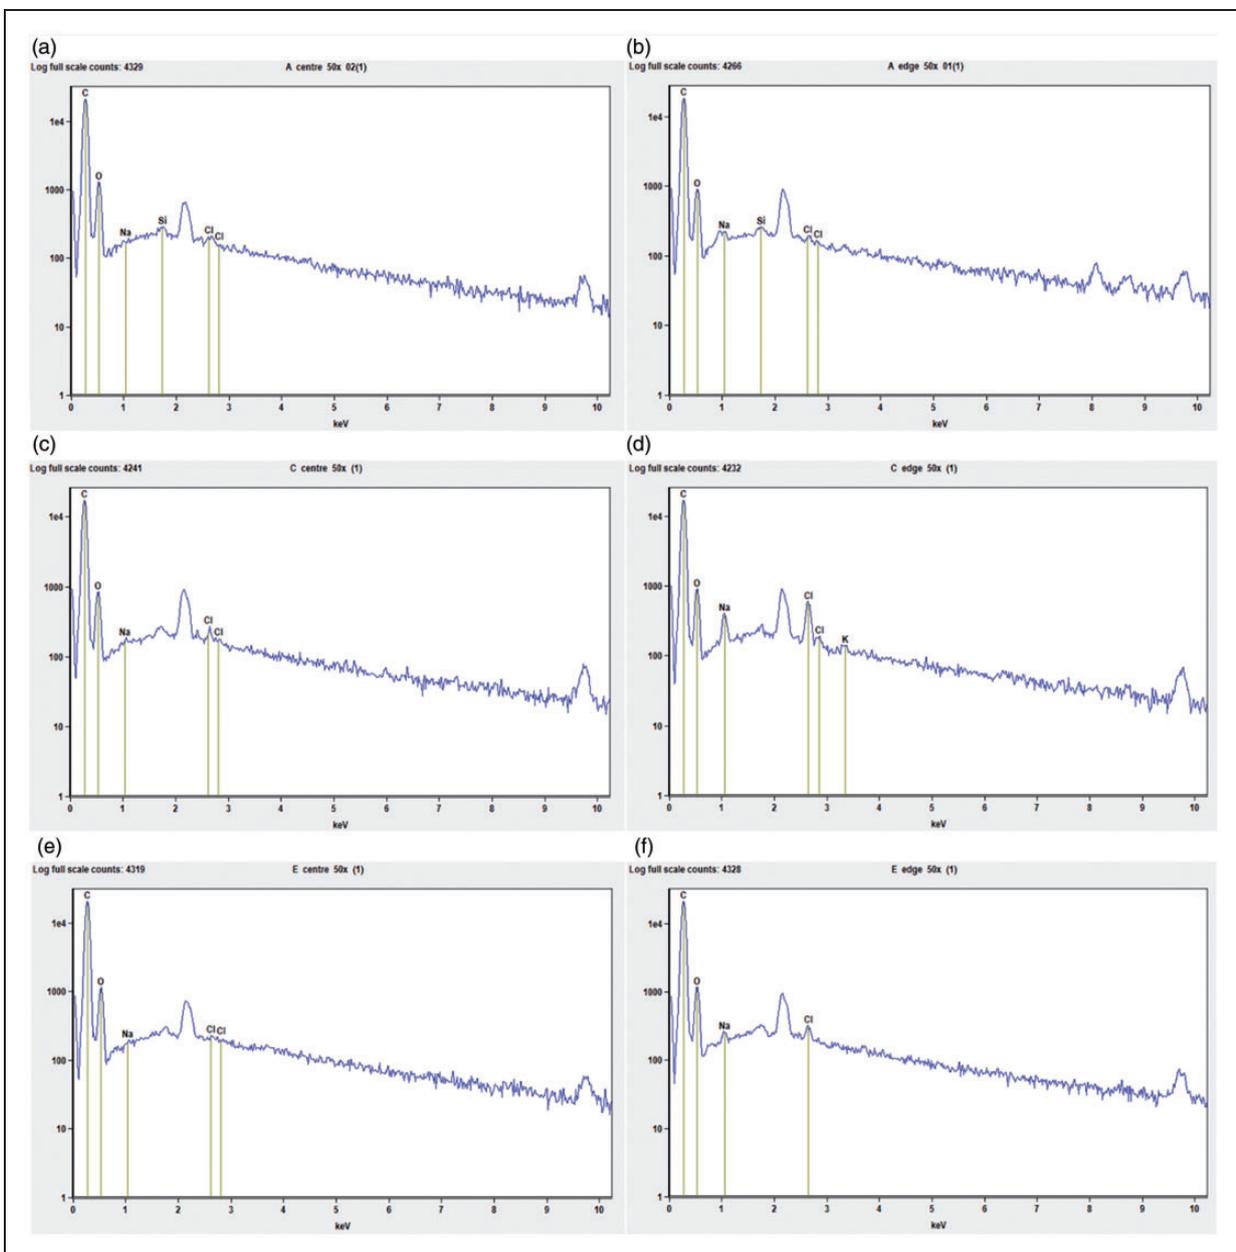
Figure 7. EDS spectrum of the fracture surfaces: (a) non-aged – centre, (b) non-aged – edge, (c) aged – centre, (d) aged – edge, (e) aged and dried - centre, (f) aged and dried – edge.

Figure 7 shows the results of the EDS analysis. The graphs display peaks that represent the occurrence of chemical elements on the fracture surface. Results revealed the presence of salt (Na and Cl elements) next to the edge of the fracture surface in aged specimen (Figure 7(d)) and in aged and dried specimen (Figure 7(f)). The incidence of these components is insignificant in both centre (Figure 7(a)) and edge (Figure 7(b)) of the non-aged specimen, as well as in the centre of the aged (Figure 7(c)) and aged and dried (Figure 7(e)) specimens. This confirms that the penetration of salt water occurred in the regions near the edge of the specimens and not at the centre. The other peaks represent the amount of carbon (C), oxygen (O) and the unnamed peaks represent gold and palladium sputtered for sample preparation. A comparative analysis of the salt content is presented in Figure 8. It is observed a decrease on the salt content at the edge of the specimen after drying. However, there was no difference between the peel loads (Figure 4 and Table 2). This reinforces the argument that the ageing process produced an unrecoverable damage on the interlaminar adhesion of the composite.

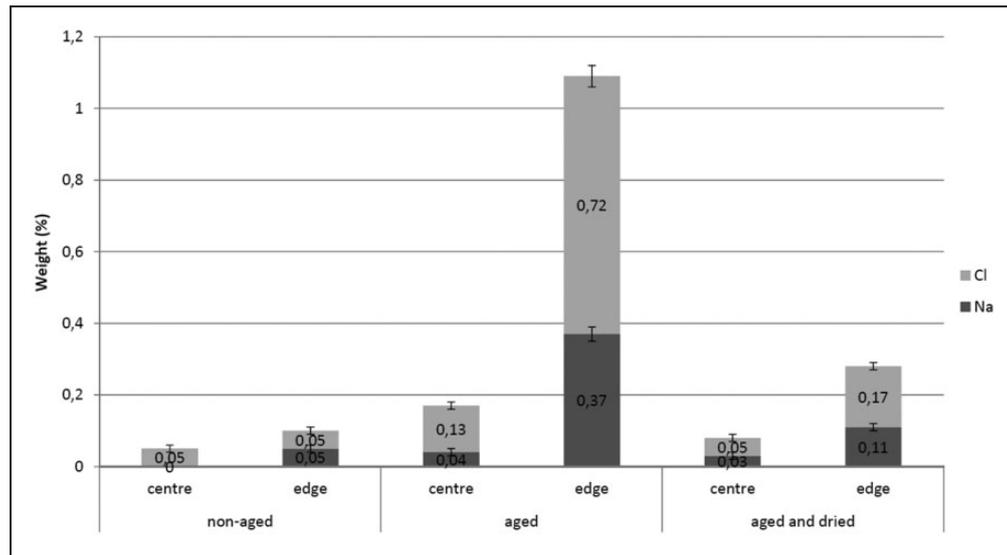
Figure 8. Salt content on the fracture surfaces.
