**On the morphological evolution of restored banks  
Case study of the Meuse river**

# On the morphological evolution of restored banks: Case study of the Meuse river

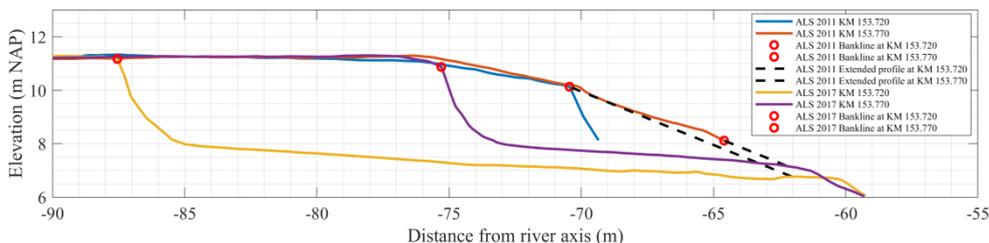
**Fig. 2.** Cross sections at km 153.720 and 153.770 on 2011, with extended profile, and 2017, with terrace at the bank toe.

The first ALS survey required the extrapolation of bank profiles due to the initial erosion that occurred before 2011. The banks immediately after the restoration works had typical slopes of 1:2.5, which is similar to the design profile of the revetments previously in place, so we considered the same slope to "refill" the banks. Since a variety of erosion magnitudes occurred, we first identified whether there was a bank scarp on each profile along the reaches. For those sections with a scarp, the top edge was identified based on slope changes, and we took it as the initial point for the bank extrapolation. In those cases where the erosion was still low, the extrapolation was done at the end of the measured profile, i.e. slightly above the water level. In both cases, the profiles were extended until the terrace level on 2017, from the second ALS survey. Figure 2 shows two typical bank profiles on early 2011 with distinct erosion magnitudes and respective extensions.

In this way, the initial bank profiles after restoration were estimated and all reaches had a condition similar to the initial one. Figure 2 also presents profiles of 2017 during the low water level, which shows the terrace at the bank toe. For this survey, bank edges were also identified to limit the subtraction of the two profiles to the eroded part. The erosion volume was finally calculated every 0.5 m with the areas between the profiles. We performed all computations with MATLAB.

Irrespective of the erosion magnitude, the presence of a terrace at the bank toe resulted ubiquitous. The approximate elevation of this terrace (~7-8 m, see Figure 2) is close to the regulated water level (~8 m), where ship waves can act to erode banks [e.g., 8] and might explain the terrace formation. On the other hand, a weak soil stratum at the mentioned elevation could also have created it.

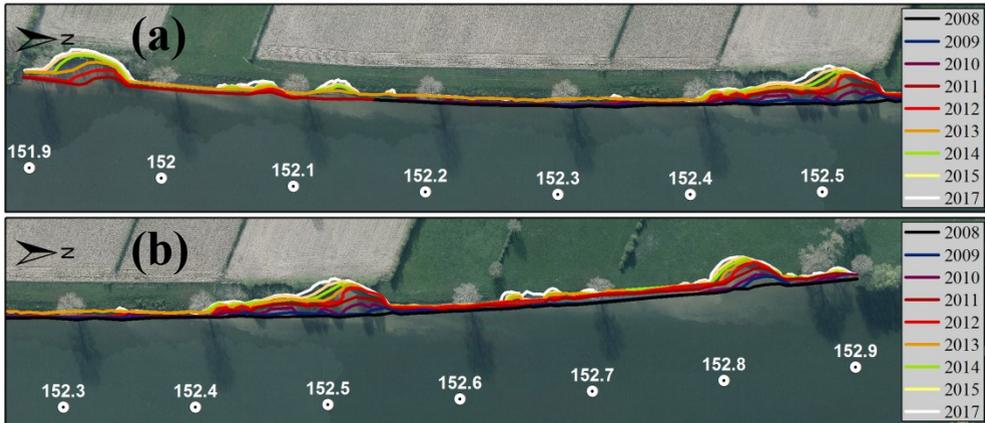
**Fig. 3.** Bankline migration at reach “A” over 9 years for upstream (a) and downstream (b) sub-reaches

The banks after seven-to-nine years of restoration present two distinct patterns in both reaches under analysis: uniform retreat and embayments (Figures 3-4). This difference is clearly evident for reach A, which has long reaches with barely any erosion and three ~30 m deep isolated embayments (Figure 3a-b). On the other hand, reach B shows two sub-reaches: the first with a series of rather continuous embayments (Figure 4a), and the second with a uniform type of erosion until the last 100 m (Figure 4b).

Over the years, the banks evolved from a smooth continuous bankline into highly heterogeneous ones, with specific areas that experienced high erosion rates up to 7 m/year (e.g., Figure 3a, km. 153.92-153.98 between 2011 and 2012). The trend of the erosion patterns was evident 1 or 2 years after the restorations for most embayments, so the initial response of the system was then further developed in time. The temporal evolution of embayments shows some differences between reaches A and B. In the former, embayments appeared to progress with a somewhat uniform erosion rate (separation between consecutive banklines), but in the latter, the highest rates in general occurred during the first two years and then decreased over time. Finally, the embayments of reach A evolved with an upstream shift whereas those in B did it in downstream direction.

Factors influencing the bank resistance may then also be playing a role. For instance, the presence of trees next to the bankline sometimes appear to create strong points of relative low retreat (e.g., Figure 3a, km. 152.1), but in other places it seems not to have influenced bank erosion rates (e.g., Figure 4a, km. 153.94, where there used to be a tree that was dislodged). In addition, bank material characteristics may change bank erosion rates [e.g., 7], which would require further investigations.

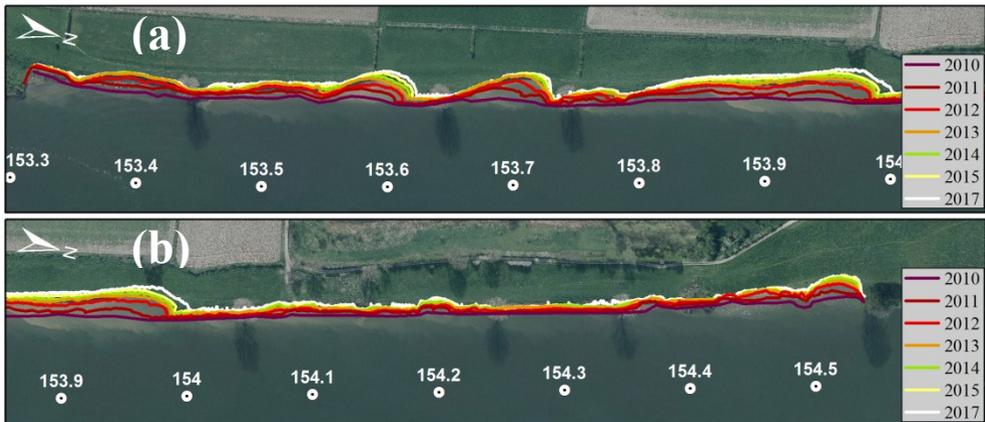
**Fig. 4.** Bankline migration at reach “B” over 7 years for upstream (a) and downstream (b) sub-reaches

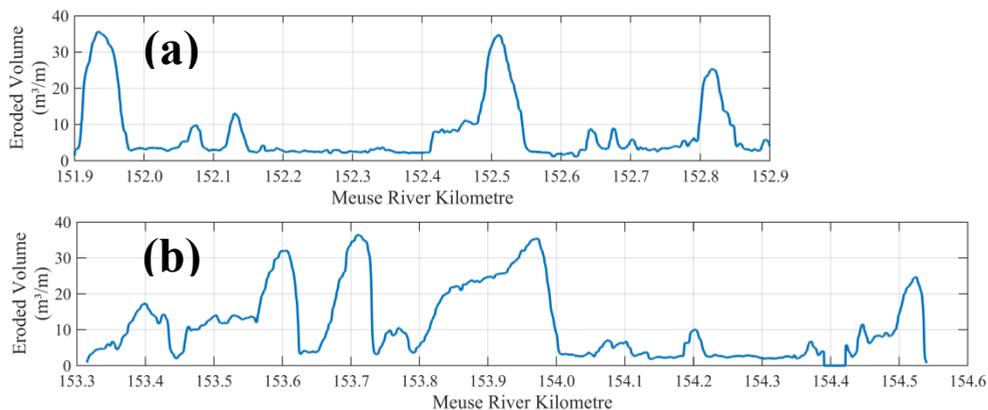
**Fig. 5.** Eroded volumes of reach “A” (a, top) and reach “B” (b, bottom) until January 2017

Figure 5 presents the eroded volumes per metre of river length for reaches A and B. A huge variability of sediment yield is evident in both reaches, whose maximum amplitudes are similar but frequencies differ. The minimum eroded volume per metre is located where uniform retreat occurred, with an average value of 2.5 m<sup>3</sup>/m. The maximum eroded volume happened at embayments, with peak values of 36 m<sup>3</sup>/m. Finally, the average for reach A was 7.6 m<sup>3</sup>/m whereas for reach B was 11.4 m<sup>3</sup>/m.
