**On the morphological evolution of restored banks
Case study of the Meuse river**

On the morphological evolution of restored banks: Case study of the Meuse river

Gonzalo Duró^{1,*}, Alessandra Crosato^{1,2}, Maarten Kleinhans³, and Wim Uijttewaal¹

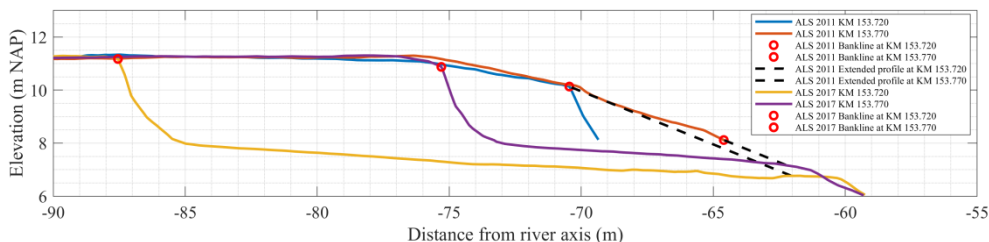
Fig. 2. Cross sections at km 153.720 and 153.770 on 2011, with extended profile, and 2017, with terrace at the bank toe.

The first ALS survey required the extrapolation of bank profiles due to the initial erosion that occurred before 2011. The banks immediately after the restoration works had typical slopes of 1:2.5, which is similar to the design profile of the revetments previously in place, so we considered the same slope to “refill” the banks. Since a variety of erosion magnitudes occurred, we first identified whether there was a bank scarp on each profile along the reaches. For those sections with a scarp, the top edge was identified based on slope changes, and we took it as the initial point for the bank extrapolation. In those cases where the erosion was still low, the extrapolation was done at the end of the measured profile, i.e. slightly above the water level. In both cases, the profiles were extended until the terrace level on 2017, from the second ALS survey. Figure 2 shows two typical bank profiles on early 2011 with distinct erosion magnitudes and respective extensions.

In this way, the initial bank profiles after restoration were estimated and all reaches had a condition similar to the initial one. Figure 2 also presents profiles of 2017 during the low water level, which shows the terrace at the bank toe. For this survey, bank edges were also identified to limit the subtraction of the two profiles to the eroded part. The erosion volume was finally calculated every 0.5 m with the areas between the profiles. We performed all computations with MATLAB.

Irrespective of the erosion magnitude, the presence of a terrace at the bank toe resulted ubiquitous. The approximate elevation of this terrace (~7-8 m, see Figure 2) is close to the regulated water level (~8 m), where ship waves can act to erode banks [e.g., 8] and might explain the terrace formation. On the other hand, a weak soil stratum at the mentioned elevation could also have created it.

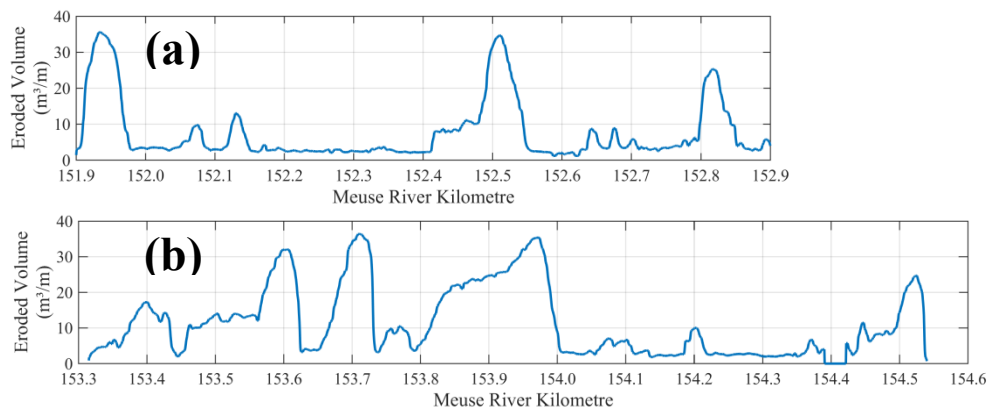
Fig. 5. Eroded volumes of reach “A” (a, top) and reach “B” (b, bottom) until January 2017

Figure 5 presents the eroded volumes per metre of river length for reaches A and B. A huge variability of sediment yield is evident in both reaches, whose maximum amplitudes are similar but frequencies differ. The minimum eroded volume per metre is located where uniform retreat occurred, with an average value of 2.5 m³/m. The maximum eroded volume happened at embayments, with peak values of 36 m³/m. Finally, the average for reach A was 7.6 m³/m whereas for reach B was 11.4 m³/m.
