Experimental and computational study of the influence of pre-damage patterns in unreinforced masonry crack propagation due to induced, repeated earthquakes

Korswagen Eguren, Paul; Longo, Michele; Meulman, Edwin; Rots, Jan

Proceedings of the Thirteenth North American Masonry Conference

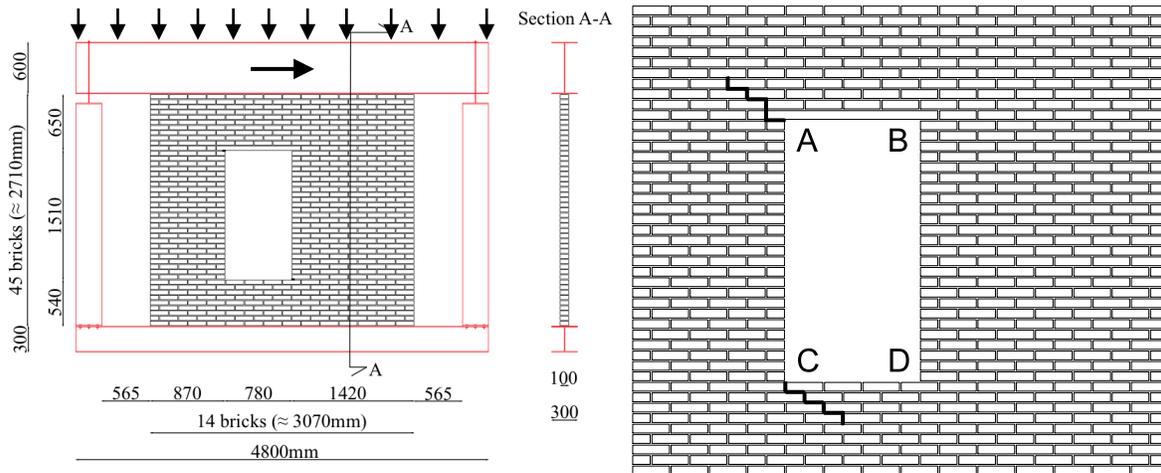
Figure 1. Left, geometry of the masonry wall. Right, position of plastic strips to simulate pre-damage on window corners A and C.

A single-wythe masonry wall built with baked-clay bricks in a running bond and having an asymmetrical window opening is used as the main case of this study, see figure 1. The specimens are built to match four walls of identical geometry and material previously tested that are used as benchmarks against which comparisons are drawn. An elaboration of the selection of the material and geometry of the walls is provided in Korswagen et al. (2019). Briefly, the combination of brick and mortar were chosen to

Two identical specimens of the wall described (designated TUD-Comp45 and Comp46, with ‘Comp’ indicating ‘component’) are experimentally tested in this study. The walls are pre-damaged by means of reduced bond at specific joints. The reduction in bond is accomplished by placing strips of PVC at the moment of construction. The strips run along predefined joints simulating the presence of an open crack. The bond between the mortar and the plastic was determined by a series of bond-wrench tests where the bond area between the bricks was reduced by incorporating different ratios of PVC. From these tests, the bond strength of the plastic to the mortar was keyed at around 0% to 5% of the bond between brick and mortar, hence adequately replicating an open crack. The position of the strips is illustrated in Figure 1 and was chosen to mimic uneven settlement damage on the wall, where the right side of the wall settles more than the left. The precise position of ‘cracks’ was determined by a combination of finite element models and review of damage cases, see Figure 2.

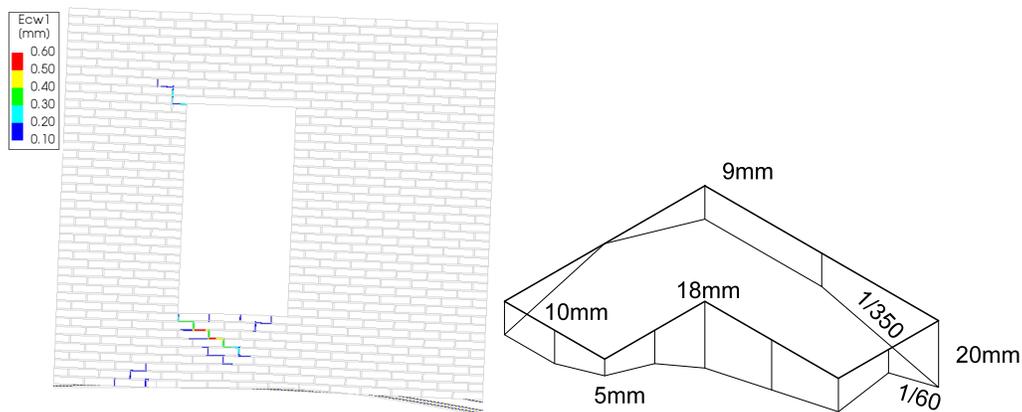
Figure 2. Left, crack width plot of a computational model. Right, example of measurement of bed-joint levelling to determine a settlement configuration which could resemble the employed settlement.

Concrete and steel materials (for lintel and beams respectively) are modelled as linear elastic ($\rho=2.4 \text{ ton/m}^3$, $E=31\text{GPa}$, $\nu=0.2$; $\rho=7.85 \text{ ton/m}^3$, $E=210\text{GPa}$, $\nu=0.3$). Furthermore, to model the reduction in bond of the joints of the two specimens (see Figure 2), weak spots resembling the pre-damage are modelled (dark

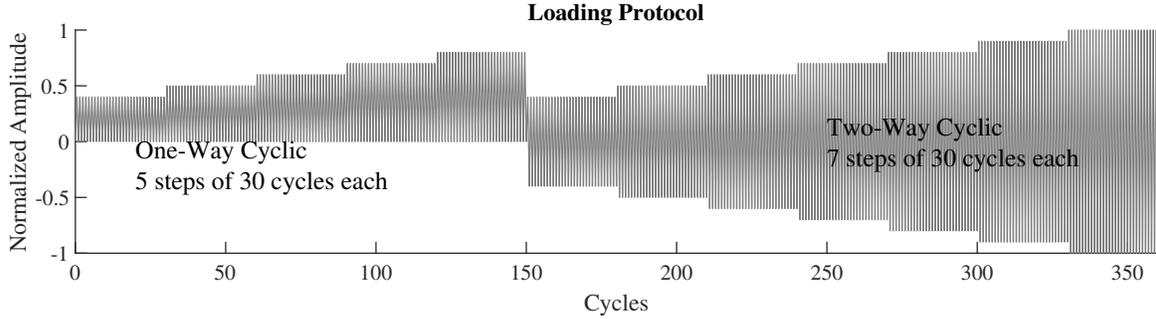
Figure 3. Loading protocol with a high number of small cycles.

The walls were subjected to an overburden of 0.12MPa during the test, representing a moderate gravity load. The specimens were attached to the testing setup at the bottom and fixed to a top steel beam that was free to rotate but whose horizontal displacement (in the plane of the walls) was prescribed. See Messali et al. (2017) for additional details on the test setup. The walls were then subjected to a step-wise increasing top lateral displacement (drift). The loading protocol consisted of five one-way cyclic steps of 30 cycles each and seven two-way cyclic steps also of 30 cycles each for a total of 360 cycles with a maximum drift of 0.75‰; this is illustrated in Figure 3.

Three load cases are applied: dead load, overburden, and in-plane displacement-controlled loading. The displacement protocol is the same as the one employed in the experiment (see Figure 3), albeit with a reduced number of cycles per step, since the material model does not include force degradation for one-way cyclic loading; therefore, only one repetition per step is applied. Efforts to include strength degradation in the composite material model are underway, see Bindiganavile (2018).

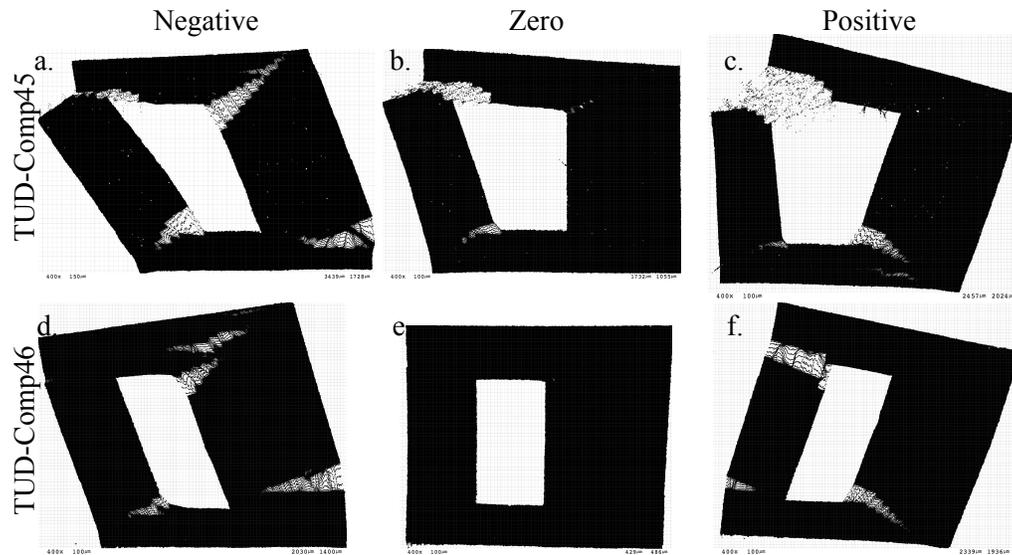
Figure 4. Magnified (400x) deformed shape plots captured using DIC for a negative, zero, and positive drift towards the end of the test (after 300 cycles) for walls Comp45, top, and Comp46, bottom. Note the full detachment of the left pier of Comp45 at this stage.

The behaviour of both pre-damaged walls was partly influenced by the existing crack. While the bottom pre-damaged joints seem to contribute little to the crack development, the weakened joints at the left top corner of the window did influence the crack growth. Especially for the first wall, Comp45, where a full opening and detachment of the left pier was observed with a crack of up to 2mm in width towards the end of the test. See Figure 4c. This also led to reduced hysteresis in comparison to the second wall as evidenced by a more narrow ‘neck’ of the cyclic force-displacement curve presented in Figure 5.

When observing the damage parameter Ψ , a relationship can be traced between the drift to which the walls are exerted to, and their damage intensity. Figure 7 shows that at larger drift values, increased damage is also expected. A power fit is applied to the data outside of the axes (non-zero damage and non-zero drift). For the walls without pre-damage, the curves appear closer to linear fits, while for the walls with pre-damage, the fits have a stronger curvature. Note that the fits do not consider the fact that damage increases at the same value of drift (strength degradation and damage aggravation), and are thus approximate fits. Nonetheless, it would seem that, walls with pre-damage (Comp45 and Comp46) display more severe damage at lower drift values but equalise with the rest of the walls at higher drift values. Note also that pre-damage walls have a significantly higher number of points on the vertical axis, showing detectable damage at zero drift. Additionally, the case of Comp45 where the left pier detached completely from the top of the wall, displays a clear increase in damage in the positive direction. In the negative direction, the damage decreases between 0.4‰ and 0.5‰ before increasing again; this is likely related to the significant amount of sliding occurring at the top of the left pier which closes the crack at the bottom of the left pier, but later contributes to opening it further as depicted in Figure 4a.

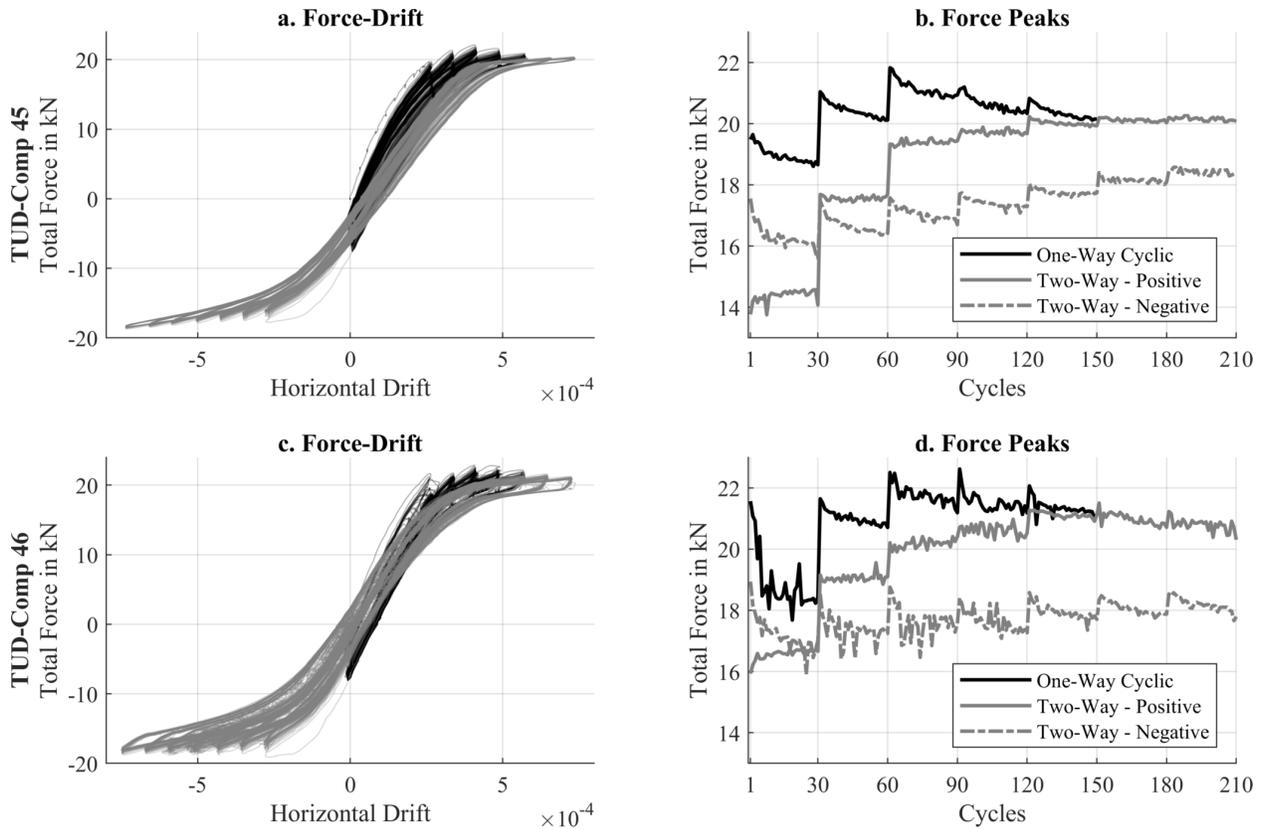
Figure 5. Force-Drift (displacement) plots for pre-damaged walls, including the progression of force peaks during the test. Top, Comp45; bottom, Comp46.

Here, several noteworthy observations are highlighted. First, even though the walls have a window placed off-centre, the behaviour is similar for the positive and the negative directions; the negative direction, where emphasis is given to the small pier, does show consistently lower strength. Second, the strength degradation due to the repetition of multiple cycles per step, is clearly observable in Figure 5.b and Figure 5.d. On average, the degradation is around 5%. In Figure 5.b, it is also interesting to note how the two-way cyclic portion of the test does not display degradation for the positive drift, but does show it for the negative drift; presumably this is because the one-way cyclic portion of the test has already degraded the wall, but only for the positive drift. Third, the strength during the first step of the two-way cyclic test is significantly lower than it was during the very beginning of the test. This is clear evidence that, even though the wall had only been pushed to approximately 0.65‰ of drift, its behaviour against subsequent excitations has changed.

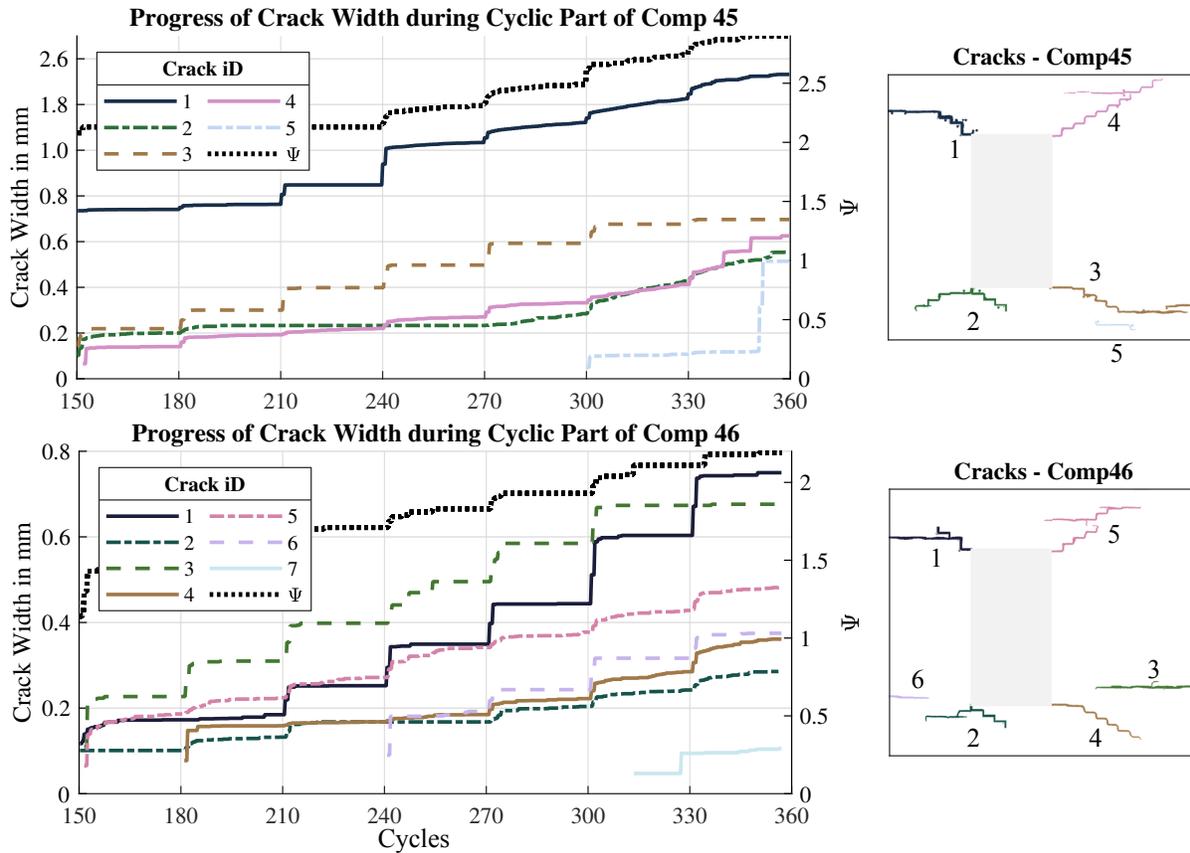
Figure 6. Progression of crack width during two-way cyclic portion of the pre-damaged walls.

The degradation per step is also evidenced in the crack progression of the walls throughout the test. Figure 6 shows the crack pattern and the progression of the width of the cracks. Cracks are evaluated from and to a cutoff width of 0.1mm and are required to be longer than 100mm. Here, the increase in crack width of the various cracks does not only occur at the change of step (which is easily identifiable), but also throughout each step. In the case of Comp45, the detachment at the top of the left pier (crack 1) leads to a large crack width and a consequent high value of damage ($\Psi \approx 3$). Here, the large crack increase of crack 1, accompanies propagation of cracks 2 and 4 which are linked to the same failure mechanism (see Figure 4a). In Comp46, the width of the cracks is more uniform, but the steady increase, also within each step, is also present. In both walls, the damage parameter Ψ also increases steadily.

corner of the window. At the end of the protocol (Figure 12.c), a rocking crack in the bed joints located in the larger pier at the top (right) window corner also occurs. These cracks are similar to those of the experimental test (Figure 6) differing only by the more pronounced stair-case trajectory of the test against the straighter one of the model, illustrated best by the crack at the top right corner of the window.

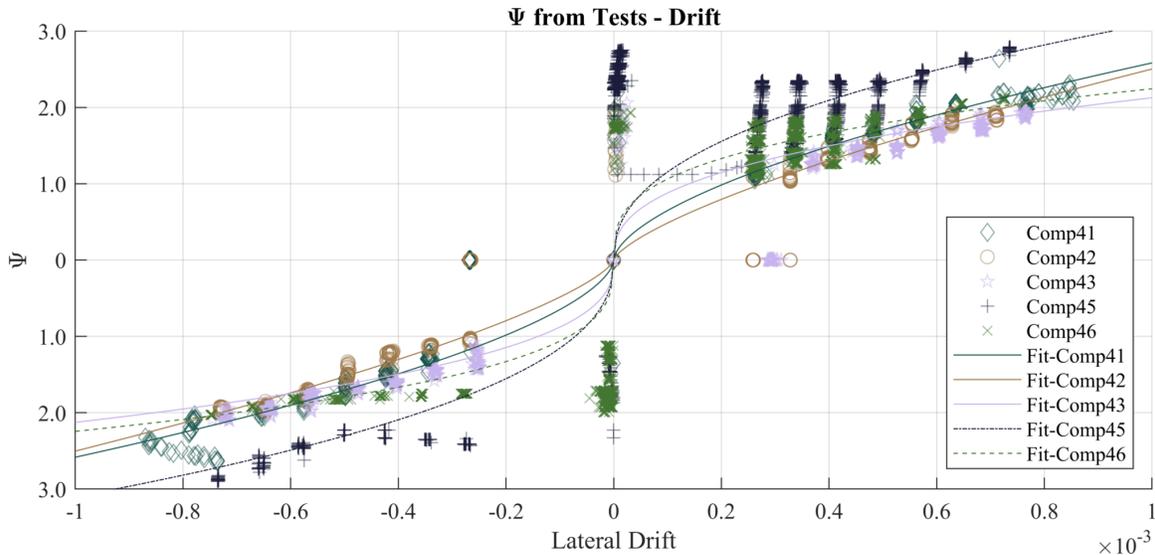
Figure 7. Damage parameter Ψ against values of drift for five walls, two of which (Comp45 and Comp46) were pre-damaged.

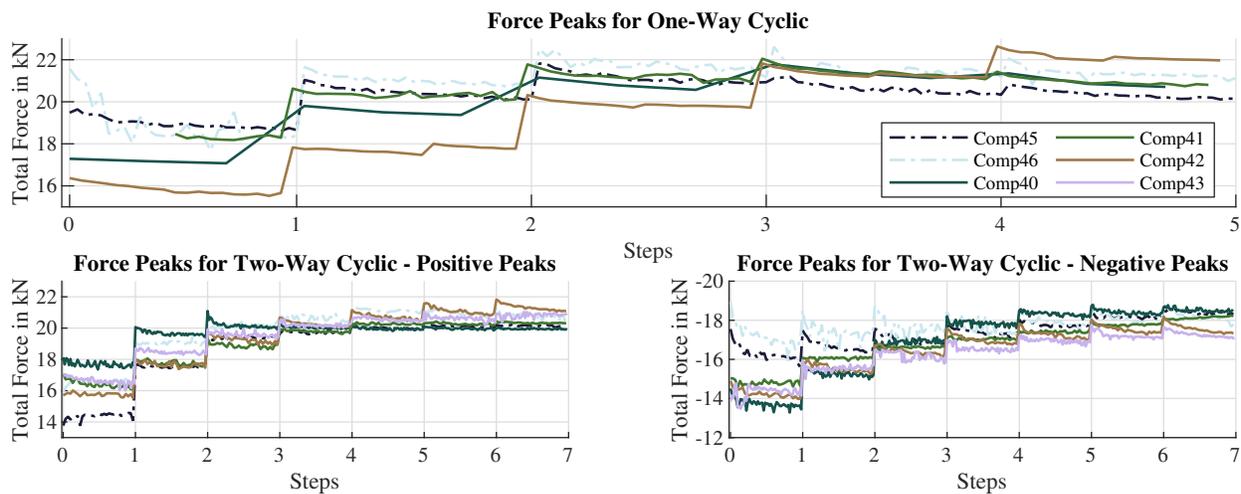
Figure 8. Comparison of force degradation during the tests.

In terms of force degradation, no significant differences can be observed between the virgin and the pre-damaged walls. In Figure 8, the strength degradation during the multiple cycles only reveals that towards the end of the test, the pre-damaged walls do not display much degradation whereas the virgin walls (in particular Comp42) do show a decline in force.

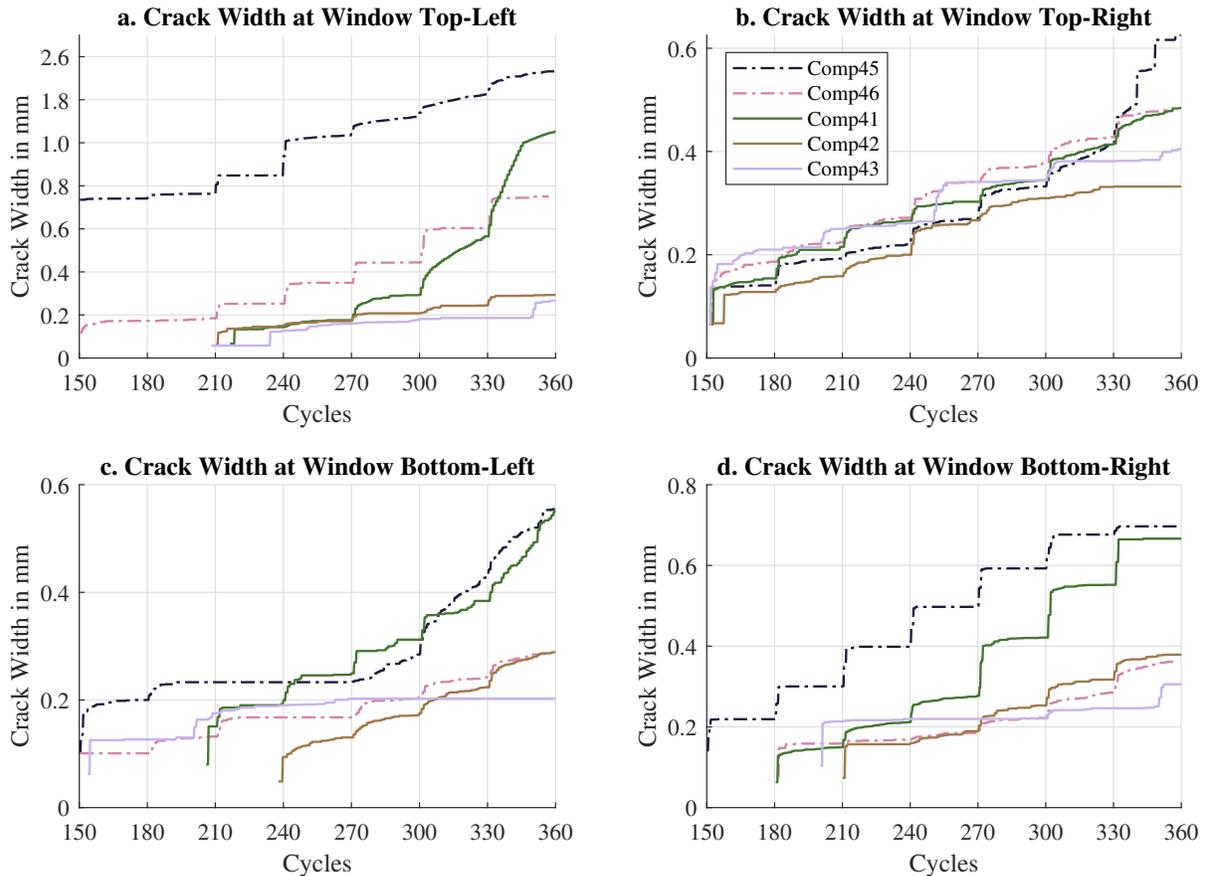
Figure 9. Comparison of crack width as detected by DIC for the two pre-damaged walls (Comp45 and Comp46) and the non-pre-damaged walls, for the four corners of the window during the two-way cyclic portion of the test.

The higher damage of Comp45 is also visible in Figure 9, where the width of the four cracks at the window corners is compared for the two-way cyclic portion of the test. In Figure 9a, the crack for Comp45 is significantly wider than the same crack for the other cases. The second pre-damaged wall, Comp46 also shows increased crack-width, evidencing that for the crack at the top left window corner (from here on, crack a), the pre-damage has had an influential effect. This is reasonable, since this crack was partly pre-damaged (see Figure 2), and the failure mechanism related to the in-plane lateral loading fosters the crack propagation over the pre-damaged joints. Conversely, the crack at the bottom left

window corner (crack c, Figure 9c) does not display unusual width; in this case, the pre-damaged joints trigger the presence of a crack but do not seem to affect its propagation as the crack travels in a different direction (see Figure 9). In fact, the cracks at the left corners of the window (a and c) are not part of the same failure mechanism (see Figure 4) but appear to be related when significant sliding occurs at the top of the pier. Comp41 also shows a large crack width at the top of the left pier (a) which is evidence of a full detachment of the pier towards the end of the test; then, the crack width at the bottom of the pier (c) grows accordingly. Moreover, the crack at the bottom right corner of the window (d), which is related to the mechanism that causes crack a, does mimic the behaviour seen in Figure 9a. Finally, for the crack at the top right corner of the window (b), no influence of the pre-damage is evident.

Figure 9 compares the crack width during the two-way cyclic portion of the tests. This means that all the walls had been partly pre-damaged during the repetitive portion of the test; hence, Figure 10 looks at the one-way cyclic portion of the test. Here, only two cracks are compared as the other window corners are not engaged in the positive drift direction (see Figure 4f). In this figure, both pre-damaged cases develop cracks earlier than the virgin walls. Moreover, the width of crack “a”, a pre-damaged crack, is noticeably higher in the case of the pre-damaged walls, even before the pier detachment of Comp45 takes place.

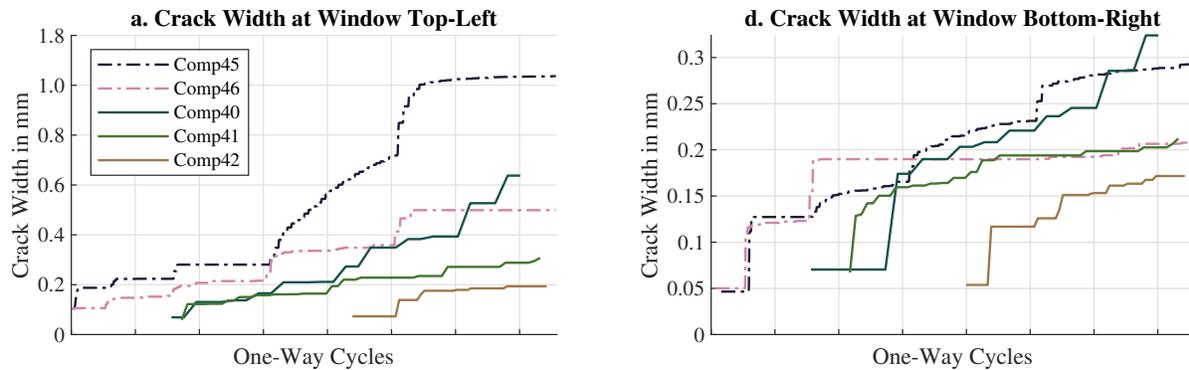
Figure 10. Comparison of crack width as detected by DIC for the two pre-damaged walls (Comp45 and Comp46) and the non-pre-damaged walls, for the two corners of the window during the one-way cyclic portion of the tests.

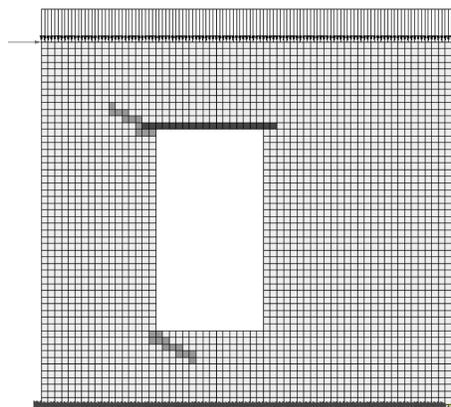
Figure 11. Finite Element Model of TUD-Comp 45 and 46 with 'weakened' elements.

The pre-damaged, in-plane loaded, baked-clay, brick masonry wall with an asymmetric window is modelled with 2D plane stress elements. The wall is 3050mm wide and 2700mm high with a thickness of 100mm. The opening is 800x1500mm and is placed 550mm from the bottom edge and 900mm from the left edge. The concrete beam above the window opening is modelled with a dimension of 1000x50mm. Both wall and lintel are modelled using 8-noded quadratic elements with a mesh size of 50x50mm. The integration scheme is set to 3x3 points per element. The top and bottom steel beams of the set-up are also modelled. One-dimensional beam elements having 3-nodes are employed. The two lines are placed at the top and bottom edge of the wall; as cross-section, HEB-600 and HEB-300 geometries are assigned, respectively. The top boundary condition is cantilever, thus allowing the top of the wall to rotate and displace vertically. Hence, only the bottom beam base is constrained in both horizontal and vertical directions. Before applying the in-plane top displacement to the wall, a vertical uniform load is applied as a line load on the top wall edge to simulate the 0.12MPa overburden. The mesh view of the DIANA model is shown in Figure 11.

grey elements in Figure 11). For these elements, half of the wall elastic properties are used. Moreover, no tensile strength is assigned to the material, since the plastic strips replicate an open crack. A shear resistance that accounts for the brick-PVC interaction is assigned to the weak spots (see Table 2). Accordingly, a non-linear material model is employed for both damage and non-damaged clay masonry. This allows to study the phenomenon of cracking in detail. As constitutive model, the Engineering Masonry Model with the diagonal stair-case option is used. This material model considers the orthotropic behaviour of the masonry, non-linearities in tension, shear and compression, and specific, different unloading/reloading characteristics according to experimental observations. Detailed information about the material model can be found in Schreppers et al. (2017) and Rots et al. (2016). The properties of clay masonry are partly taken from small companion tests and partly calibrated from the in-plane wall experiment results. A summary of the properties for both virgin and pre-damaged material is shown in Table 2. Physical non-linearities are considered in the model. A quasi-Newton (secant) approach is selected as iteration method. Either a force norm, with a tolerance of 10^{-2} , or an energy norm, with a tolerance of 10^{-4} , need to be satisfied for the equilibrium calculation. The Parallel Direct Sparse method is used to solve the system of equations. A tolerance of 10^{-8} is here for employed.

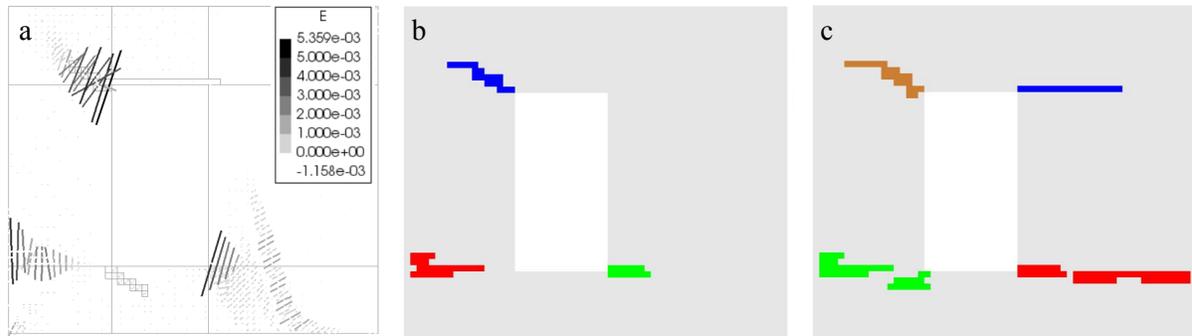
Figure 12. Left (a) Tensor plot of positive principal strain for a drift value of approximately to 0.4%. Right, Crack pattern of the FEM wall model (b) after the one-way cyclic and (c) at the end of the protocol.

When modelling the wall, strains focus at the foreseen crack locations and reveal the intended crack path during positive drift. This is illustrated in Figure 12a where the strain tensors are drawn. The final cracks comprising the crack location, width and length of the pattern produced by the FEM are depicted in Figure 12. As for the experimental results, cracks are evaluated from and to a cutoff width of 0.1mm and span a minimum length of 100mm. After the one-way cyclic protocol (Figure 12.b) three main cracks are detected: a rocking crack starting from the left edge at the height of the window, the opening of the pre-damage wall part at the top left corner of the window, and another rocking crack at the bottom right

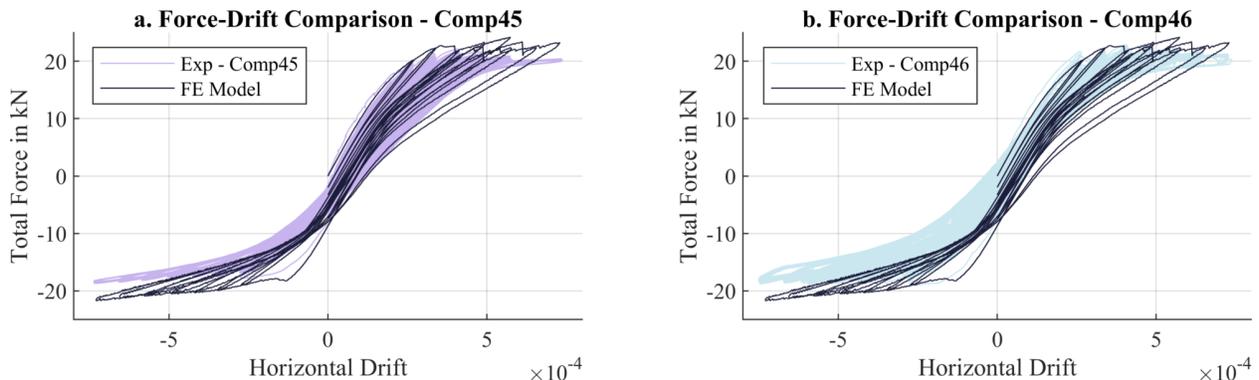
Figure 13. Force-Drift plots comparing the finite element model and the experimental (a) TUD-Comp 45 and (b) TUD-Comp 46 tests.

Next, when plotting the force-drift behaviour (Figure 13), the model looks to be in reasonable agreement with the experiments. Both initial stiffness and positive force are well matched by the model, though the energy dissipation is overestimated in the two last cycles of the positive side. Regarding the negative side of the plots, the force (viewed as absolute value) and the energy dissipation are slightly higher when compared to the wall TUD-Comp 46. For the other specimen (TUD-Comp 45) the experimental hysteretic behaviour is comparable with the FE model.

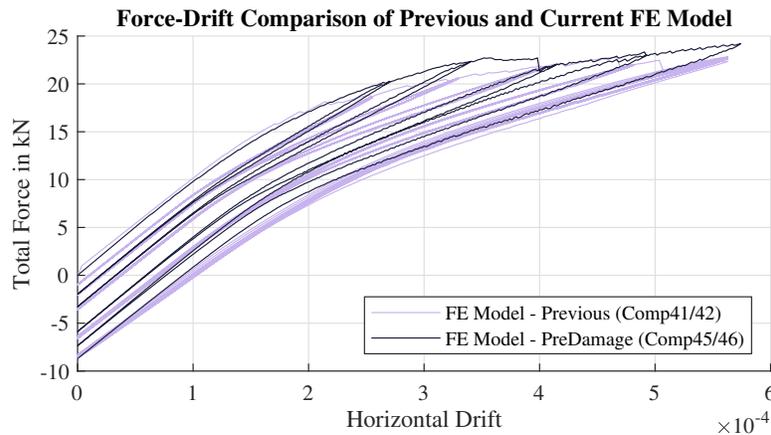
Figure 14. Force-Drift plots comparing the one-way cyclic part of finite element models: TUD-Comp 41/42 vs TUD-Comp 45/46.

Furthermore, the finite element model calibrated only against the virgin walls (as discussed in Korswagen et al., 2019) does not differ significantly from the improved model (Figure 14). The difference between these two models can be found mainly in the modelling of the boundaries and in the material parameters. In the virgin walls only the top stiff beam was modelled using plane stress quadratic elements. A dummy stiffness and cross section was adopted for these elements. In the updated FE model, line beam elements are used to reproduce the rigid beams of the experiment (see Figure 1). Realistic values of stiffness, cross section and eccentricity are given to both bottom and top beam elements. In addition, the converge norm is switched from force or displacement (virgin wall) to force or energy (pre-damaged wall) since the analysis is run under displacement control. From these adjustments, the analysis duration and stability are improved. Ultimately, the material properties of the pre-damaged wall are updated based on the new small scale companion tests. Elastic, tensile and shear properties are slightly higher than the ones found in the

previous campaign (see Korswagen et al., 2019 for a collection of values). Hence, a minor increment in force and global stiffness is detected in the force-drift graph of Figure 14.

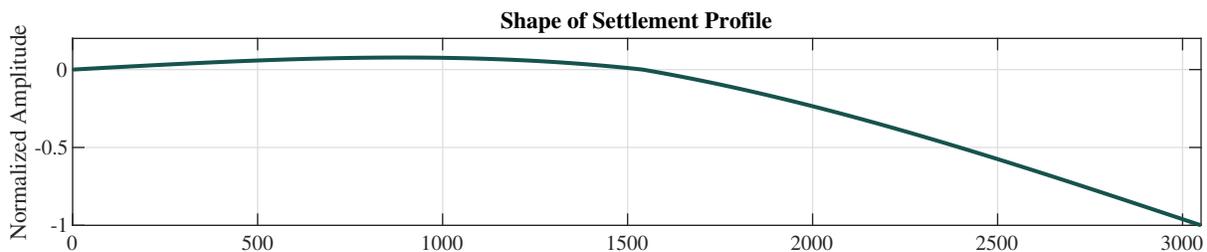
Figure 15. Settlement shape applied to the wall model.

The calibrated model described in the previous section (5.1) is adopted for NLTHAs. The scope of the study is to compare the effect of specific initial conditions on the increase of the wall damage generated by a given earthquake excitation. Three different initial conditions are considered: no pre-damage, a virgin wall is considered; pre-damage via weak spots where the wall is weakened through weaker elements resulting in the same approach as in the previous section (5.1); and, pre-damage via settlement loading. For the latter, the wall is subjected to a settlement deflection case before applying the motion. The shape of such deformation, representing a right-side hogging settlement, is shown in Figure 15 (see also Figure 2).

The non-linear analysis procedure is subdivided in three phases. In the first phase, the gravitational load and an overburden of 0.12 MPa are applied. The second phase is used only for the case with pre-damage via settlement deflection. Here, the settlement shape, pictured in Figure 15, is assigned as displacement to the bottom side of the interface. The hogging deformation is applied at a rate of 0.01 mm per step, up to 4 mm of vertical displacement on the right edge of the wall. The third phase is related to the application of the dynamic motion. Horizontal and vertical accelerations are added to the bottom edge of the wall. The entire duration of the signal amounts to 12.5 s at steps of 0.001 s each.

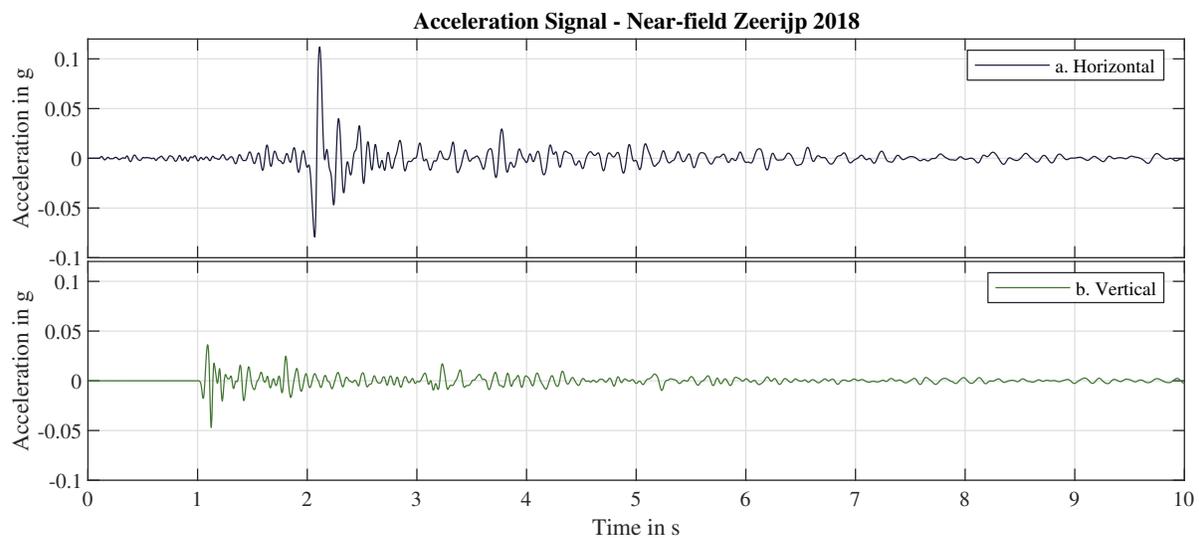
Figure 16. Near-field Zeerijp (2018) earthquake signal, (a) horizontal and (b) vertical acceleration plot.

As input for the base motion, a set of horizontal and vertical components of the recent Zeerijp earthquake (8th of January of 2018) is chosen and applied at the base of the wall. This signal was recorded at the Garsthuizen station close to the epicentre and was selected mainly to be representative of a ‘near-field’ record of the ground motion in the Groningen region. The amplitude of the original signal is taken unmodified from its original peak ground acceleration (PGA) of 0.11 g in the maximum rotated horizontal direction and applied at the base of the model. This PGA is equivalent to a peak ground velocity (PGV) of approximately 32 mm/s for this record. Additionally, the effect of amplification factors with values of 2 and 3 are also investigated. These are arbitrary values selected to produce reasonable light damage within the interval defined as DS1. A representation of the set of records is given in Figure 16.
