## The effect of manufacturing flaws in the meso-structure of cast glass on the structural performance

Bristogianni, Telesilla; Oikonomopoulou, Faidra; Veer, Fred; Nijse, Rob

Advances in Engineering Materials, Structures and Systems: Innovations, Mechanics and Applications

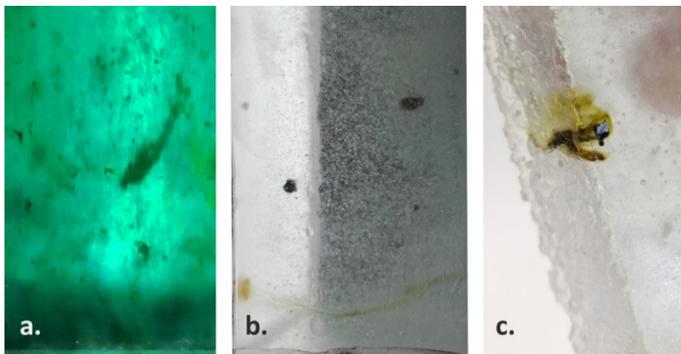
Figure 4. Crystalline inclusions observed in the cast specimens: a) Sample no. 7, defect A1. b) Sample no. 11, defect A1. c) Sample no. 11, defect A2.

Mostly ceramic inclusions of max. 2mm diameter were observed in samples no. 7-12. These are linked to sand, stone and ceramic contamination in the cullet. They are tolerable within the glass matrix due to their small size.

Linear metallic inclusions that did not exceed a diameter of 1mm and were non-disruptive. Observed in samples series 11.

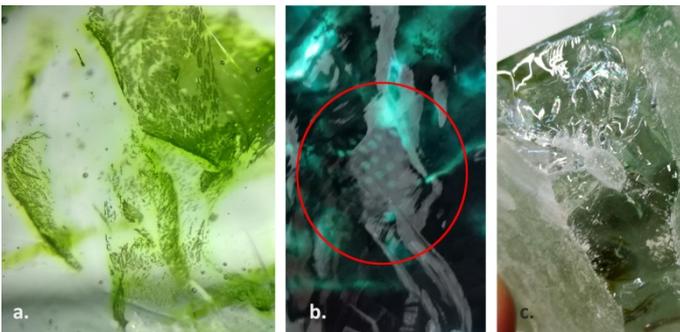
Figure 7. a) Glassy inhomogeneities (B2) due to the heat-resistant frit in sample 9. b) Sample 8, incompletely molten frit, retaining the pattern of the initial coating. c) Presence of different glass type in sample 10, leading to cracking (B3).

frit material were observed in samples no. 8-9. These dark-coloured non-spherical minuscule inclusions are organized in 3D “veils” that partially retain the planar geometry or even pattern of the initial frit-

ted surface. In the case of sample 9, the X-ray diffraction (XRD) analysis has not identified crystalline material. This could mean that indeed these inclusions are amorphous, or that their percentage is less than 1 wt% and cannot be traced by the test. Thus these inclusions are for the purposes of this paper classified under the “Glassy inhomogeneities” category, yet further research should be conducted to verify the absence of crystallinity. The XRF analysis of the “black frit” (Fig. 2, sample 9) - which seems to be associated with these inclusions - indicates a relatively thick layer of coating (the % of SiO<sub>2</sub>, Na<sub>2</sub>O and CaO corresponding to the glass below is low), of a composition rich in metal oxides. The composition suggests that a powdered natural mineral was used in the frit, and PbO was added to reduce the melting temperature. The Cr<sub>2</sub>O<sub>3</sub>, Al<sub>2</sub>O<sub>3</sub> and TiO<sub>2</sub> compounds in the frit have high melting temperatures (2435°C, 2030°C and 1855°C respectively, NIH Database) which could explain its impartial melting and the presence of suspended material in the glass matrix which was not readily incorporable. The minuscule size of these defects ( $\geq 0.1\text{mm}$ ) does not per se induce local stress to the matrix. However, the quantity of these inclusions and the density of their appearance introduces zones in the matrix, which although tolerable, seem to be disruptive to the glass network (see section 3.2).

The presence of such contaminants would lead to cracking during cooling, due to their different thermal expansion coefficient to the glass matrix. This was mainly observed in samples series 10, and at a less extent in samples 9. XRD analysis in a sample from series 10 did not identify crystalline material/glass ceramic, thus linking the crack to the presence of a different glass type in the cullet.

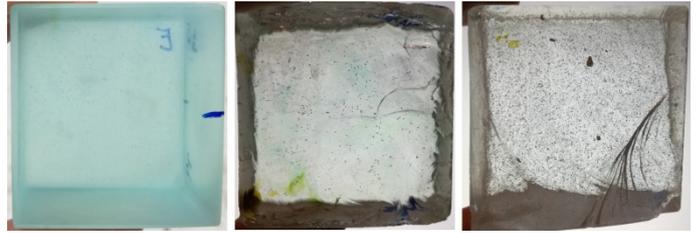
Figure 8. Bubble content increases with the decrease of cullet size. From left to right, samples no. 1, 10 and 11.

All samples presented minuscule bubbles. In general, the finer the cullet the higher the number of bubbles (e.g. series 7, 11). In the coated sample series 3-6, where the cullet was vertically organized inside the moulds, minuscule bubbles seem to clus-

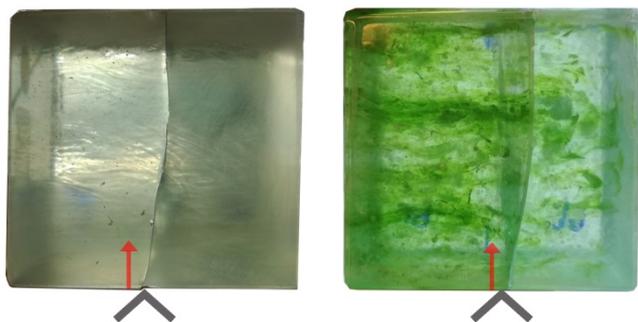
Figure 11. Side view of samples 10ii (left) and 11ii (right), showing the upward direction of the force and the perpendicular to the force- zones of inhomogeneities.

veil structures, hinting at orthotropy in the material properties. In other samples, where these parallel veils are perpendicular to the force direction (series 6, 9-11), the crack seems to slightly deviate when crossing these zones (Fig. 11). Series 11, which had the highest content of minuscule evenly distributed bubbles, also showed a wider range of failure values, and overall higher deformation than other samples. Samples 8 and 9, that contained a high amount of inhomogeneities from tints and frit, presented a lower failure strength average.
