Proceedings of the 17th European Conference on Composite Materials

IN-SITU FATIGUE DAMAGE ASSESSMENT OF CARBON-FIBRE REINFORCED POLYMER STRUCTURES USING ADVANCED EXPERIMENTAL TECHNIQUES

Keywords: fatigue, damage assessment, Acoustic Emission, Digital Image Correlation

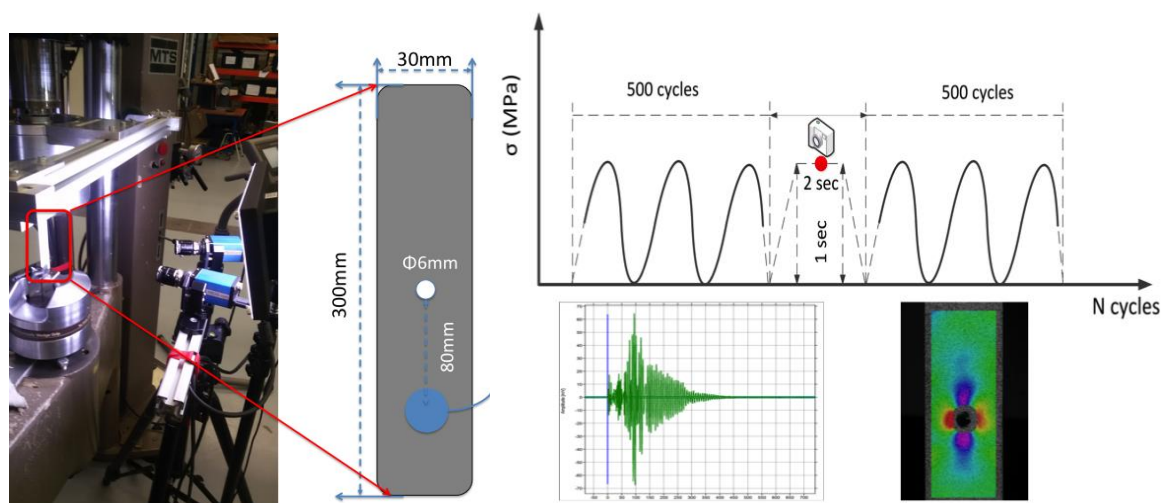
Figure 1. The experimental set-up and the acquisition data process.

An AMSY-6, 8 channel AE system, was used in order to perform the AE measurements. One wide-band piezoelectric sensor AE1045S-VS900M, with external 34 dB preamplifier and a band pass filter 20-1200 kHz, was attached on the surface of the coupon using a special clamping device., ultrasonic gel coupling was applied on the sensor surface, in order to maximize the conductivity between the sensor and the specimen. The AE system was continuously recording AE activity until the failure of the specimen. The sensor was placed in the lower part of the specimens in a distance of 80mm from the hole and a threshold of 55dB was selected.

Figure 1 presents the experimental set-up and the fatigue loading with the data acquisition process.

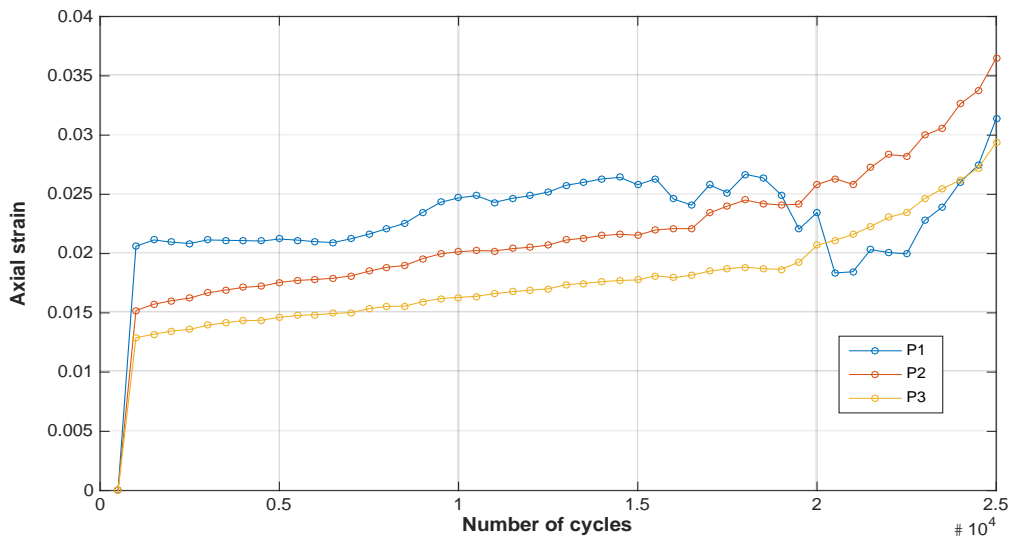
Figure 4. The strain evolution for points P1, P2 and P3 of specimen 2.

Based on the analytical model of Lekhnitskii [3], which calculates the effect of a notch on the stress/strain distribution, three points were selected in order to calculate the fatigue module. The analytical model was reproduced in the MATLAB environment where the stresses in respect to the distance from the centre of the hole in the direction perpendicular and parallel to the load direction were calculated, see Figure 3. In addition, the strain evolution during the fatigue test for three points P1, P2 and P3 with a distance 4,6 and 8mm respectively from the centre of the hole of specimen 2, is presented in Figure 4.
