## On the influence of glass fiber mat on the mixed-mode fracture of composite-to-metal bonded joints

Moreira Arouche, Marcio; Teixeira de Freitas, Sofia; de Barros, Silvio

Composite Structures

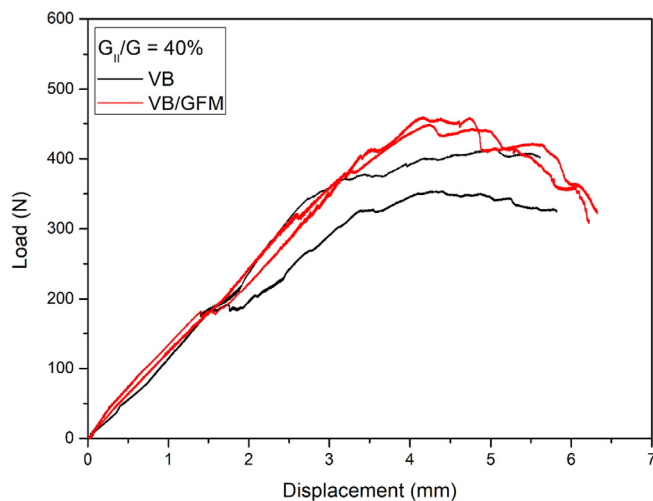
**Fig. 4.** In this condition, all tests presented a smooth variation of the test load during crack propagation. Specimens with an inserted layer of GFM presented slightly higher loadings in compared to the specimens without GFM. Overall, the insertion of a layer of GFM between

Fig. 4. Load-displacement of specimens manufactured using vacuum bagging under 40% mode II fracture.

adherends increased the fracture loadings of the bonded joints although in different degree depending on the manufacture process and fracture mode ratio.

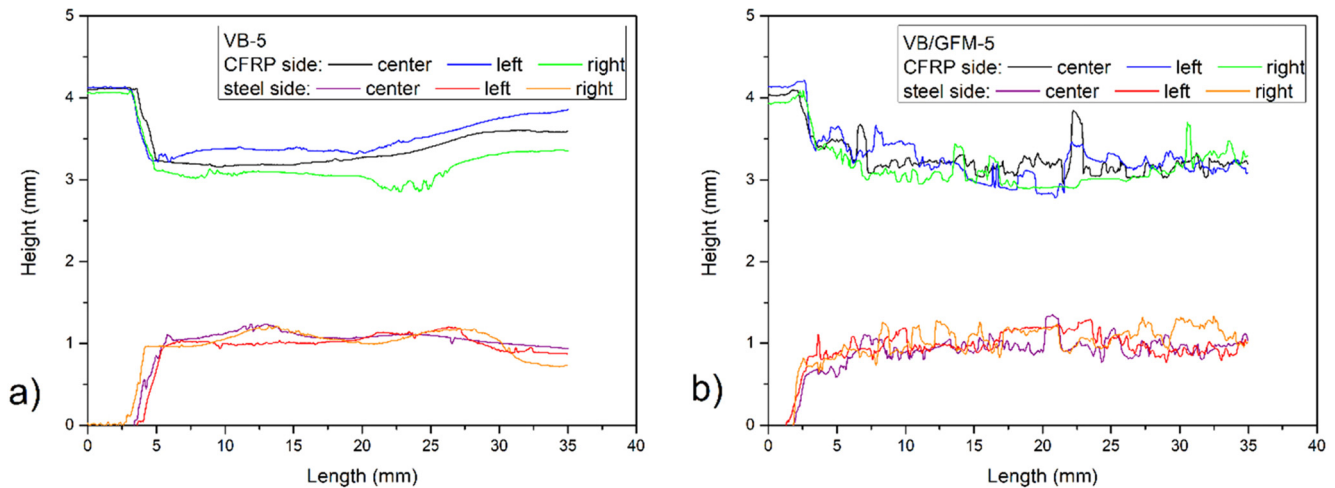
to the previous cases of 75% mode II at room pressure (see Fig. 10) or using vacuum bagging (see Fig. 12). Likewise, the specimen with GFM (VB/GFM-5) revealed a fracture propagation within the layer of GFM. Representative height profiles are shown in Fig. 15. They reveal a more irregular fracture surface in the specimen with GFM.

Fig. 15. Representative fracture height profiles of specimens manufactured using vacuum bagging under 40% mode II fracture (a) without and (b) with GFM.

These results are analogous to the previous cases (see Figs. 11 and 13). Therefore, the fracture partitioning ratio had no notable effect in the height profile of the fracture surfaces.
