## Experimental damage tolerance evaluation of thick fabric carbon/epoxy laminates under low-velocity and high-velocity impact and compression-after-impact

van Hoorn, Niels; Kassapoglou, Christos; Turteltaub, Sergio; van den Brink, Wouter

Published in Journal of Composite Materials

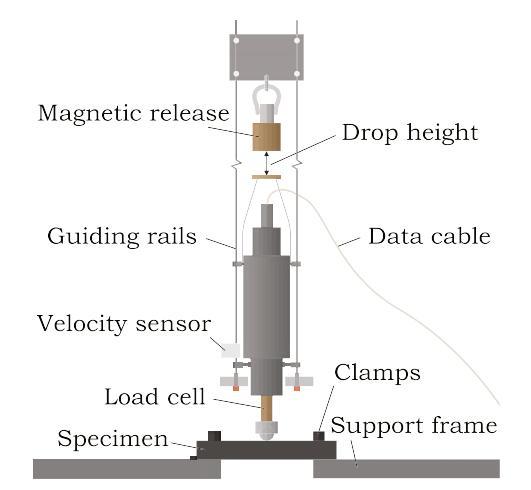
Figure 2. Illustration of the drop-weight setup used for largemass impacts.

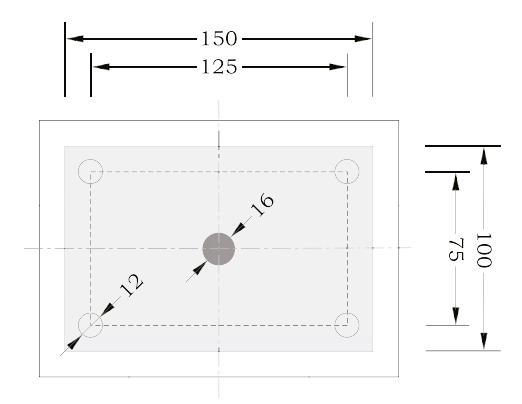
Figure 3. Top-view of the support fixture used for the dropweight and gas-cannon tests.

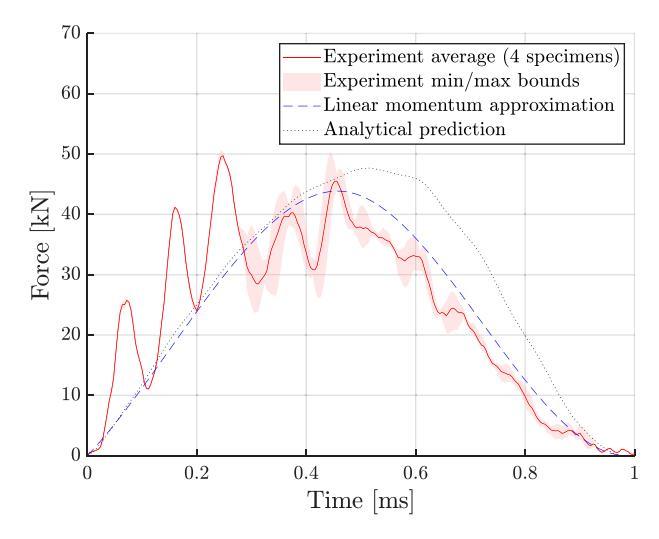
**Figure 4.** Averaged force history for 55 J drop-weight impact tests on 20 mm thick specimens.

In addition to the outputs that can be calculated directly from the experimental measurements, estimations can be made based on alternative models. For instance, the impactor indentation history,  $\delta(t)$ , and plate deflection history,  $w_p(t)$ , can be estimated by assuming a contact law. Talagani<sup>11</sup> proposed a contact law for thick composites that has been implemented in an analytical impact response model in an earlier work.<sup>12</sup> An example of a drop-weight force history, including an approximation of the analytical impact response model, is given in Figure 4.

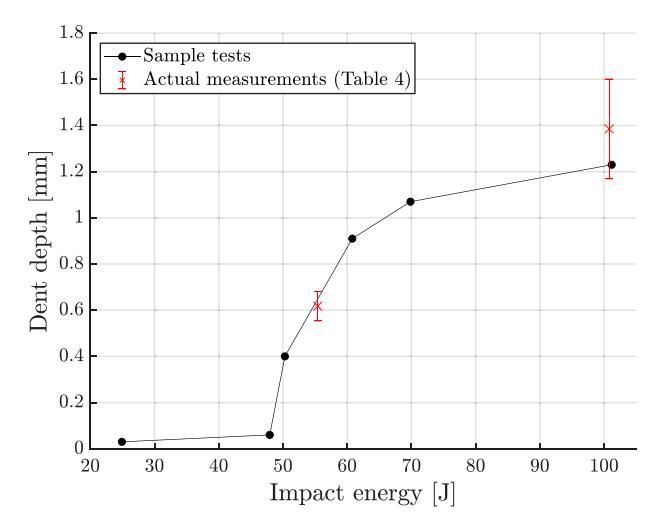
**Figure 5.** Energy level determination including the dent depths of 55 and 100 J drop-weight impact tests on 20 mm thick QI specimens.

were performed to determine the relation between impact energy and dent depth (e.g. permanent indentation  $\delta_0$ ). From the results in Figure 5, a maximum impact energy of 100 J was chosen (i.e. the limit of the gas-cannon) and, in addition, an impact energy at the point where BVID is expected to occur (i.e. 55 J). For the drop-weight impacts, these impact energies correspond to approximately 6.96 and 9.38 m/s for a 2274 g impact mass.

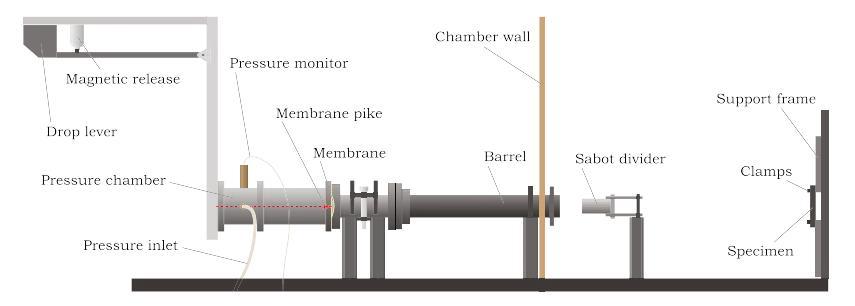
Figure 6. Illustration of the gas-cannon test setup used for small-mass impacts.

For the high-velocity impact tests, a gas-cannon designed at Royal NLR is used, as shown in Figure 6. This gas-cannon was originally designed for hail impact and modified for a 16 mm steel ball with a mass of 16.72 g, which resulted in a maximum impact energy of 100 J previously indicated. The 55 and 100 J impact energies translate to an impact velocity of 81.11 and 109.37 m/s. To match the diameter of the gascannon barrel, the steel ball is positioned in a 3D printed sabot that consists of two halves. By puncture of a plastic membrane, the pressurised gas is released and the sabot, including steel ball, travels through a 1 m long barrel. At the end of this barrel, it enters an approximately  $2 \times 2 \times 2$  m chamber, illustrated in the high-speed images in Figure 7, on the left side. Immediately the sabot is split in half and blocked by a divider, and the steel ball crosses the chamber alone before impacting the specimen. The support fixture used for the drop-weight impact experiments is mounted vertically to feature identical boundary conditions. Two high-speed cameras and required lighting equipment are situated in the chamber and one wall is made of protective glass to observe the experiment.

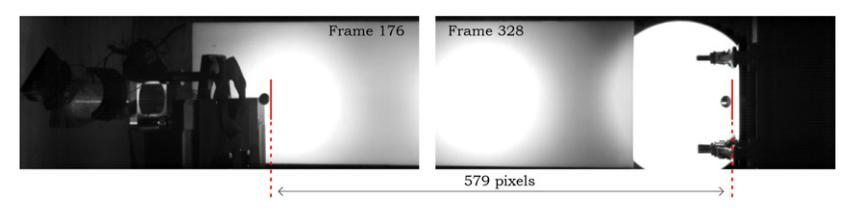
**Figure 7.** Illustration of the impact velocity determination of a gas-cannon impact on specimen 20-QI-SM-55-1. The impactor is detected at frames 176 and 328, which results in a elapsed time of 7.6 ms over a distance of 579 pixels. Knowing that 1 pixel equals 1.035 mm the resulting impact velocity is 78.87 m/s.

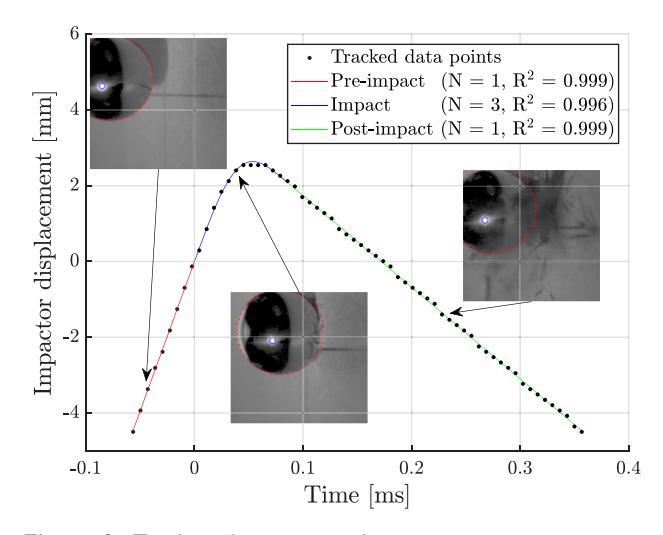
Figure 8. Tracking the impactor during a gas-cannon impact on specimen 20-QI-SM-55-1.

From Figure 8, it can be concluded that the impactor displacement can be tracked very accurately. The values of the tracked data points in terms of pixels are translated to length measured in mm by using the fact that the slope of the pre-impact region should be equal to the initial velocity measured from Figure 7. In addition, three regions are defined: pre-impact (red), impact (blue) and post-impact (green). During impact the tracked data points can be fitted using a cubic polynomial. Similar to the pre-impact region, the post-impact region can be fitted using a linear expression of which the slope represents the exit velocity.

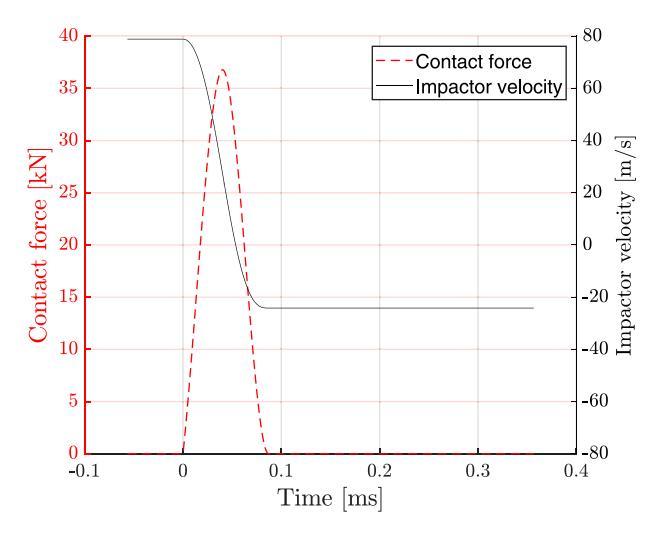
Figure 9. Estimated contact force and impactor velocity history of specimen 20-QI-SM-55-1.

The impactor velocity history is determined by integrating the impactor acceleration, as shown in Figure 9.

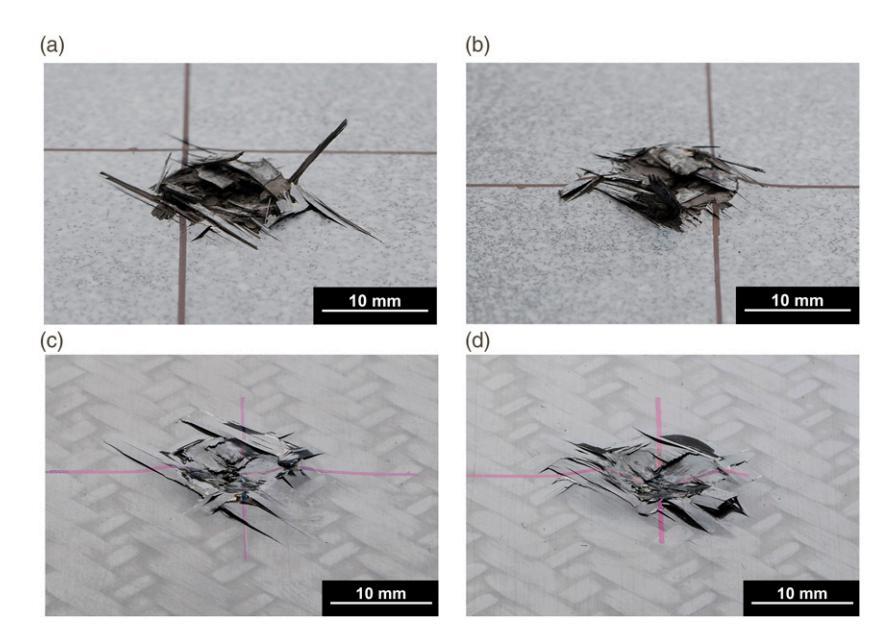
Figure 10. Typical dents for 55 J drop-weight impacts and gas-cannon impacts on 20 mm thick specimens with a QI and OT layup.

energy is dissipated by creating a dent at the impact location, see Figure 10. This dent is formed due to crushing of several plies at the impact location of which some parts are propelled in the air. At the same time, material is pushed outward in the top few layers that experience compression in the longitudinal direction. In this area, kinking and buckling occurs, which is identified by protruding layers around the dent. This phenomenon may be observed in Figure 13, which shows the cross-section of a specimen subjected to 55.3 J impact. Kinking and buckling, which may be seen at the bottom left of Figure 13, is mainly observed for large-mass low-velocity impacts on 20 mm specimens, with a lower impact energy, that result in smaller dents.

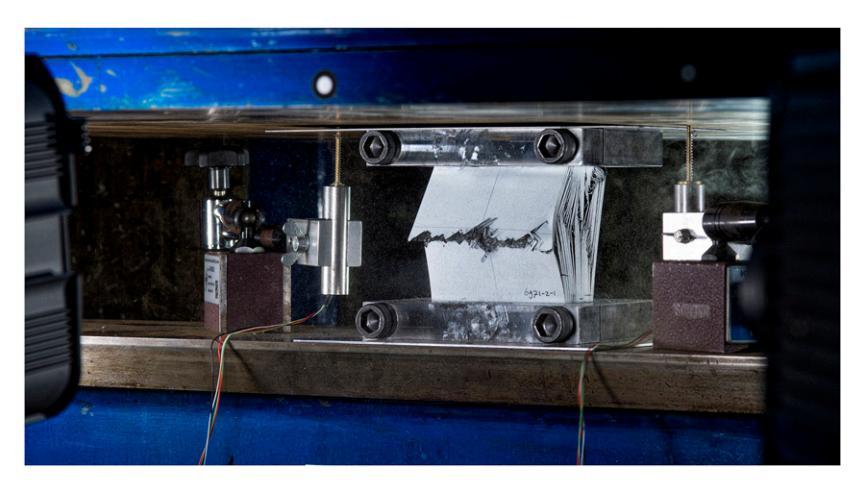
Figure 11. The CAI test setup with a 40 mm thick specimen subjected to a 100 J gas-cannon impact (40-QI-SM-100-1) showing a Middle Top Progress failure mechanism. Note: CAI: compression-after-impact.

The CAI experiments were performed using a static test bench at Royal NLR, see Figure 11. It was chosen to deviate from the ASTM standard for determining the compressive residual strength as it is focused on testing of thin specimens. The expected failure mode, and lack of a global buckling mode, require a different support fixture, contrary to the recommendations of ASTM standard for thin laminates. Instead of the ASTM standard, the following method was applied: The support fixture is derived from previous CAI experiments performed at NLR,<sup>20</sup> and consists of two anti-brooming devices clamped on the short edges of the specimen. If not used, brooming or splitting of plies might occur at the contact surface with the test bench due to high contact forces. The applied load is measured by the test bench as well as the applied displacement. However, due to the deformation of the test bench itself, the actual displacement is measured using two calibrated Linear Variable Differential Transformers (LVDTs). These are positioned on both sides of the specimen such that an average

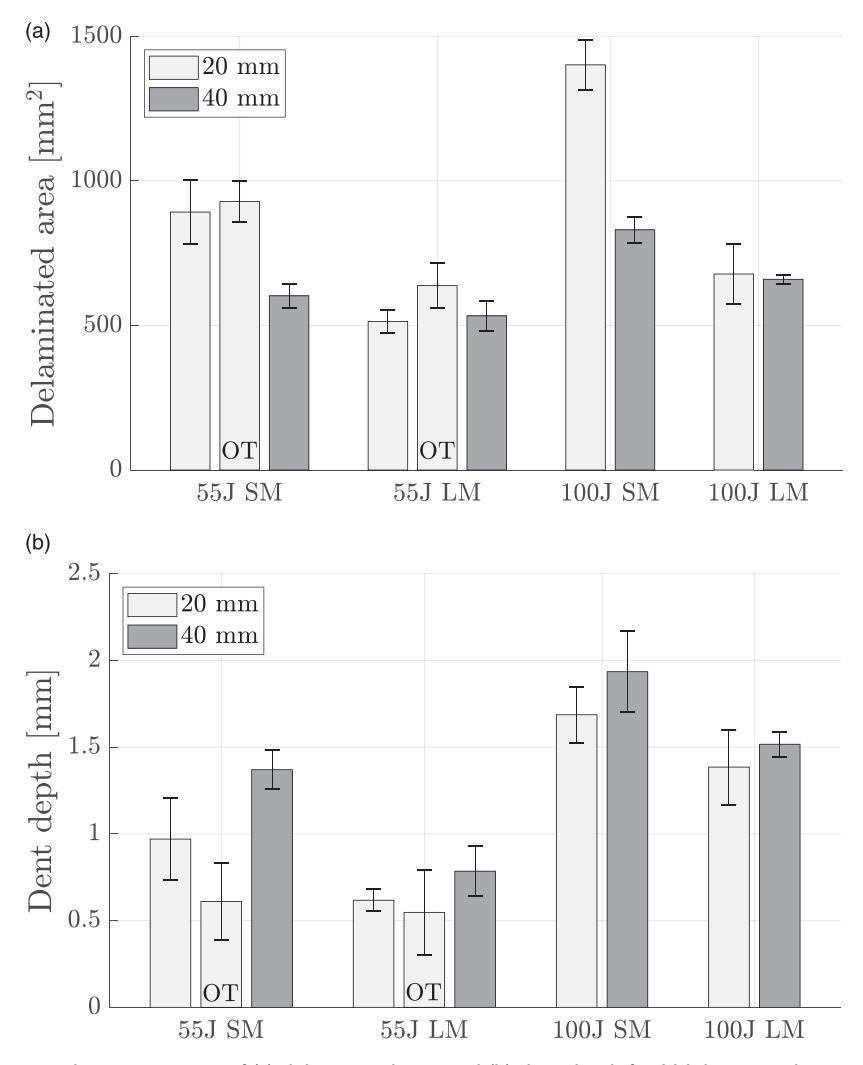
**Figure 12.** Average impact damage in terms of (a) delaminated area and (b) dent depth for LM drop-weight impacts and SM gas-cannon impacts. Note that the results annotated with OT contain the specimens with an orthotropic layup. Note: LM: large-mass; SM: small-mass.

This section starts with a description of the observed characteristic impact damage of thick composite laminates. A complete overview of the measured damage can be found in Appendix 1. Figure 12, which is based on the detailed data given in the Appendix, shows the average impact damage in terms of the dent depth and the delaminated area for large-mass (LM) drop-weight impacts and small-mass (SM) gas-cannon impacts. With this data, the effect of four different aspects can be evaluated, namely (i) specimen thickness, (ii) drop-weight versus gas-cannon, (ii) impact energy, and (iv) specimen layup.

The effect of laminate thickness. A thickness effect is observed when comparing impacts on 20 and 40 mm thick specimens in Figure 12. The impactor displacement of the 20 mm specimens is approximately 8-11% higher compared to the thicker specimens. For the drop-weight experiments, the dent depth of 20 mm specimens is 21.52% lower for 55 J impacts and 8.55% lower for 100 J impacts. In the case of gas-cannon impacts, the dent depth of 20 mm specimens is 29.20% lower for 55 J impacts and 12.89% lower for 100 J impacts. Accordingly, it can be assumed that this higher impactor displacement is a result of more bending. This increased bending of the 20 mm specimens on average results in a noticeably higher delaminated area in the case of the gas-cannon impacts (i.e. +48% for a 55 J impact and +69% for a 100 J impact). Surprisingly, no significant difference in delaminated area is observed for the drop-weight impacts (LM specimens in Figure 12(a)).

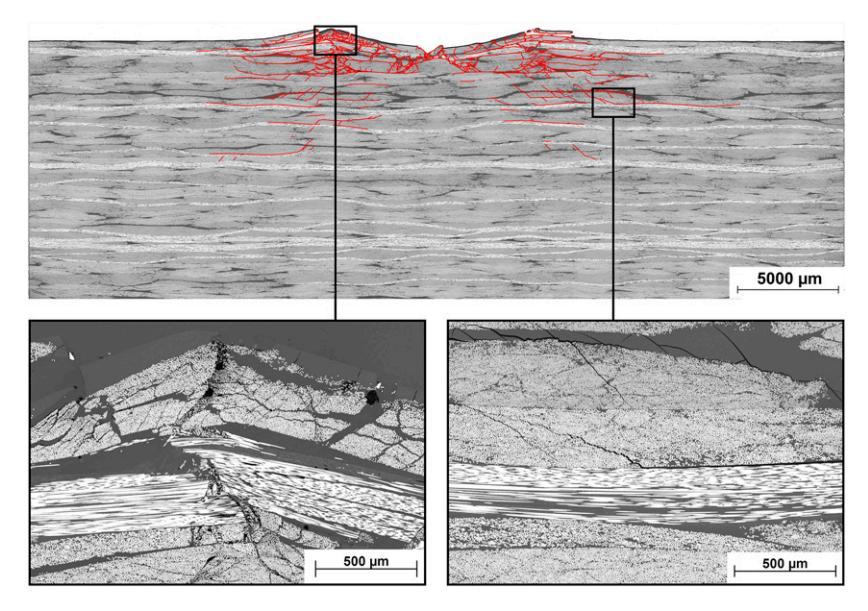
Figure 13. Cross-section of specimen 20-OT-LM-55-4 with highlighted crack boundaries and a detailed view of two damage mechanisms characteristic of thick composite specimens. On the left, longitudinal compressive loads resulting in fibre kinking and buckling in the top plies and, on the right, interaction between transverse cracks and delaminations.

Beside a dent, no damage is typically observed directly underneath the impact location. Due to increasing transverse shear stresses away from the centre of impact, delaminations and transverse cracks appear, resulting in a typical hat-shaped damage pattern as highlighted in red in Figure 13. In the same figure, the detailed interaction between delaminations and transverse cracks is illustrated in the magnified view, which shows the transition from transverse cracking to delamination. In all cross-sections the dominant delaminations extend along the interface between warp yarns. For instance, the delamination in Figure 13 initiates from a transverse crack and propagates along the warp yarn in white. Interestingly, these delaminations only occur above the warp yarns. The bending, although limited, leads to compressive forces in the top half of the specimen. The compression causes slight buckling of the warp yarn, which makes it easier for these interfaces to delaminate. The depth of delaminations is approximately 4-7 mm. In contrast to impact damage in thin composite specimens, the damage does thus not fully extend to the bottom of the specimen and no fibre breakage is observed at the back side. Due to this, beside the dent, all the critical damage for the residual strength is not visible.

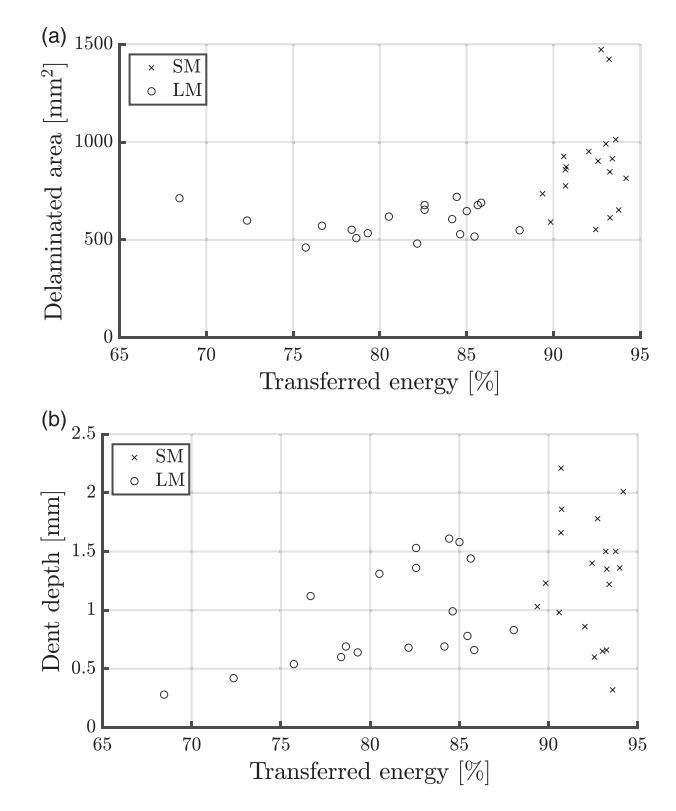
**Figure 14.** Relation between transferred energy and (a) delaminated area and (b) dent depth for LM drop-weight impacts and SM gas-cannon impacts. Note: LM: large-mass; SM: small-mass.

To get further insight on the damage induced in each type of test, the delaminated area and the dent depth are shown in Figure 14 as functions of the energy transferred from the impactor to the specimen. The results in Figure 14 show a 68–88% transferred energy range for large-mass low-velocity test, while for small-mass high-velocity tests 89–94% of energy is transferred to the specimen. For the drop-weight impacts an overall trend is that for a higher transferred energy the dent depth increases (see Figure 14(b)), while no significant change in delaminated area is observed (see Figure 14(a)). Since drop-weight impacts generally tend to a quasi-static response, the force

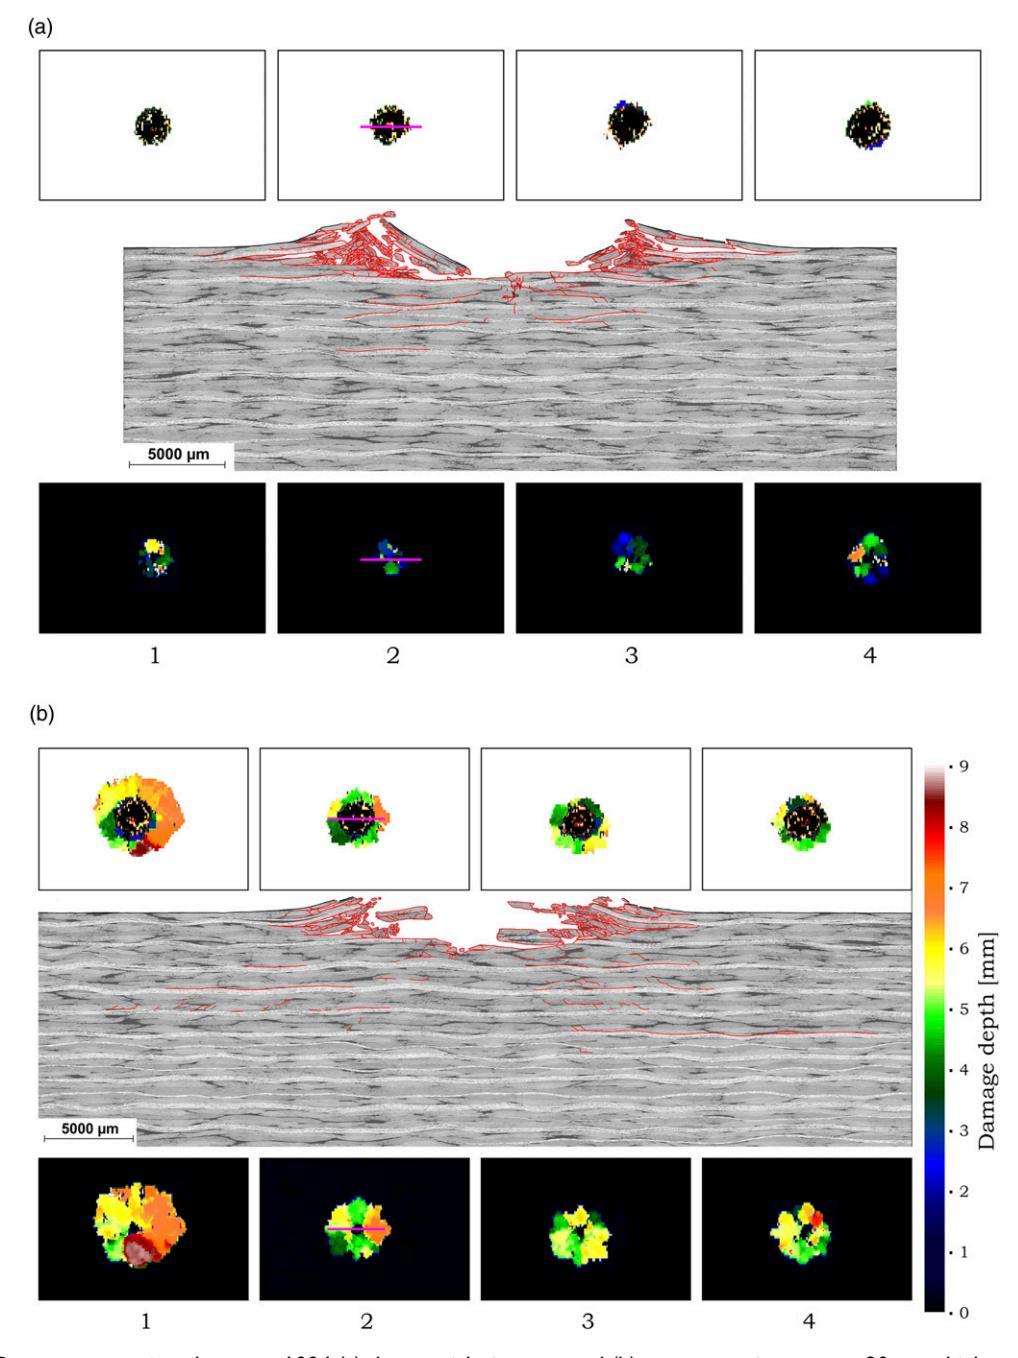
**Figure 15.** Damage comparison between 100 J (a) drop-weight impacts and (b) gas-cannon impacts on 20 mm thick specimens. In the middle, the cross-section of one of the four specimens is shown, 20-QI-LM-100-2 in (a) and 20-QI-SM-100-2 in (b), where the crack boundaries have been highlighted in red. TOF scans are shown for all four specimens, the impact side on top and non-impact side on the bottom. Note: LM: large-mass; SM: small-mass; TOF: time of flight.

Typical damage information based on cross-sections and C-scans is shown in Figure 15. The considerable higher

delaminated area for gas-cannon impacts is shown in Figure 15 for a 100 J impact on a 20 mm thick specimen. Similar to Figure 13, the delamination shown in Figure 15 initiates from a transverse crack and propagates along the warp yarn. In Figure 15(a) all internal damage is hidden behind the dent and therefore not visible in the impact side

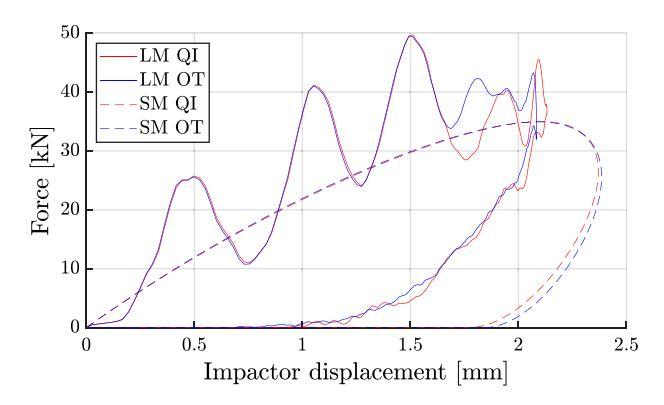
Figure 16. The effect of layup for 55 J LM drop-weight impacts and SM gas-cannon impacts on 20 mm thick specimens. Note: LM: large-mass; SM: small-mass.

For 55 J impacts on 20 mm thick specimens, the impact force as a function of the impactor displacement, is shown in Figure 16. From the figure, it can be seen that the dropweight and gas-cannon impact each have a distinct impact response. Gas-cannon impacts generally have a higher impactor displacement and lower peak force.

The effect of laminate layup. Comparing the responses for the distinct layouts, it can be concluded from Figure 16 that the details of the layup have a negligible effect on the overall impact response. However, there are some important differences in terms of damage. In Figure 12, the observed damage in 20 mm specimens with a OT lavup are compared to 20 mm specimens with a QI layup. For the gas-cannon impacts, specimens with the OT layup show on average a 37% shallower dent compared to the specimens with a QI layup. At the same time, the delaminated area is only 4% higher on average. For the drop-weight impacts, the decrease in dent depth is only 11% and increase in delaminated area 24%. According to these results, it seems that the OI layup is more sensitive to crushing of the first few plies. As more energy is dissipated in this damage mechanism, the energy that is left for bending and subsequent delaminations is lower.

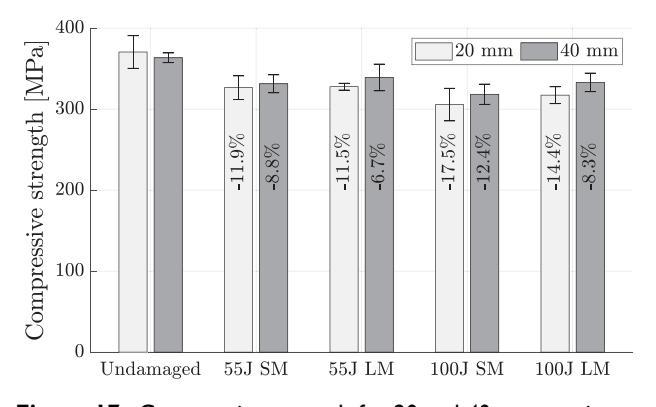
Figure 17. Compressive strength for 20 and 40 mm specimens subjected to LM drop-weight impacts and SM gas-cannon impacts. Note: LM: large-mass; SM: small-mass.

The resulting compressive strengths are visualised in Figure 17. Exact values of the residual CAI strengths can be found in Table A4, while the compressive strengths of undamaged specimens are given in Table 3. As expected, the residual CAI strength is closely related to the delaminated area and damage depth. For instance, specimens subjected to a 100 J gas-cannon impact have the highest delaminated area and therefore the largest reduction in residual CAI strength (i.e. 12% and 18%). In addition, the effect of both gas-cannon and drop-weight impacts is larger on the residual CAI strength of 20 mm specimens compared to the 40 mm impacted specimens. For the 20 mm specimens with gas-cannon impacts, this is explained by larger delaminations that appear deeper in the specimen. For the 20 mm specimens, with drop-weight impacts, the gap with 40 mm specimens is larger, with no significant change in delaminated area. A possible explanation is that the delaminations are approximately 25% deeper for 20 mm specimens. Deeper delaminations mainly affect the sub-laminate bending stiffness, which results in failure at a lower load.

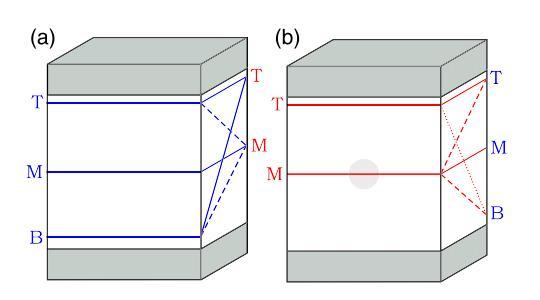
**Figure 18.** Failure mechanisms observed during the CAI tests with buckling of sub-laminates at the middle (M), top (T) or bottom (B) of the specimen. Distinction is made between symmetric failure (MM and TT) and asymmetric failure (MT, MB and TB). Note: CAI: compression-after-impact.

categorised based on the location of sub-laminate buckling. Depending on the location where buckling initiates, the failure is identified with a letter as follows: T for top, M for middle and B for bottom. This is recorded for each side of the specimen separately, so TT indicates that buckling initiated at the top of the specimen on both sides. Similarly, MT indicates that buckling initiated in the middle on one side and at the top on the other side. By convention, the first letter refers to the side of the specimen that was previously damaged by impact. Due to the absence of global buckling, these damage mechanisms are usually not observed in CAI tests on thin composite specimens. For instance, in addition to the in-plane behaviour, the through-thickness behaviour is equally important for thick composite specimens.

Symmetric failure (MM and TT) occurs when delaminated plies start to buckle at approximately the same location on the impact and non-impact side of the specimen. As a result, the through-thickness damage pattern is also symmetric and usually horizontal, with variations that have a vor w shape. Within the symmetric failure mechanism two distinctions are made. MM failure occurs at the middle of the specimen, usually through the impact location, and represents 11% of the cases. TT failure occurs near the antibrooming device at the top of the specimen and is the second frequent observed mechanism in 34% of the cases. No symmetric failure near the bottom of the specimen (BB) is observed.

Asymmetric failure (MT, MB and TB) occurs when sublaminate buckling of delaminated plies occurs at a different location on the impact side and non-impact side. For instance, the most common case is an MT failure mechanism observed in 45% of specimens. In this mechanism, the impact side sub-laminate buckling occurs in the middle (M) and on the non-impact side at the top of the specimen (T). Sub-laminate buckling generally starts at the impact side. During progressive failure, the cracks in the thickness direction propagate to the location of sub-laminate buckling on the other side. Asymmetric MB and TB failure is observed in two specimens for each mechanism.

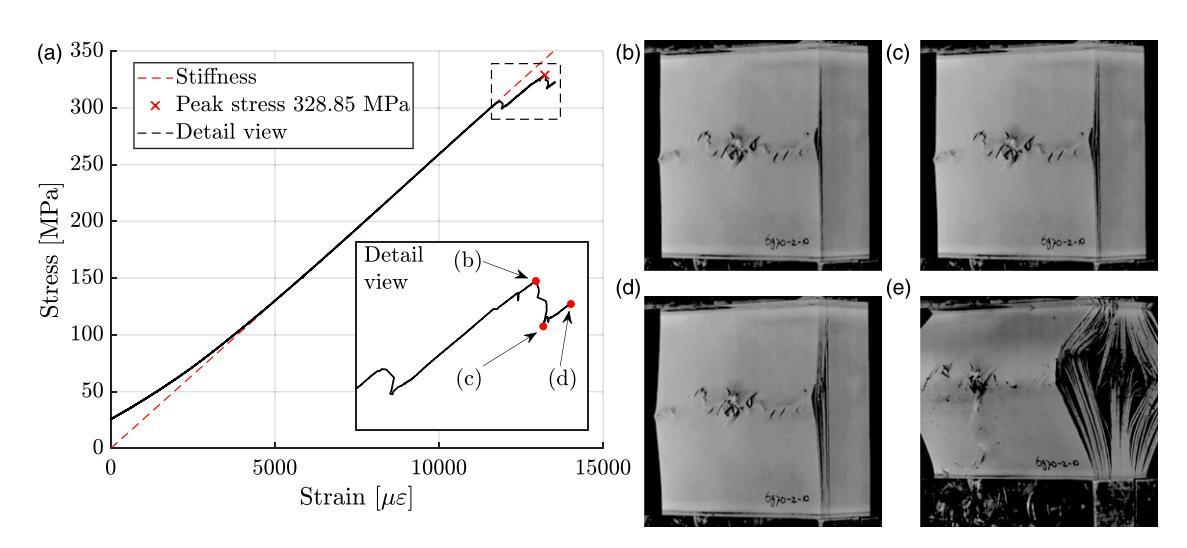
**Figure 19.** CAI test of a 40 mm thick specimen subjected to a 55 J drop-weight impact (40-QI-LM-55-4) with in (a) the stress-strain curve and detail view of progressive sub-laminate buckling (b)–(d) leading to (e) final failure with a MMP failure mechanism. Note: CAI: compression-after-impact; LM: large-mass; SM: small-mass.

An example of a CAI test is illustrated in Figure 19. A 40 mm thick specimen subjected to a 55 J drop-weight impact shows progressive damage of category MMP. It is observed that it takes a while for the stress-strain curve to align with the stiffness slope, which indicates that the test bench and specimen are settling. The slope of the stressstrain (i.e. compressive stiffness) originates from the centre and is used to align the stress-strain curve. A compressive stiffness of 25.9 GPa is approximately 50% lower than the undamaged compressive stiffness and comparable discrepancies are observed for the other specimens. Only a part of this difference is explained by the impact damage. For instance, specimen 40-QI-LM-55-4 in Figure 19 has a damage depth of 4 mm, which is approximately 10% of the specimen thickness. The apparent stress, and thus compressive stiffness, should only be 10% higher if it is assumed that this 4 mm of the specimen does not bear any load. The main reason is that due to high compressive forces the steel support of the test bench started to indent, resulting in additional displacement measured by the LVDTs. Since a measured compressive stiffness has no effect on the residual strengths the values obtained are still valid.

From the detailed view in Figure 19(a), it is observed that multiple events occur prior to final failure. The first load drop at 1205 kN indicates propagation of one or multiple

delamination(s) and subsequent sub-laminate buckling. This propagated delamination is present when the specimen reaches its peak strength, visualised in Figure 19(b). A second load drop of 47 kN occurs due to a second delamination that propagates, see Figure 19(c). Between this point and the point illustrated in Figure 19(d), a third delamination propagates, after which final failure occurs. Despite multiple delaminations, the specimen is able to carry an increasing load.
