Microbiologically Induced Concrete Corrosion: A Concise Review of Assessment Methods, Effects, and Corrosion-Resistant Coating Materials

Chaudhari, Bhavesh; Panda, Biranchi; Šavija, Branko; Chandra Paul, Suvash

Published in Materials

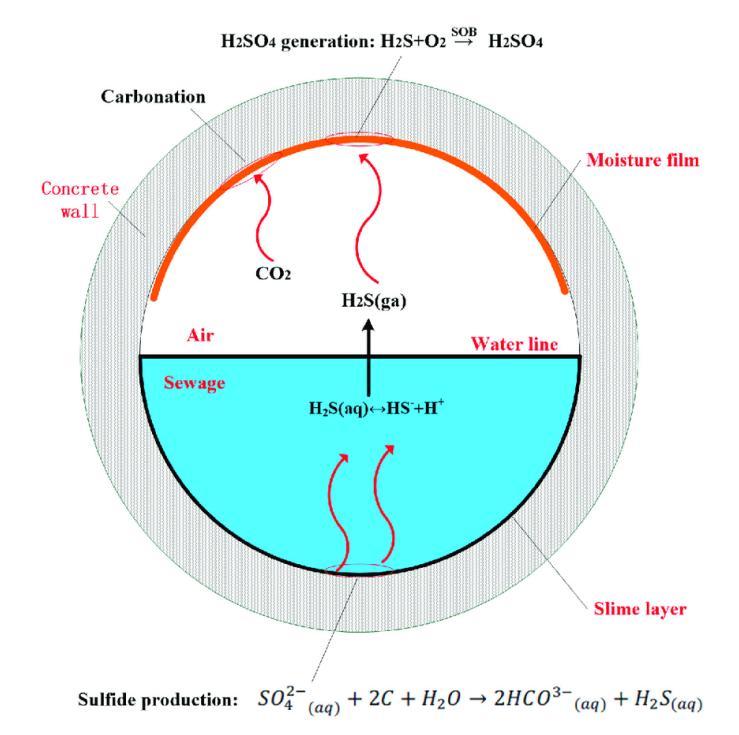
Figure 1. The sulfur cycle in the sewer system [31].

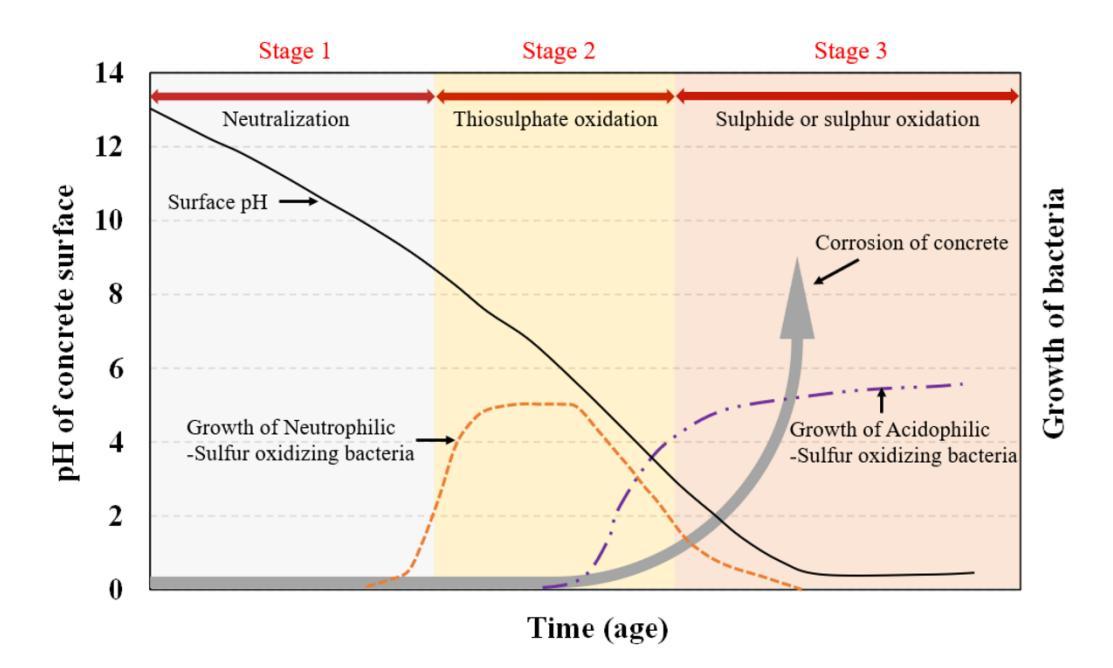
Figure 2. Stages of biocorrosion in concrete [33].

In the last stage of MICC, the metabolization of sulfur and thiosulfate into sulfuric acid (H_2SO_4) takes place by acidophilic SOB [28,29]. This causes an additional reduction in the pH of concrete, especially on the surface, reducing it to around 2. The developed sulfuric acid reacts with the calcium hydroxide (CH) present in the concrete, leading to the formation of gypsum (CaSO₄.2H₂O). Subsequently, gypsum reacts with calcium aluminate hydrate (C₃A) and forms ettringite (3CaO.Al₂O₃.3CaSO₄.32H₂O) [19,30]. Because of the ettringite formation, the volume of the material expands by up to 700%, which causes

exfoliation and cracking in the concrete microstructure [9,20,31]. These stages of MICC were initially summarized and adopted by [29,32] (Figure 2).

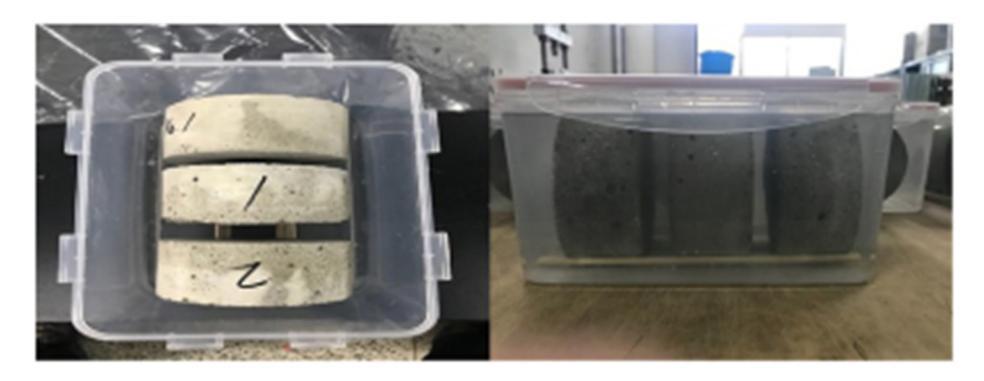
Figure 3. Sulfuric acid immersion test [39].

In chemical tests, prismatic mortar samples of dimensions varying from $25 \times 25 \times 250$ mm to $40 \times 40 \times 200$ mm, cylinder height from 50 to 150 mm, and cube dimensions from 50 to 100 mm are prepared. These samples are then immersed in the aggressive solutions of either sodium or magnesium sulfate or sulfuric acid [20,39] (Figure 3). The concentrations of sulfate and sulfuric acid solutions vary from 5–10% and 1–10%, respectively [39–41]. While samples are immersed, the pH of the solutions is kept constant either by automatic titration or by replenishing it at regular intervals. The duration of sample immersion can range from 1 to 3 years in the case of sulfate solutions and from 7 days to 6 months in the case of sulfuric acid solutions [20,42]. Then, the samples are taken out and the performance of concrete is evaluated based on parameters such as strength loss, weight loss, penetration index, change in geometry, surface morphology, etc. [20,39,43].

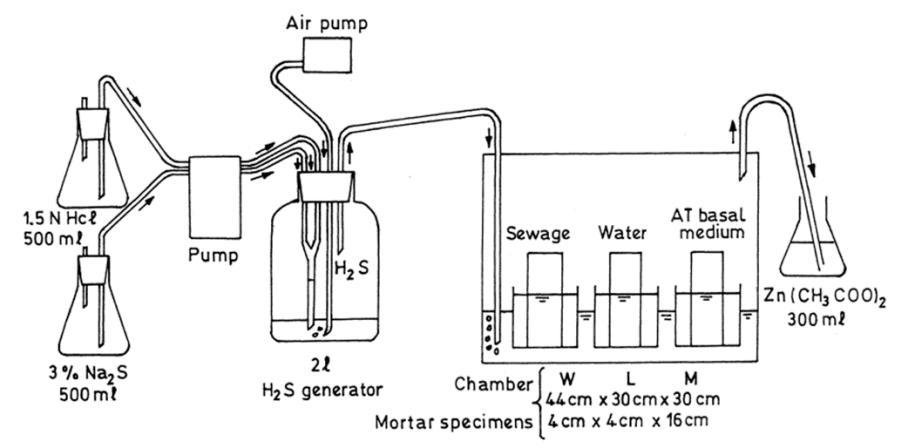
Figure 4. Simulation chamber developed by [52].

Mori et al. [52] developed a simulation chamber to investigate the effects of nutrients on the corrosion of concrete. They used a much higher concentration of H₂S (400 ppm) in the chamber as compared to that observed on site. Mortar samples with dimensions of $4 \times 4 \times 16$ cm were placed in a solution containing nutrients and minerals desirable for bacterial growth without thiosulfate. The duration of the experiment was 6 months. Furthermore, during the first two months, the samples were inoculated with T. thiooxidans every two weeks. A scanning electron microscope was used for the investigation of corroded samples, and the reduction in cross section of specimens was used to determine the corrosion rate. Additionally, by plate counting of the bacteria, the number of T. thiooxidans was determined. The authors concluded that to cause the maximum corrosion rate, nutrients and oxygen must be present. The simulation chamber developed by [51] is shown in Figure 4.

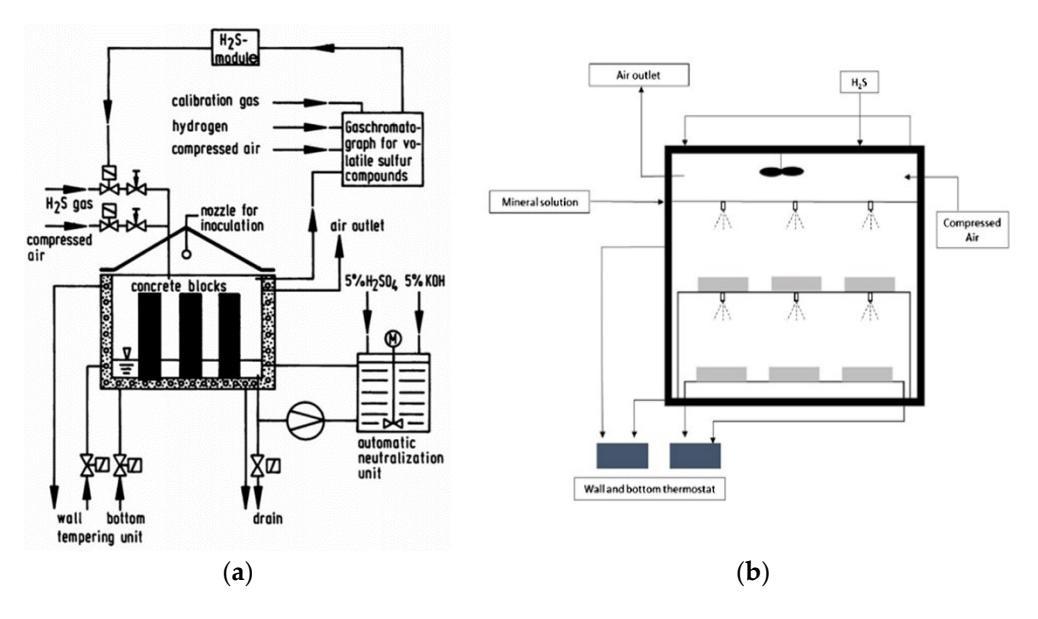
Figure 5. (a) Original Hamburg chamber [54]; (b) Hamburg chamber modified by [53].

Ehrich et al. [53] modified the Hamburg chamber [54,55], which had a corrosion rate 8 times faster than in situ. They used mortar samples with dimensions $2 \times 2 \times 2$ cm instead of concrete samples. Also, the concentration of hydrogen sulfide (H₂S) was controlled at 10 + / - 5 ppm along with relative humidity higher than 98%. It was observed that the corrosion rate in the modified chamber was 24 times faster than in situ. According to Scrivener et al. [46], the Hamburg chamber is the most representative laboratory test for studying MICC, and the setup of the chamber is shown in Figure 5a,b.

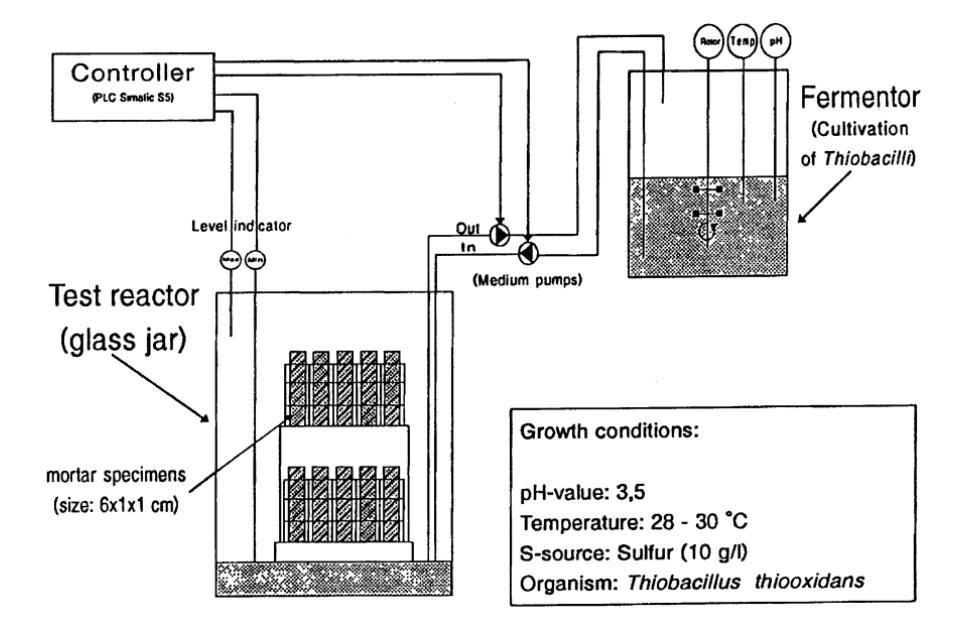
Figure 6. Heidelberg chamber for biogenic acid corrosion [56].

The Research, Development, and Consulting Department of Heidelberg University developed another simulation chamber [56,57]. In this chamber, the time required to investigate the resistance of materials against biogenic corrosion was reduced to 3–5 months. As shown in Figure 6, the chamber consists of the growth and reaction parts. The test specimens were kept in the reactor part of a bioreactor made of glass, whereas T thiooxidans was cultivated at optimum conditions in the growth part. A warm (28–30 °C) and humid environment was maintained in the reactor. Bacteria solution was sprayed on the specimens of dimensions $10 \times 10 \times 60$ mm for 5 min every hour. The performance of concrete against corrosion was measured by using the weight loss of the test specimens and by determining the cell density on the surface of the specimens. Some researchers [58,59], argue that, although bacteria are involved in the process, it is still a pure acid test because of the 55 min gap. The corrosion rate in the chamber as compared to in situ is still not clear. The test setup for the Heidelberg chamber is shown in Figure 6.

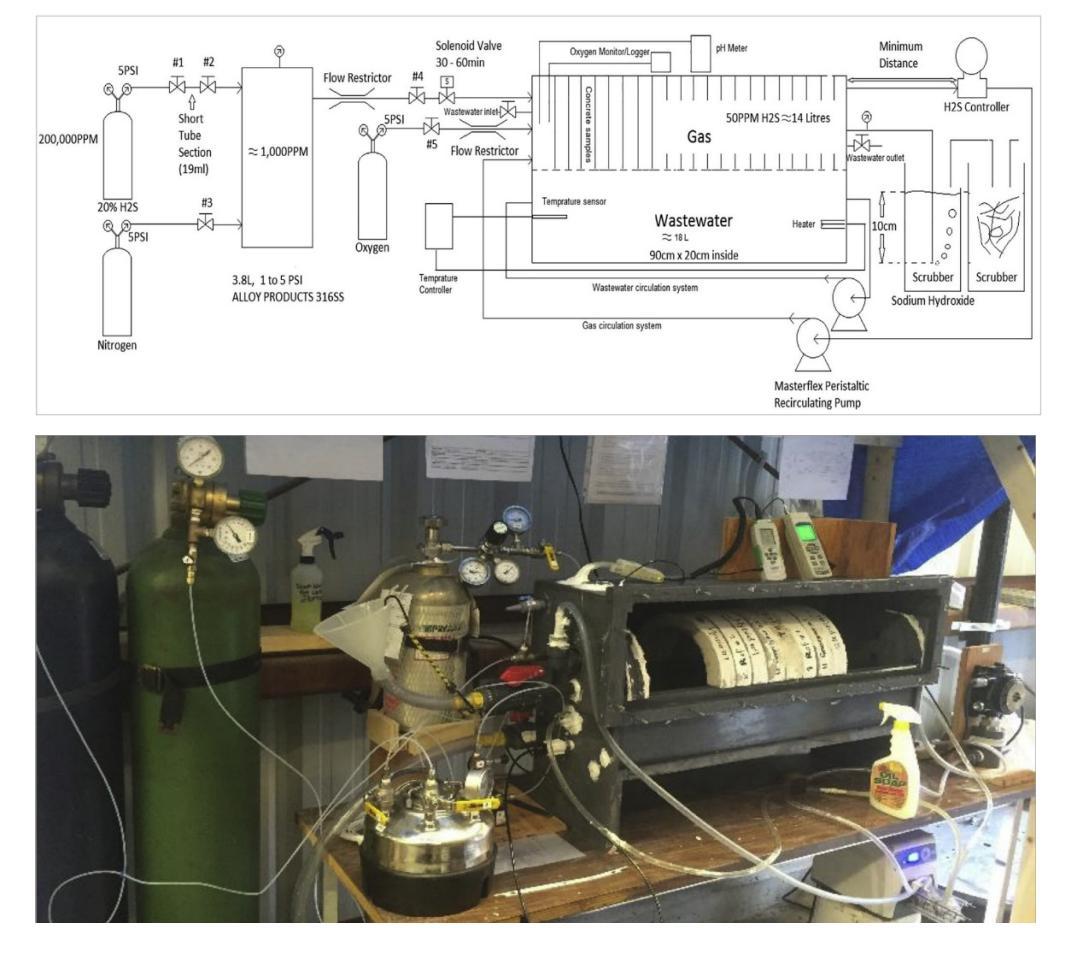
Figure 7. Chamber for simulating concrete biocorrosion [1].

Recently, Roghanian et al. [60] developed a chamber to obtain a controlled environment to simulate the real sewer conditions. To replicate the gravity conditions in sewers, a reactor of dimensions $90 \times 20 \times 10$ cm of 10 mm thick poly (vinyl chloride) panels with free water surface was constructed. The main components of the reactor, shown in Figure 7, were an intermediate container; the main chamber containing concrete specimens (arch-shaped); tanks of H₂S, nitrogen, and oxygen; a wastewater circulation system; and an air circulation

system. H₂S and nitrogen were injected from tanks into intermediate containers whereas oxygen was injected directly into the chamber. The concentration of H₂S and oxygen was maintained at around 50 ppm and 15% for all corrosion cycles, which were performed using the H₂S gas monitor and oxygen meter/logger, respectively. The intermediate tank was refilled manually when the pressure dropped from 5 psi to 1 psi. The temperature of 28 °C +/-1 °C, relative humidity of 85 +/- 5%, and oxygen level of 15 +/- 5% were kept constant during the entire test for optimum growth of bacteria. After reaching a stable pH, approximately two thirds of the wastewater were replaced by fresh wastewater every 2 to 3 weeks. To study the reliability of the chamber, arch-shaped concrete samples were placed in the chamber for a 6-month duration, and parameters like flexural strength loss, pH variation, and surface morphology were evaluated. This chamber has the potential to act as the most representative laboratory test for studying MICC, as the authors have compared the in-situ conditions with simulated conditions in detail.

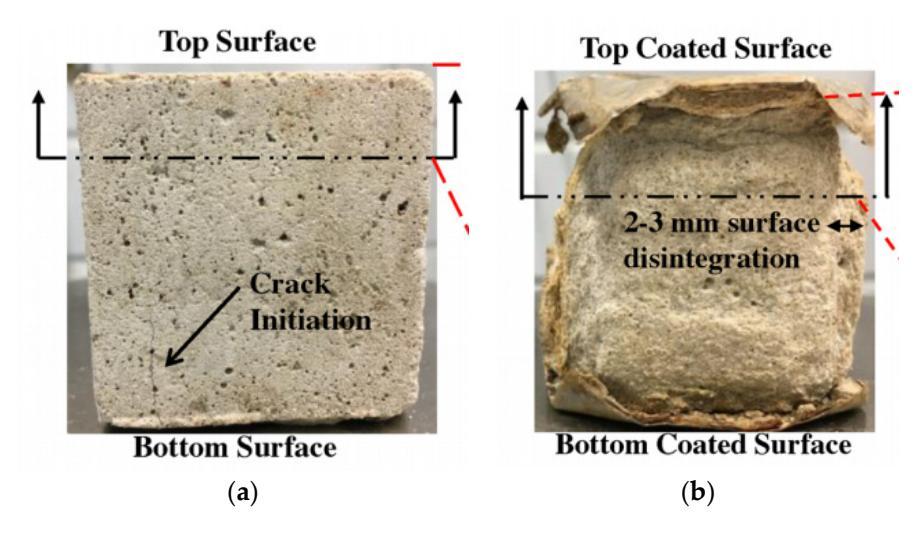
Figure 8. Visual assessment of geopolymer mortar after two years of exposure [64]. (a) FA-GPm; (b) SRPC.

After two years of exposure to the natural sewer environment, the samples of flyash-based geopolymer mortar (FA-GPm) and sulfate-resistant Portland cement mortar (SRPCm) showed surface degradation. SRPCm showed major degradation and a loss of 2–3 mm from the surface, whereas FA-GPm showed a smooth cubical surface with minor crack propagation near the edges [64]. The crack initiation and surface degradation of the samples are shown in Figure 8. House et al. [50] observed that most of the samples with dimensions of $38 \times 38 \times 200$ mm prepared with different mixtures showed a 10 to 12 mm reduction in width. Monteny et al. [45] performed microbiological tests on prisms ($20 \times 20 \times 50$ mm) and chemical tests on cylinders (230 mm diameter and 70 mm height). At the end of the tests, the largest cumulative loss (after four cycles) in height of prisms in all mixtures was 0.76 mm, whereas up to a 0.6 mm decrease in average radius was observed in cylinders.

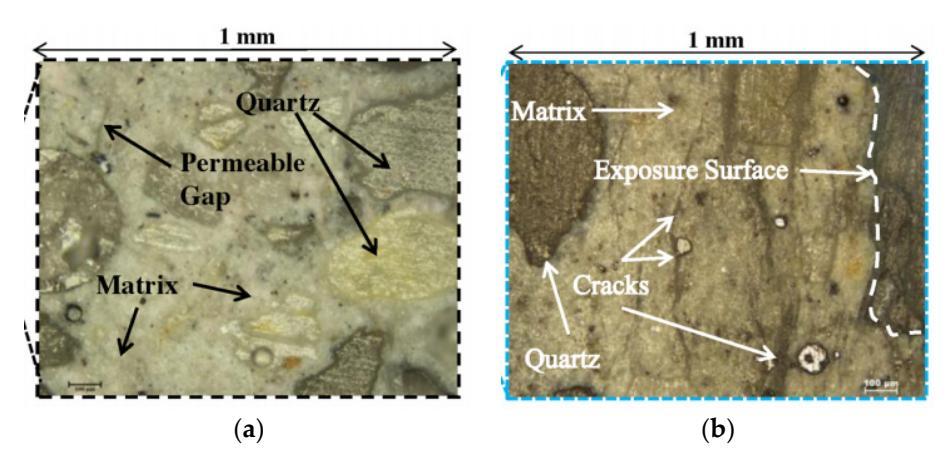
Figure 9. Optical microscopic image analysis of geopolymer after two years of exposure [64]. (**a**) FA-GPm; (**b**) SRPC.

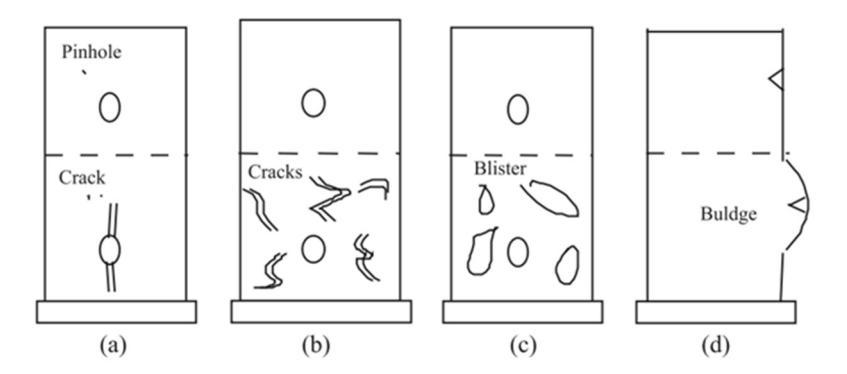
Figure 10. General failure types in coated concrete specimens with pinholes [49].

Vipulanandan and Liu [49] used two polyurethane-based coatings with slightly different properties, such as density, hardness, thickness, etc., to protect concrete pipes from corrosion. The performance of the coatings was evaluated under a 3% sulfuric acid solution (pH = 0.45; representing the worst reported condition in the wastewater system) environment for more than five years. The combination of a full-scale hydrostatic test, bonding test, and chemical resistance test was performed for evaluation. The hydrostatic test results showed the overall rating of the coating as "pass" and "satisfactory" on dry and wet application conditions, respectively. Contradictory results were seen, as one coating had very good bonding strength on the dry concrete surface but low bonding strength on the wet surface, whereas the other coating had very low bonding strength on a dry surface and was better on the wet surface. Both coatings performed extremely well in the chemical resistance test, as no failure was observed either coating after five years of immersion. The authors identified the failure types of concrete specimens as cracking of coating starting from the pinhole, or on the surface, and blistering at the pinhole (Figure 10).

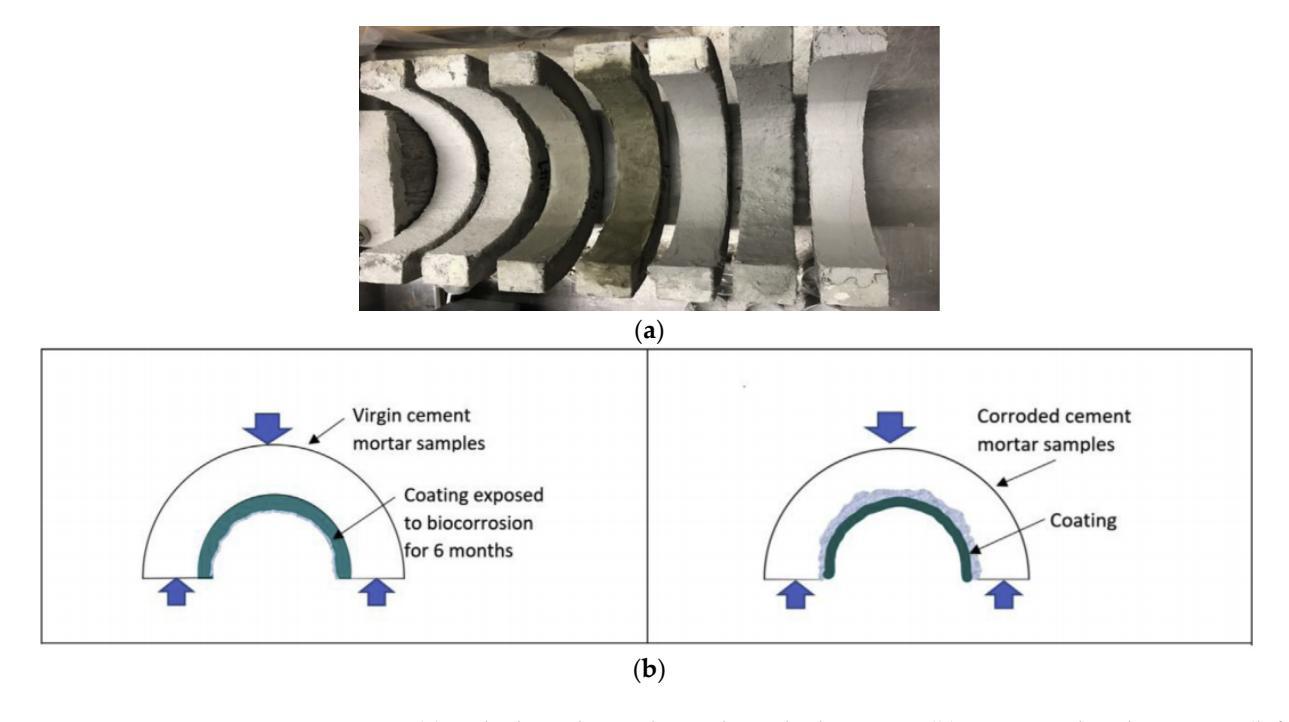
Figure 11. (a) arch-shaped samples with applied coatings (b) coatings placed on virgin (left) and corroded (right) samples [1].

Roghanian et al. [1] evaluated the performance of eight coatings developed from three base binders, i.e., cement mortar, geopolymer, and a blended mix of geopolymer and magnesium phosphate. Two broad mechanisms of directly adding zinc oxide as an antibacterial agent to the coating material and mixing zinc-doped clay particles with the coating were considered. Thirty arch-shaped cement mortar samples were cast to represent the upper half portion of the sewage pipe (Figure 11a). After curing the samples, their surfaces were prepared, and a 6 mm coating was applied. Again, after the curing period, samples were kept in an accelerated biocorrosion chamber developed by the authors for a six-month duration. The results showed that the surface pH of the cement-based samples reduced to an average of 2 by the end of the corrosion cycle, while geopolymer and blended samples showed pH values of 5 and 6, respectively. All three coating materials significantly improved flexural strength compared to uncoated samples, with geopolymer having the highest. Strength loss after corrosion increased to 35% for multiphase composite coating and geopolymer coating, which was much less compared to cement samples (52%) and uncoated samples (73%) (Figure 12). A similar trend was observed in the pull-off test, i.e., cement-based samples showed the lowest bond strength, followed by blended samples and geopolymer. Additionally, after applying geopolymer coating to corroded cement mortar samples, the pipe restored its strength by an average of 40%, which shows that geopolymer samples can be effectively used to protect not only virgin pipes, but also corroded pipes (Figure 11b).

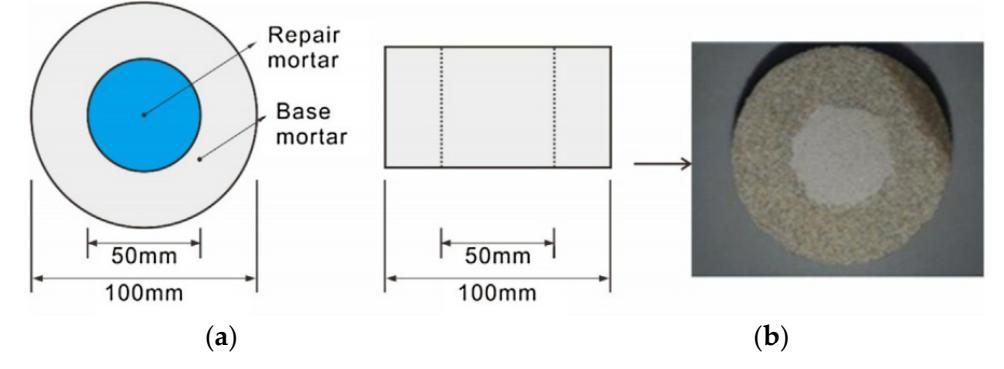
Figure 13. Test specimen details (a) top view, (b) side view [39].

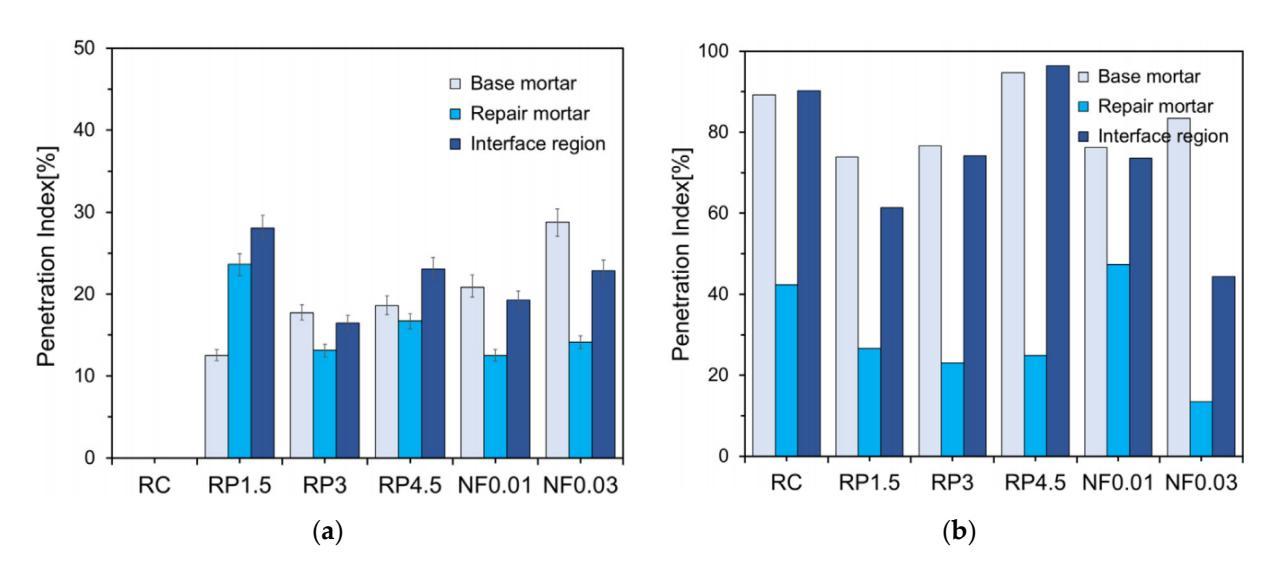
Figure 14. Penetration indices of the accelerated water tightness test after (**a**) sulfuric acid immersion and (**b**) freeze–thaw cycles [39].

interface, an accelerated test on the watertightness of the interface after 10% sulfuric acid immersion for 7 days, and an accelerated test on the watertightness of the interface after 100 freeze–thaw cycles. The penetration index (PI) was calculated by dividing penetrated area by the total area. Figure 14 shows the performance of the coatings based on the PI of the accelerated water tightness test after sulfuric acid immersion and freeze-thaw cycles. Based on the test results, the authors recommended 4.5% resin powder coating without fiber under moderate environmental conditions. For severe environments demanding high sulfur and freeze–thaw resistance, a combination of PVA resin powder and nylon fiber was recommended.

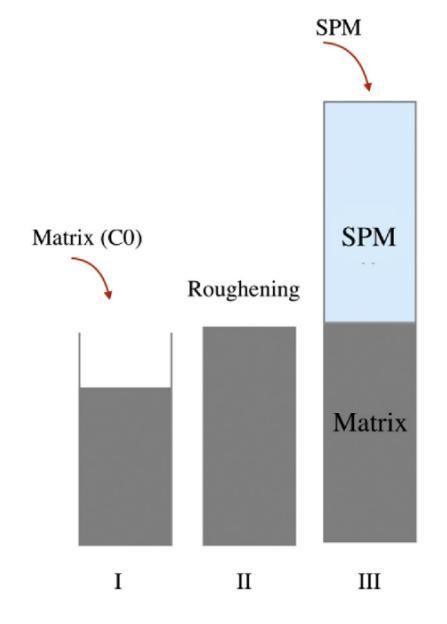
Figure 15. Casting procedure of mortar for the measurement of viscous performance [74].

To enhance the penetration resistance of the whole system under a corrosive environment, Zhang et al. [74] tried to use nanosilica (NS) and silica fume (SF) to modify cement mortar as a surface protection material (SPM). Eight different coating compositions were made by varying the proportions of silica fume and nanosilica. After casting reference mortar, at the time between the initial and final setting, the surface of the sample was roughened to increase the contact area between the surface and the SPM. Then, a 5 mm thick coating was applied to the concrete sample, and after a 28-day curing period, a rapid chloride migration test was performed on the coated structure. These coated structures were used for the measurement of rapid chloride migration to check the impermeability of mortar with SPM. Additionally, to characterize the interfacial bond strength between the matrix and the SPM, the flexural strength of mortar prepared by twice-casting was measured (Figure 15). 4% SF reduced the chloride diffusion coefficient by 32.32% in comparison with reference concrete, however, the addition of 2% NS in 4% SF reduced the coefficient by 68.27% compared to a reference, indicating excellent resistance to chloride penetration (Figure 16a). Along with the improved penetration resistance, coated sample 4%SF2%NF showed increases in flexural strength of 29% and 32% after 1 and 28 days, respectively (Figure 16b). Therefore, the authors found the coating materials performed successfully in corrosive environments, as coated samples showed significantly increased compressive strength and impermeability by densifying the interfacial transition zone (ITZ) and refining the pore structure. Additionally, coated samples showed better dimensional stability with lower shrinkage compared with reference mortar.
