Wolf Rock Lighthouse Long-Term Monitoring

Published in Infrastructures

Article Wolf Rock Lighthouse Long-Term Monitoring

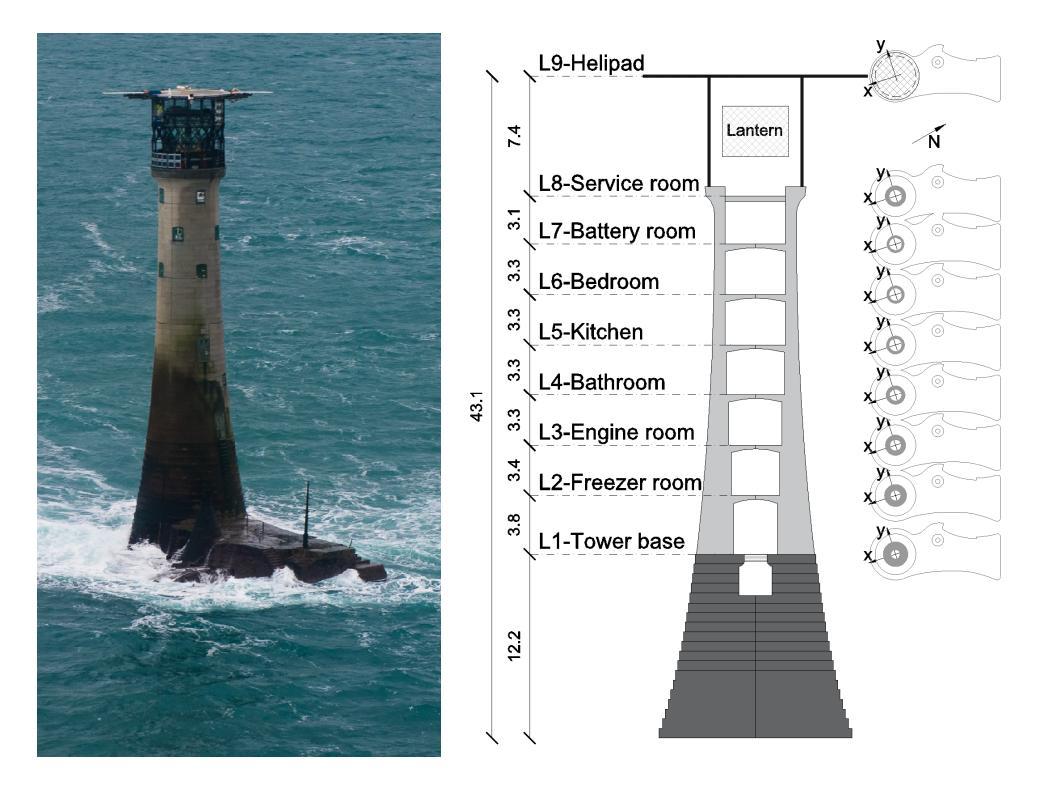
Figure 1. Wolf Rock (photo James Bassitt) and internal layout (heights in m).

The present structure at Wolf Rock (Figure 1), 15 km west of Land's End (Cornwall), was built after learning from the experiences of previous British lighthouse designs and has functioned with only minor repairs to its superstructures to the present day. In fact, since 1988, Wolf Rock Lighthouse has been operated remotely and now only accommodates personnel during maintenance visits.

Wolf Rock Lighthouse has nine levels (Figure 1), from the entrance (level 1) to the helideck (level 9). Level 8 is the service room atop the masonry tower, and there is also a mezzanine walkway (not counted as a level) externally around the steel lantern enclosure. Level 7 is the battery room housing the cells for the solar array around the helideck which powers the lighthouse while unmanned, while a generator is operated during technical/maintenance visits.

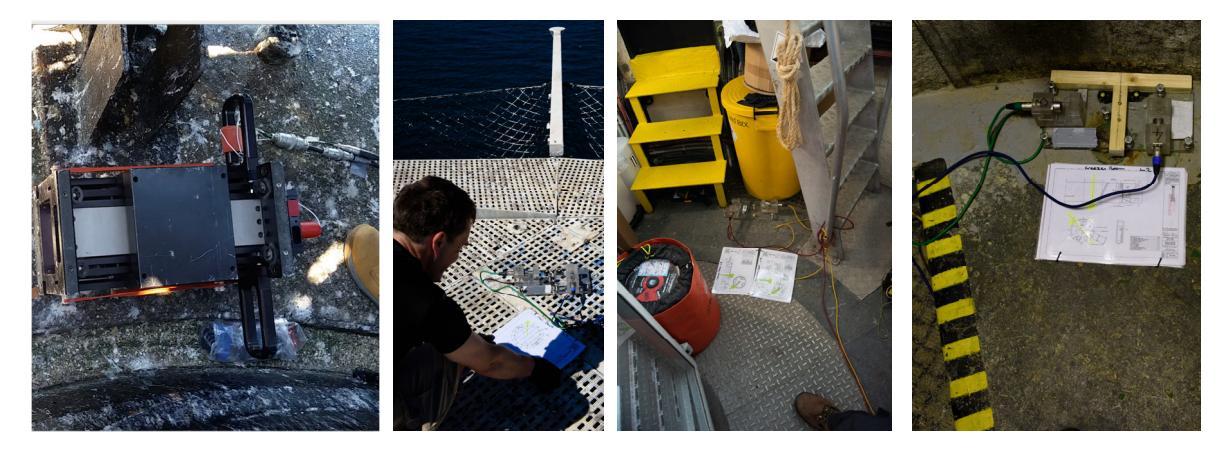
Figure 2. Modal test. Left to right shaker, accelerometers on helideck, in service room (with steps on right that lead up to lantern level), and (with alignment jig) in freezer room.

The lighthouse has a sequence of spiral staircases between levels along which signal cables needed to be laid. Avoiding disorientation and preserving alignment between accelerometer pairs at different levels was an unusual requirement for a modal test, requiring reference to floor plans marking salient features such as windows and bulkheads. Figure 2 shows the shaker in position at service room level (lantern gallery), biaxial accelerometer pair on the helideck (level 9), and biaxial pair with alignment jig in the freezer room (level 2).

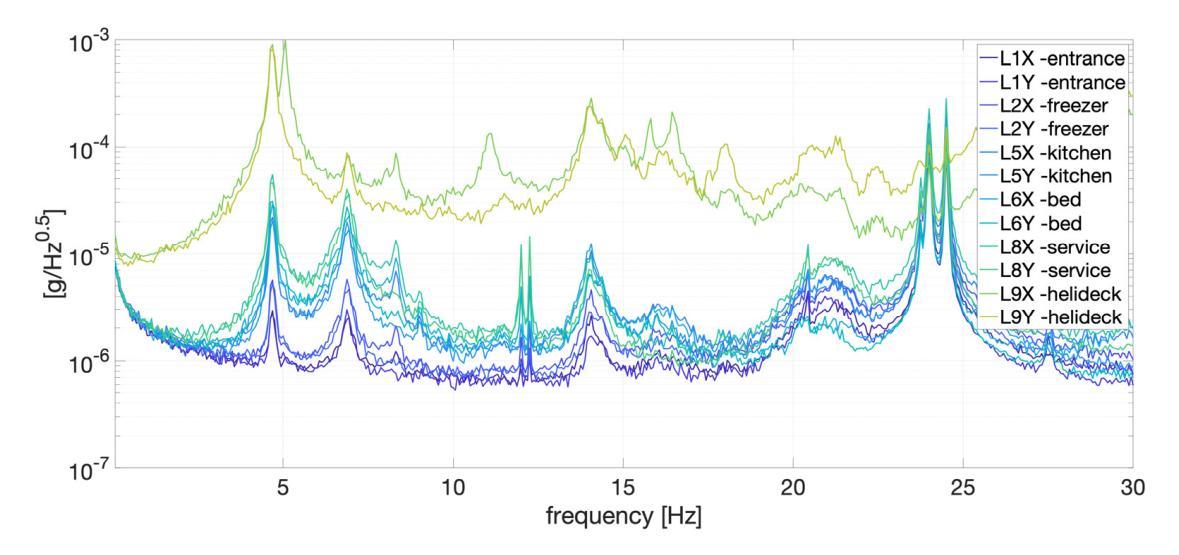
Figure 3 shows ambient response spectra from run2, showing several notable features. The strongest two signals (by an order of magnitude) are for the helideck. Other signals are from the masonry tower for which there appear to be three peaks in the range 0–10 Hz, one around 14 Hz and one around 21 Hz. As well as peaks at frequencies found in the masonry tower, there are other peaks occurring in the helideck at 5.1 Hz and 11 Hz. There are also sharp spikes around 12 Hz and 24 Hz which are most likely not true vibration modes but due to operation of the generator which does not operate at a single constant speed (an extra peak is seen in run5). Peaks believed to represent vibration modes were investigated via operational modal analysis and (including the shaker signal) experimental modal analysis in the frequency domain.

Figure 3. Wolf Rock ambient response, run2.

The upper and lower frequencies correspond closely to the 5.01–5.1 Hz mode evident from 2016 ambient response (Figure 3) and the 6.73 Hz and 6.77 Hz estimates obtained from the 2019 ambient response (Figure 8). The forcing function due to the rotors at both full and idling speeds is apparently close enough to mode frequencies to cause resonant amplification.

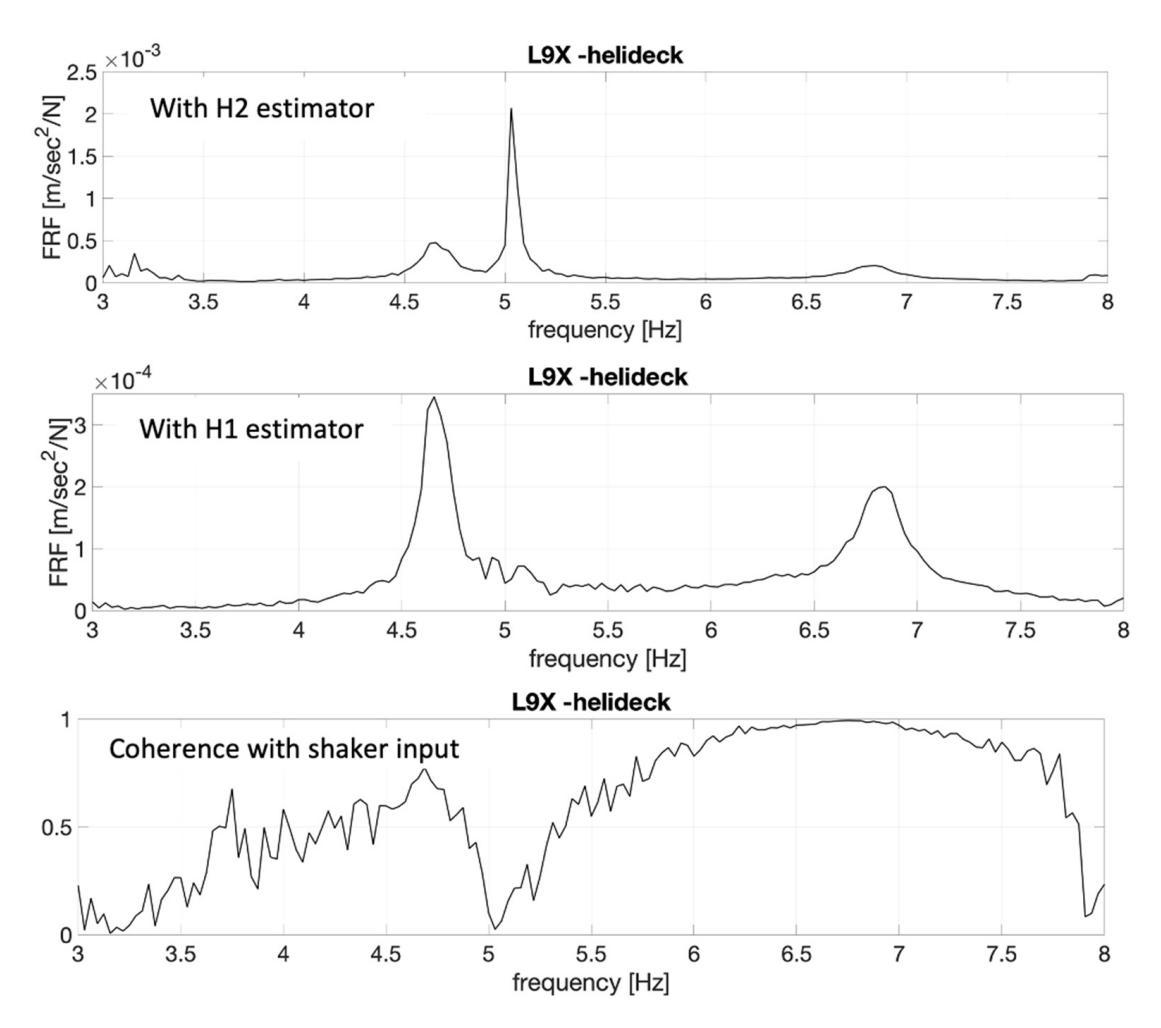
Frequency response functions obtained using the shaker are examined in Figure 4 using both types of frequency response function (FRF) estimator, i.e., 'H1' and 'H2' [21], which are, respectively, appropriate when 'noise' appears/does not appear on the response signal. The coherence function in the lower plot shows the 5.1 Hz signal appearing closer to 5 Hz uncorrelated with the shaker (input), and the peak disappears when using the H1 FRF estimator; hence, it is purely a helideck mode with zero involvement of the tower.

Figure 4. FRFs between helideck (L9) and shaker in x-direction (run18) using H2 FRF estimator (**upper**), H1 estimator (**middle**), and coherence function (**lower**).

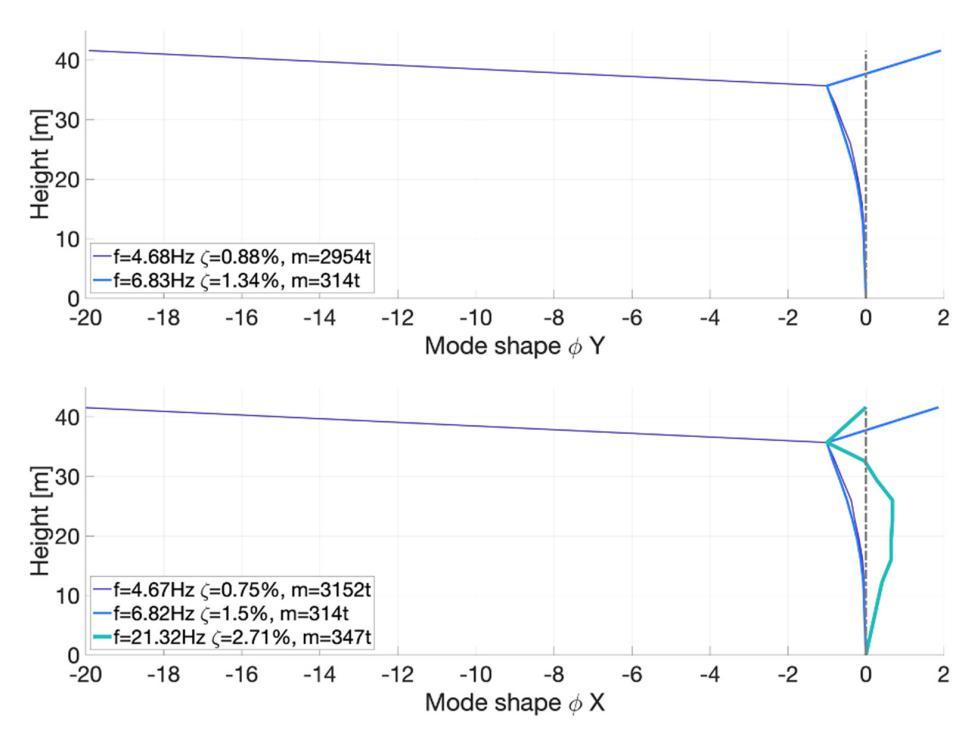
The best estimates for modal parameters obtained using the global rational fractional polynomial method [22] on the FRFs are given in Figure 5. For practical purposes, only the first two modes in each direction are relevant, having almost identical mode shapes, masses, and damping ratios and frequencies for the two directions, so that direction of loading will have a negligible effect on the response. The helideck responds much more strongly in the lowest freuqency pair of modes, which have much larger modal mass for unity scaling at the top of the tower and which will be less strongly excited by horizontal (wave) loads on the tower.

Figure 5. Key modal properties from forced vibration test.

Mode shapes for these mode pairs are, apart from the missing helideck ordinate, similar to the first two mode pairs in Figure 5, and variation in the level 8 (service room) ordinate over the 8 h is shown in two ways in Figure 8. This indicates that, for the

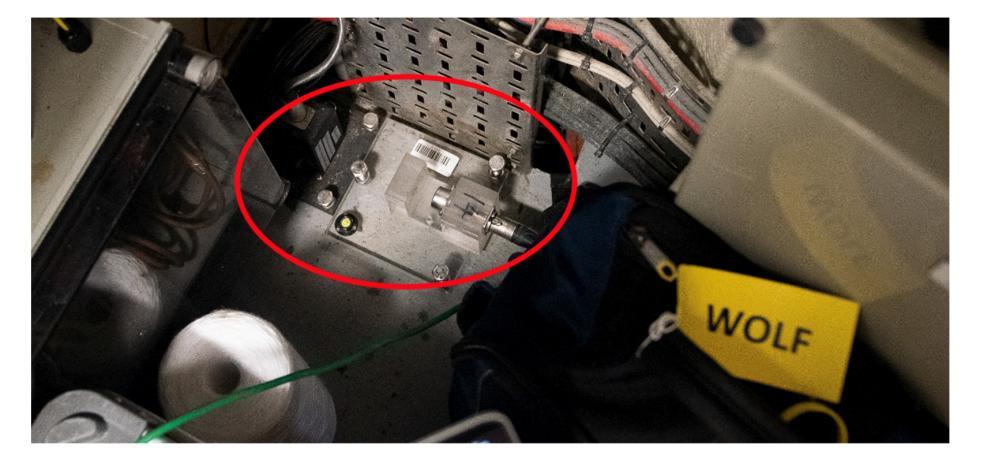
Figure 6. y-direction uniaxial accelerometer in corner of battery room (level 7) adjacent to triaxial monitoring accelerometer.

The ambient response data from the 2016 measurements were limited and insufficient to identify mode shape orthogonality other than for the assumed directions imposed in the forced vibration test. This is rather a curiosity of structural dynamics, but the issue of distinguishing distinct orthogonal eigenvectors and their preferred alignment in axisymmetric vertical structures has parallels in other applications such as telecoms towers and industrial chimneys. Hence, in 2019 [13], an ambient vibration survey limited to selected locations in the tower (excluding the helideck for operational and weather reasons) but with extended duration (due to an overnight stay) was used to track the modal parameters (frequencies, mode shapes, and damping ratios) of the first two modes. The identified eigenvector/mode shape directions happened to align with the triaxial accelerometer installed for long term monitoring in September 2017 (and discussed in the remaining sections of the paper). Figure 6 shows the y-direction uniaxial QA 750 accelerometers aligned with the (negative) y axis of the triaxial monitoring accelerometer at level 7.

A single JA-70SA triaxial servo accelerometer was installed in level 7 (battery room) (Figure 6) on 7 September 2017 with the positive x axis having a compass bearing of 33°. A National Instruments data acquisition system located in the lantern room (Figure 9) samples acceleration signals at 128 Hz and stores them as 10 min TDMS files on a USB drive, with the system automatically reset at midnight once a week to deal with the system crashing. Communication to land using 4G mobile communication was initially established but failed after a year of operation and it has never been possible to retrieve data other than manually during a visit by maintenance crew. Ideally, the system records 144 data files every day, but occasionally fewer are recorded and there are days of no data. For the period of available data (at time of writing, 8 September 2017–12 July 2023) 972 full or partial days of data are available with numerous gaps, for example during the COVID-19 pandemic when maintenance visits could not be used to retrieve data. From the collected data, significant events have been recorded, some of which are described here.

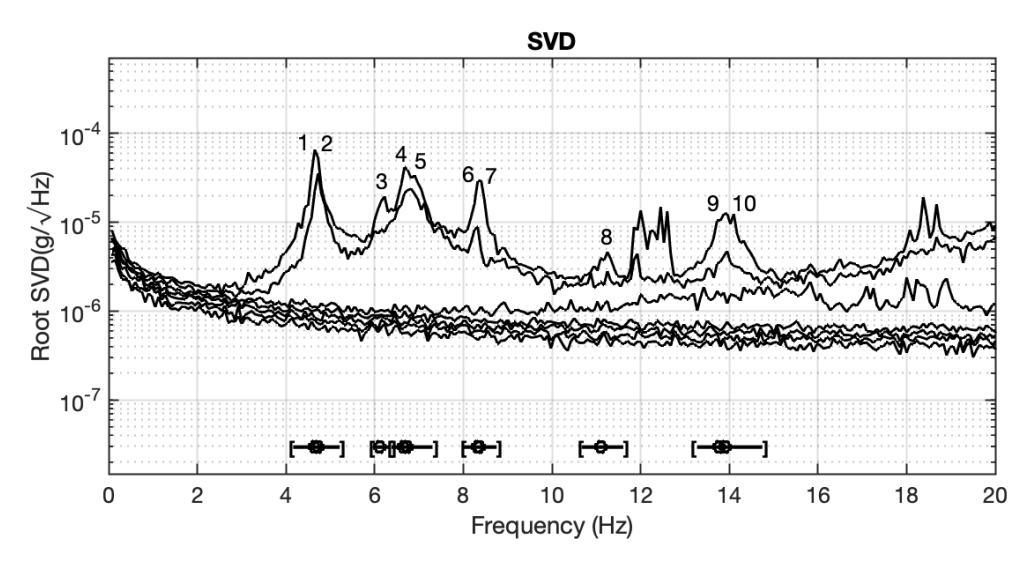
The Bayesian operational modal analysis (BAYOMA) procedure [23] was applied to acceleration signals recorded for eight hours starting 23:11 on 18 January 2019 from four biaxial accelerometer pairs, at levels 1, 5, 7, and 8. The recording was broken into 96 5 min segments from each of which mode shapes, frequencies, and damping ratios were estimated. Singular value decomposition (SVD) of cross-power spectral densities from a sample is shown in Figure 7 indicating four mode pairs. Mode 3 at ~6.16 Hz was not distinct in the overnight recording and was not tracked.

Figure 7. Singular value decomposition of acceleration cross-power spectral density.

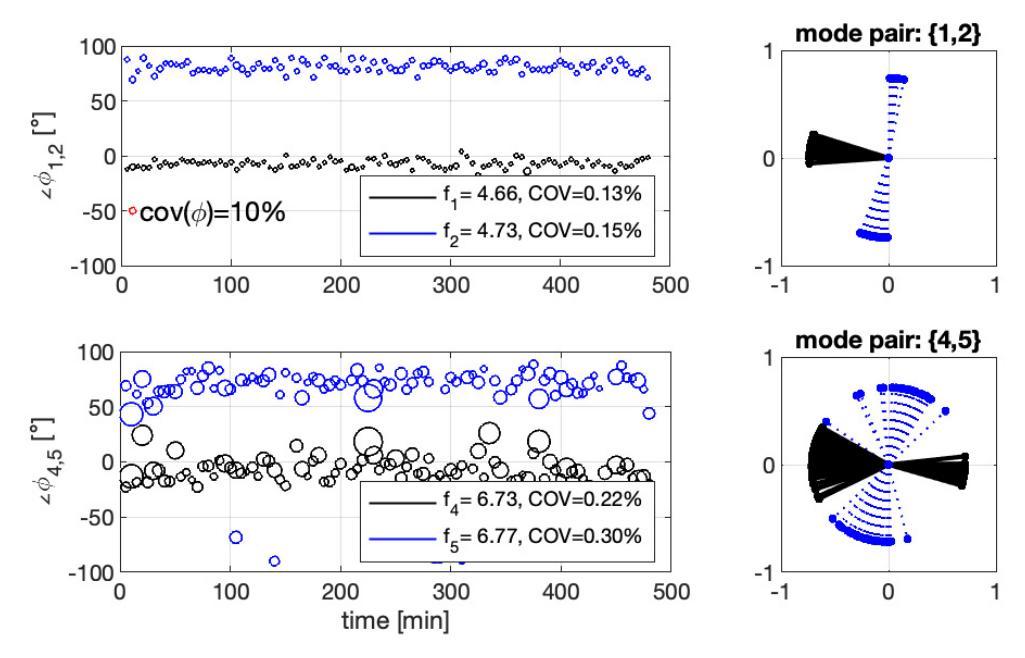
Variation of natural frequencies for mode pairs 1/2 and 4/5 over the eight hours is shown in Figure 8. Mode pair 1/2 frequencies are well separated compared to the forced vibration test values and are identified with high certainty (i.e., with low variance error). Mode pair 4/5 frequencies are close, have higher variance errors and are lower than the forced vibration test values.

Figure 8. Mode shape level 8 ordinates for first two mode pairs from Figure 7.

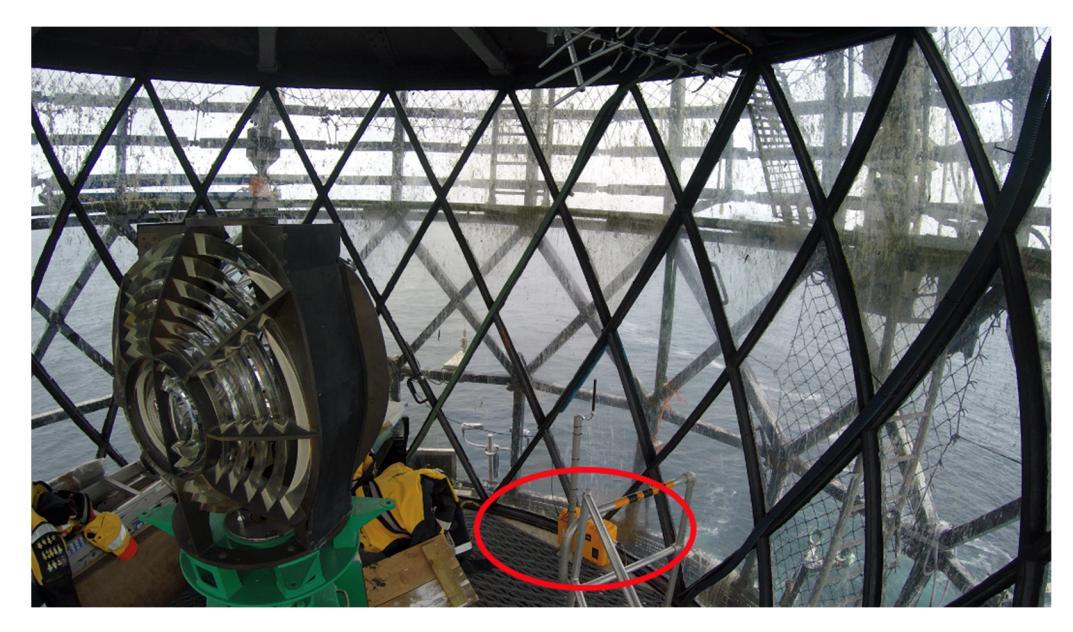
Figure 9. Yellow logger (data acquisition, storage, and communication) box in lantern room. Steel framework of helideck is visible outside.

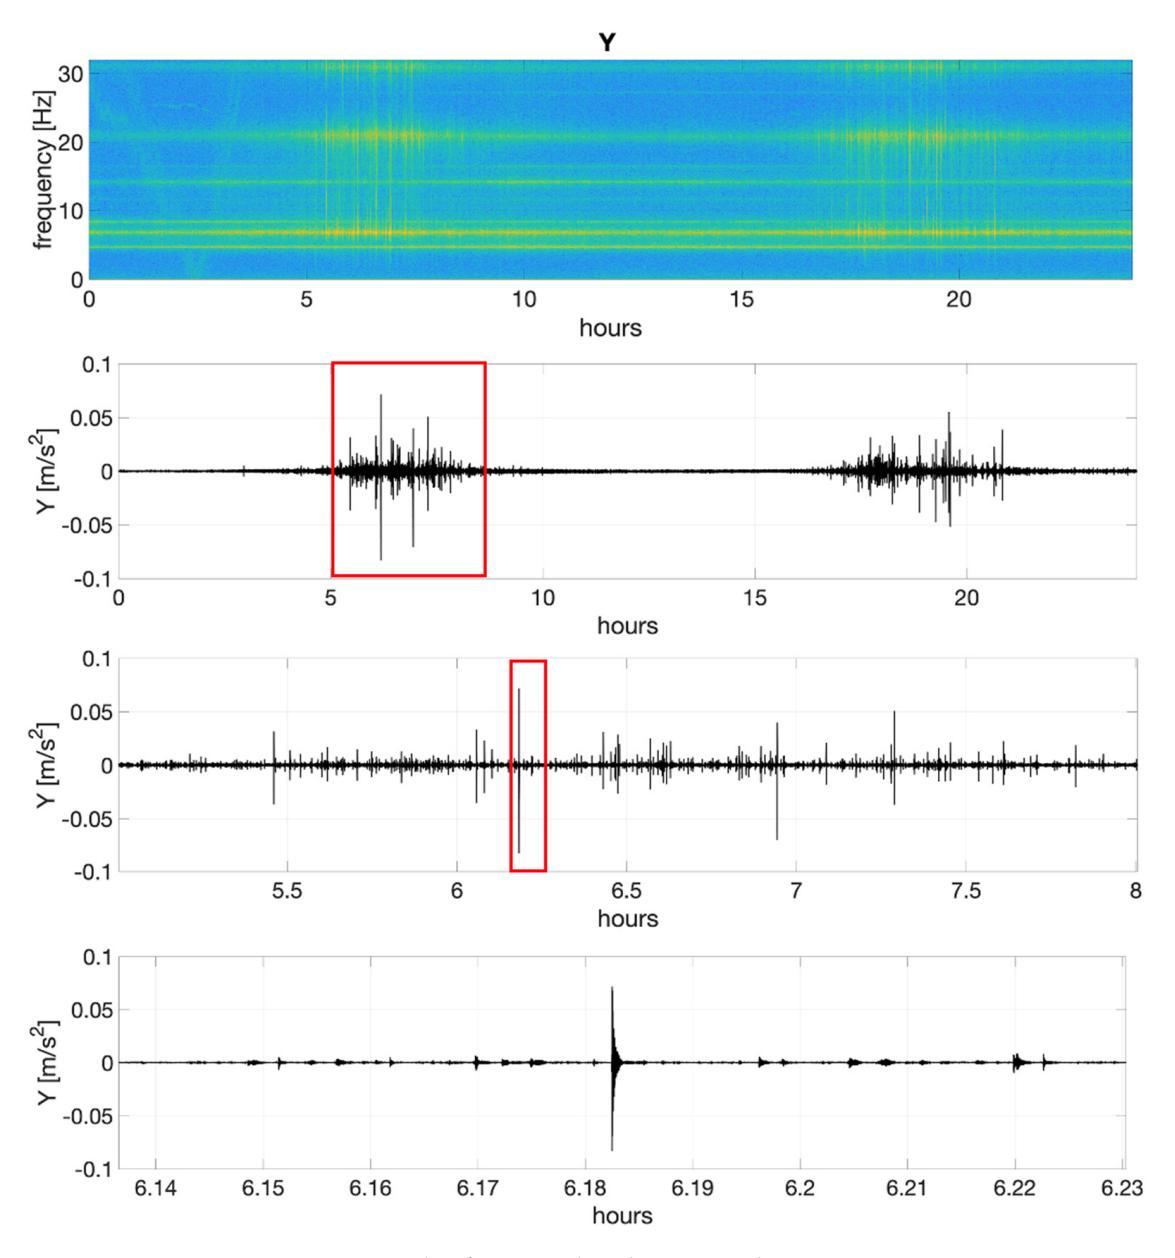
A sample of acceleration data is shown in Figure 10 for one day of relatively strong wave-induced response (23 September 2017), successively zooming in to individual transient responses to breaking waves. The stronger response occurs during the two periods

of high tide (tidal range can reach 5 m), and the spectrogram shows that the mode pair around 6.8 Hz is the most strongly excited.

Figure 10. Sample of wave-induced response during 2017 storm season. Top two rows: time-frequency plot (spectrogram) and time history for complete day, lower two plots successive zoom into single wave impact.

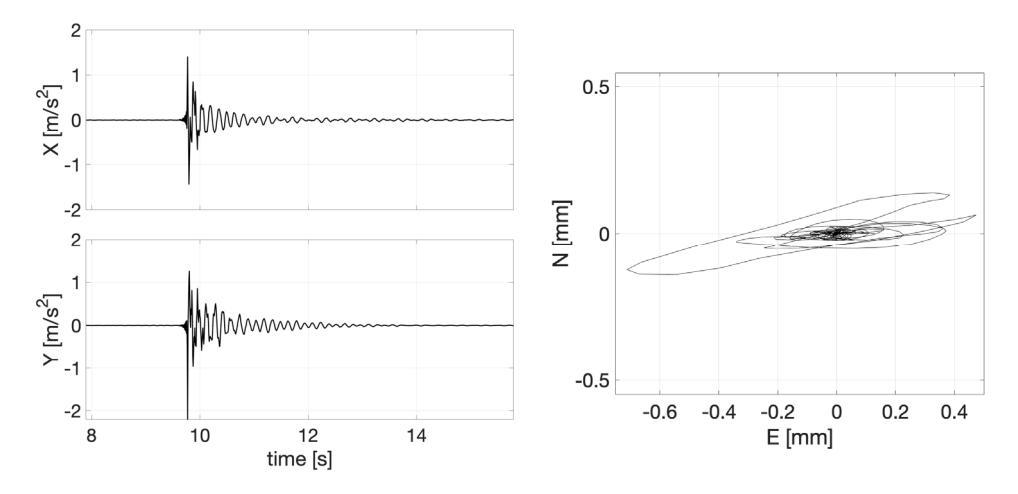
During the monitoring period with available data, several storm events were captured, the majority named by the UK Meteorological Office, others named by the USA (Ophelia), Portugal (Diana, Irene), or France (Matthis). The strongest recorded acceleration was during Storm Brian which reached 2.6 m/s², (Figure 11) corresponding to 0.7 mm level 7 displacement aligned south of west, consistent with prevailing wind (hence breaking wave) direction.

Figure 11. Response to wave impact during Storm Brian as acceleration and displacement trajectory.

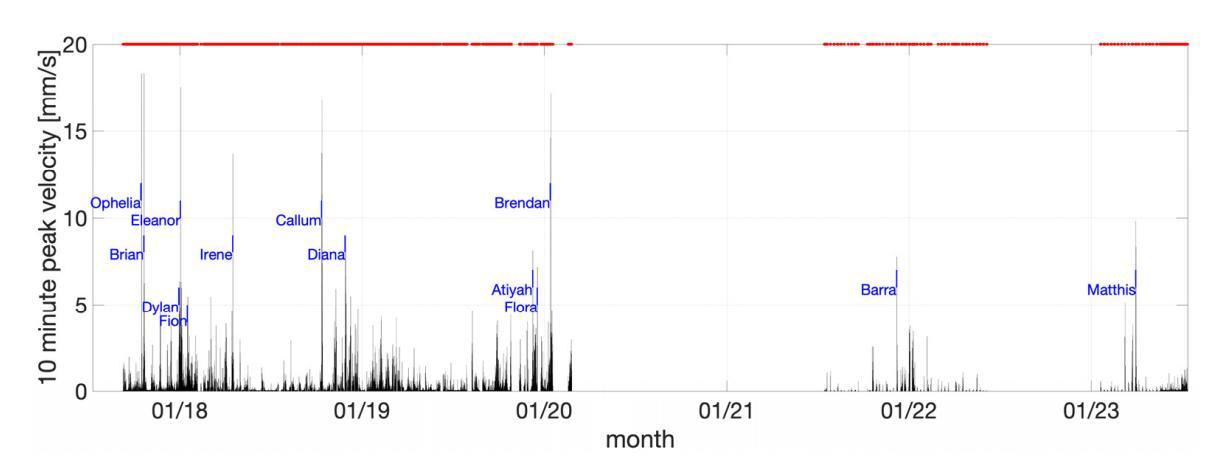
Figure 12 shows peak 10 min velocities over five storm seasons (much of 2020/21 was missed due to COVID-19). Rather than taking accelerations for the strongest wave impacts, peak velocities obtained from the vector sum of integrated level 7 accelerations are shown as they directly indicate wave loads. This is due to the impulsive nature of the response (evident in Figure 10) via the relationship of known modal mass and change of velocity (the indicated peak values) to wave force \times duration.

Figure 12. Recorded battery room peak velocities. Red dots indicate available data.

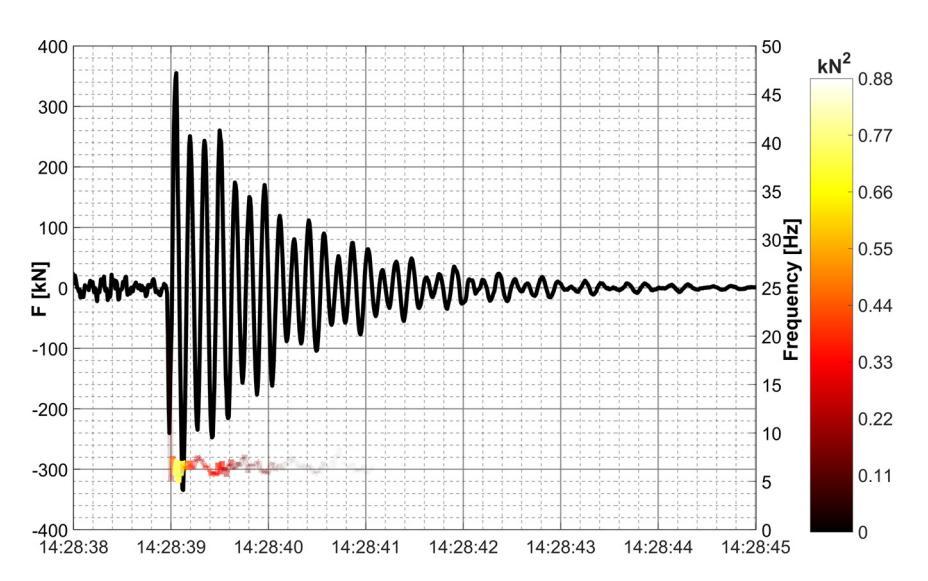
This information has been used to estimate the wave forces experienced due to breaking waves for ex-Hurricane Ophelia. The inertia force of an exemplar extreme wave impact (envisaged via the modal mass for unity mode shape at level 7) is shown in Figure 13. Via the Bayesian inverse identification process described in [25], the response corresponds to a peak force of 7 MN if applied as a breaking wave impact 7.15 m above the tower base and with the strongest part, a double-peak impulsive component lasting 0.06 s. In fact, knowledge of the point of wave impact is not known and is one objective of the video system now in operation.

Figure 13. Inertia force based on acceleration signal and modal mass and instantaneous frequency.

It is the impulse (integration of force with respect to time) that delivers the change in momentum observed as velocity change via the data acquisition system, with the duration of the wave impact being a fraction of a second. If the response is a linear elastic vibration, the impulse can be estimated via modal mass and the peak modal velocity due to the impulse.

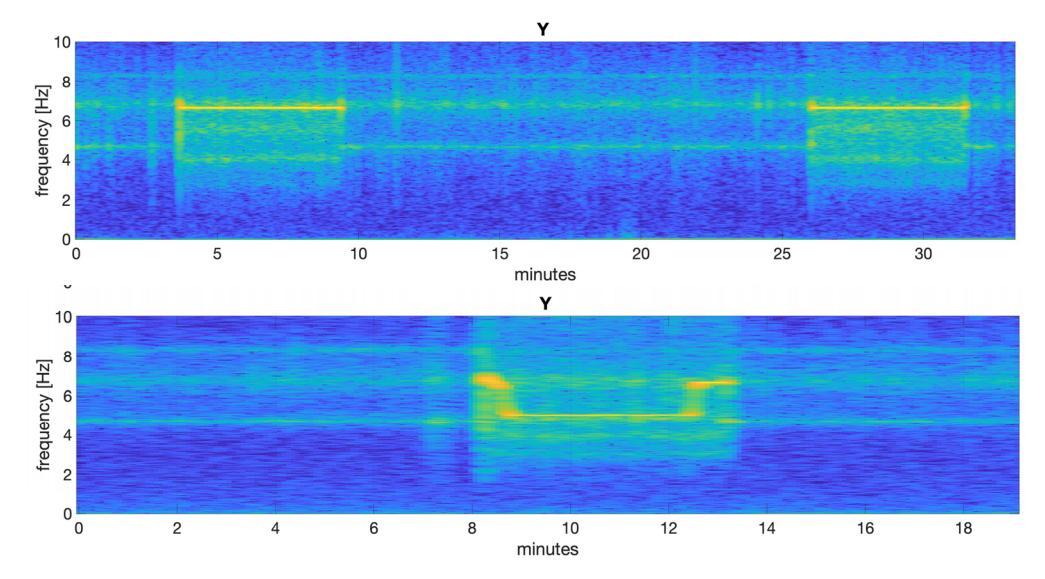
Two occasions are shown in Figure 15. The first is for the afternoon of 6 January 2020 when the same helicopter made two visits to ferry workers from the lighthouse to Land's End (St Just) airport, a distance of approximately 20 km. There is a strong steady state signal around 0.03 m/s^2 with an amplitude of 6.65 Hz. This is consistent with other known helicopter visits. The second occasion is during the ambient 2019 vibration survey (for which simultaneous monitoring data are not available) showing three periods: a steady 5.02 Hz period between two short periods of vibration, first at 6.66 Hz then at 6.69 Hz. This appears to be a unique recording (among all the monitoring data). The higher frequency corresponds to ~400 (rotor) RPM observed using video recording of the aircraft landing at the lighthouse, while the lower frequency corresponds to ~300 RPM observed from audio recording of the aircraft (idling) on the ground at Land's End Airport.

Figure 15. Spectrograms of level 7 response for helicopter visits in 2020 (upper) and 2019 (lower).

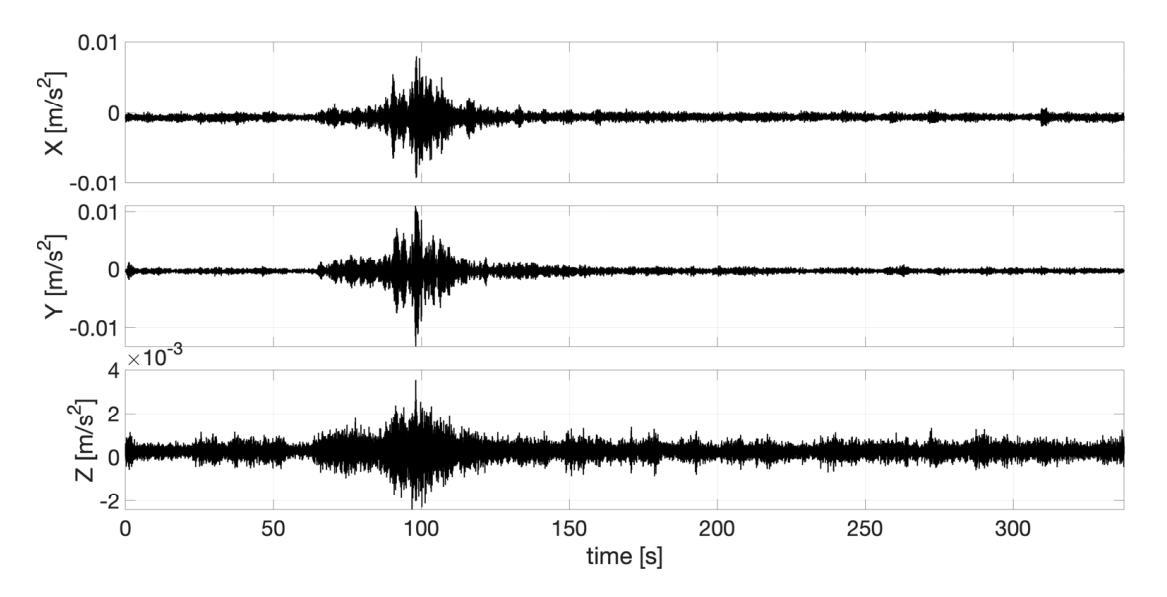
The United Kingdom does not experience strong earthquakes, but there are occasional relatively strong tremors, such as the 4.6 ML Richter local magnitude event of 17 February 2018 [29] around 2:30 P.M. with epicentre at Cwmllynfell, South Wales, approximately 230 km northeast of Wolf Rock. The triaxial response of Wolf Rock Lighthouse, occurring at low tide and with moderate level 7 accelerations due to breaking wave impacts of a rising tide, is shown in Figure 16, with signal duration consistent with the local (Wales) seismometer recordings of the event.

Figure 16. Acceleration time series due to earthquake.

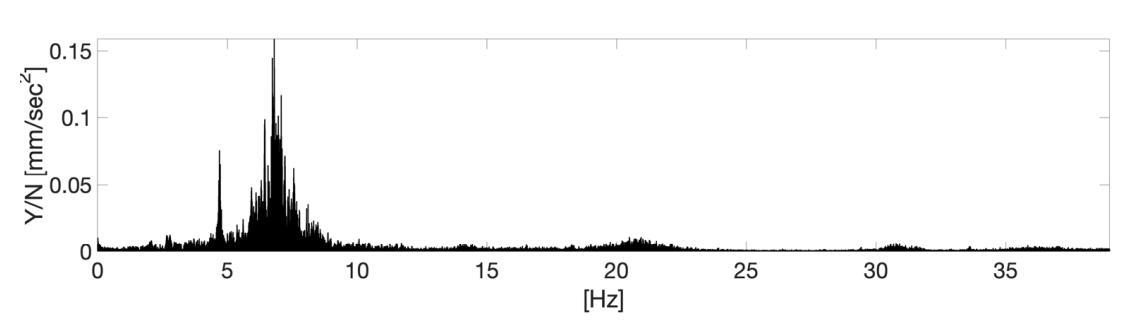
The response is mainly in the second mode (Figure 17; x/east is similar):

Figure 17. Acceleration FFT due to earthquake.

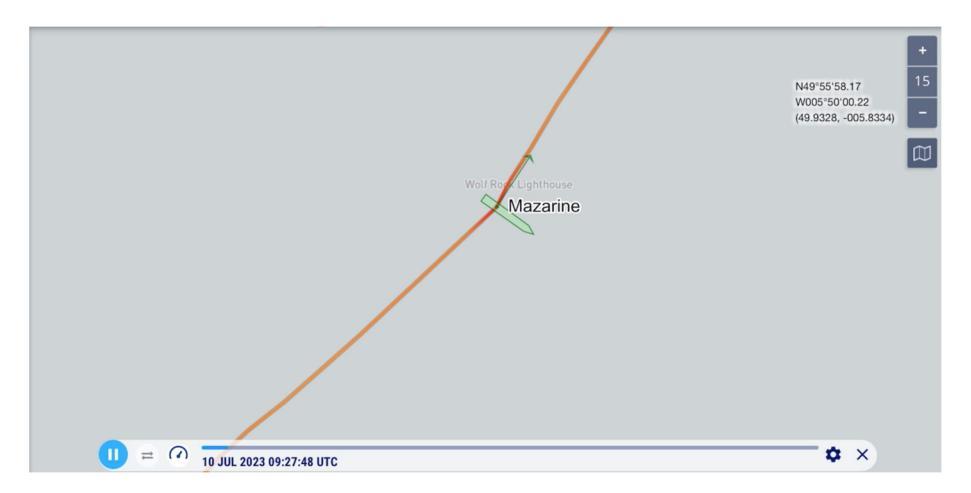
On 10 July 2023, the RoRo cargo ship Mazarine, enroute from Ireland to Belgium, lost power and drifted onto the reef of Wolf Rock. Marine tracking shows that the grounding occurred at 09:27 UTC (10:27 local time). The tide was still rising at the time (high tide at 10:00 UTC) and the ship rotated around the stern, resuming a drift towards the Cornish coast at 09:50 (Figure 18).

Figure 18. Trajectory of Mazarine, indicating grounding at 09:27.

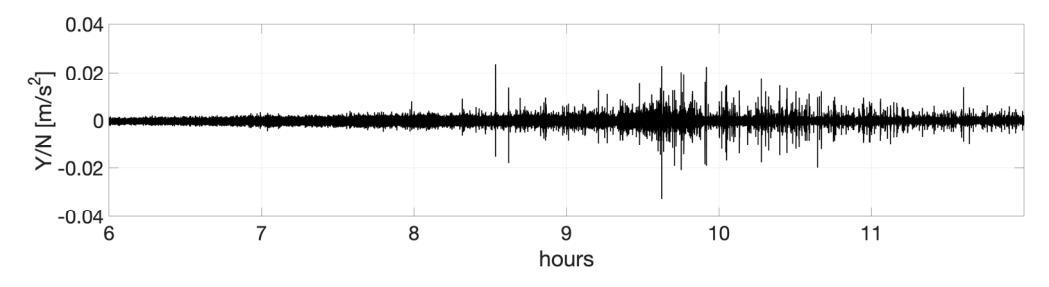
The y/north acceleration for the period from 6 A.M. to noon is shown in Figure 19 and features typical breaking-wave impacts (for a relatively windy summer day) but no evidence of the ship directly impacting the structure.

Figure 19. Acceleration response between 6 A.M. and 12 noon, 10 July 2023.
