# Re-curing of calcium aluminate cements post contact with molten slag

França de Mendonça Filho, Fernando; Copuroglu, Oguzhan

Published in 17th Euroseminar on Microscopy Applied to Building Materials

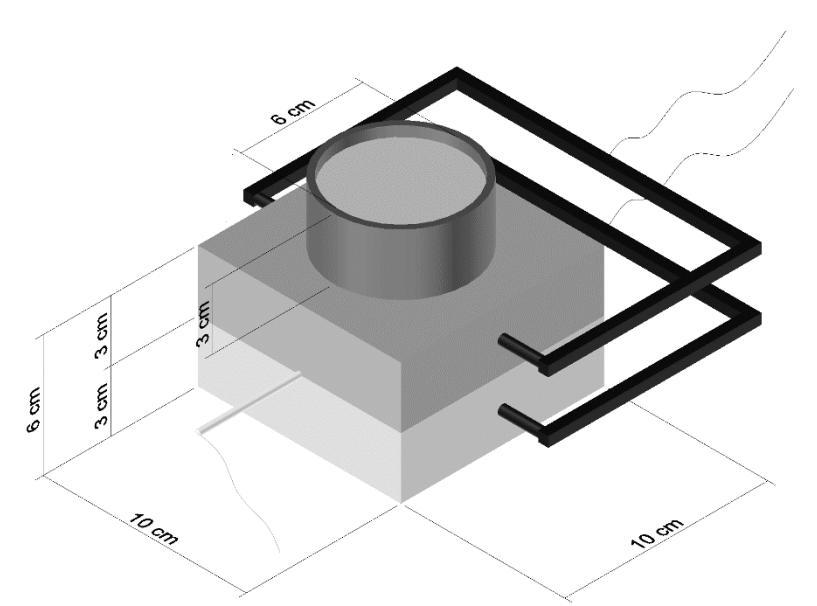
Figure 1: Components of the test setup; in light gray is the concrete sample, in dark gray is CAC sample cast on top of it, the slag is poured inside the titanium ring, a thermocouple is placed between the layers of the concrete materials and the extensioneters are in black.

Laboratory scale slabs were prepared containing two layers, one of approximately three years old OPC based concrete and one of CAC mortar (Figure 1). For the OPC concrete, cubic samples of 10 cm sides were sawn to 3 cm height. These samples had a w/c ratio, cement content and aggregate maximum size of 0.45, 355 kg/m3 and 32 mm, respectively. The cement used for fabrication was CEM III/B 42,5 N and all samples were cured in a fog room at RH>95% for 28 days. For the layer of CAC mortar, the cement REFRO50 (CIMSA) was used in combination with Glenium 51 (BASF), the mix proportions for cement, aggregate, water and super plasticizer were 1:1.35:0.2:0.004. The composition of REFRO50 can be found in Table 1.

Two samples were prepared as in Figure 1, and subsequently moved to a curing chamber for 27 days. The sample were then dried in an oven at 40°C for one week before the execution of the experiment. Sample 01 was kept as a reference, while sample 02 received the thermal treatment. At first, 40 grams of steel furnace slag were weighted in an alumina crucible and placed in an oven to be heated at a rate of  $15^{\circ}$ C/min until 1530°C. The composition of the used slag is also found in Table 1. The temperature was held for 30 minutes to guarantee liquification of the slag, then the oven was opened and the molten material was poured on top of sample 02 at the orange area in Figure 1. To avoid leakage and concentrate the pour in place, a titanium ring was fixed with cement paste on top of the sample prior to the experiment

Sample 01 was sawn into 30 x 20 x 10 mm specimen parallel to the height of the sample as seen in Figure 1. The specimen was then vacuum impregnated with epoxy resin and further ground and polished until a flat surface was achieved. Finally, a 10 nm layer of conducting carbon coating was placed on the top of the polished surface using a Leica EM CEDO030 carbon evaporator. Sample 02 was first cut in half, one half of the sample went through identical process as sample 01. The other half had the sawn face sealed with aluminum tape and was moved to a curing room where it was cured for one week. Thereafter, the second half was also prepared for microanalysis.

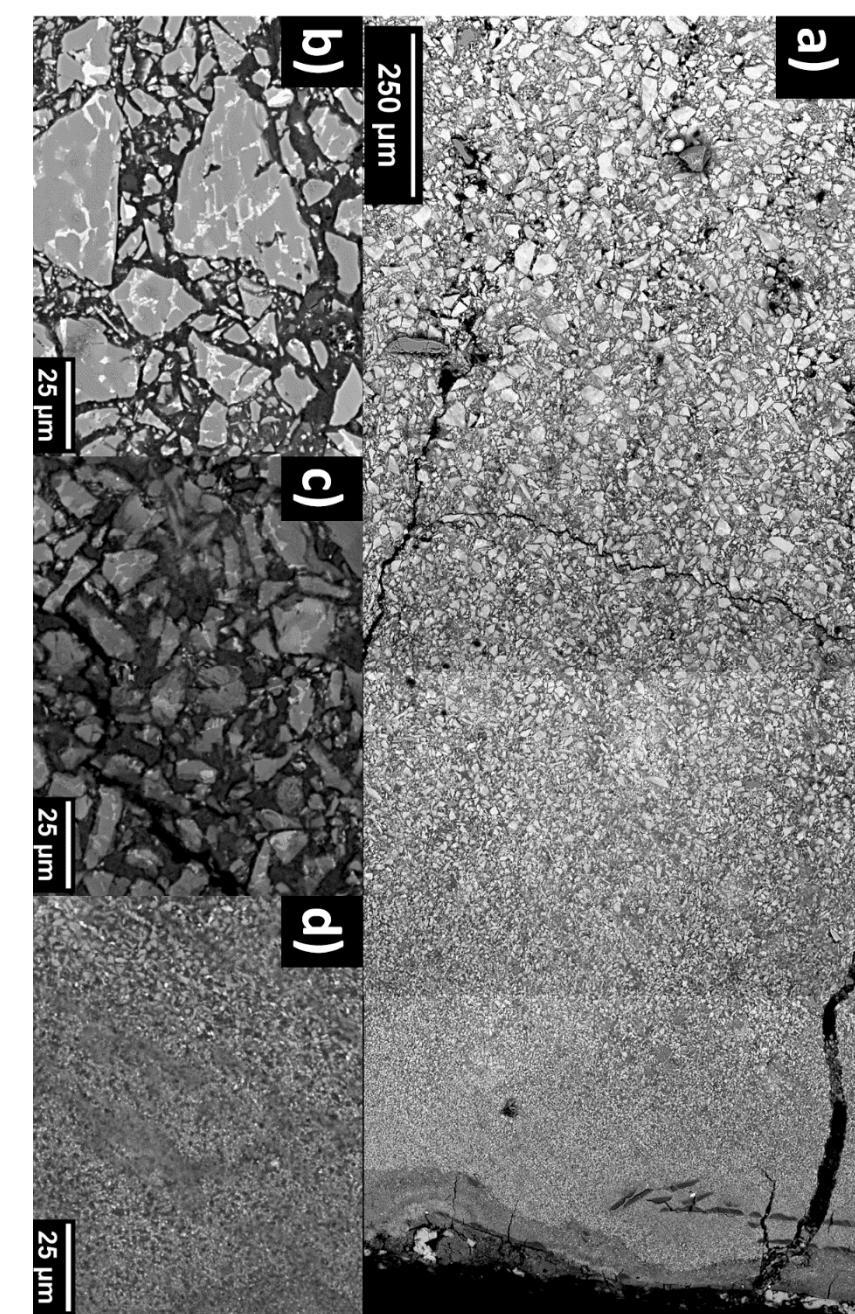
(b) Unaffected area, similar to that of reference; (c) Transition area, at  $\sim 400 \mu m$  from surface; d) Near surface affected by molten slag Figure 2: Microstructure after cooling; (a) Stitching of first  $\sim 2$  mm from sample surface, the face in contact with slag is on the right side;

The effect of pouring molten slag on the surface of the sample can be observed in its microstructure for the first 1,5 mm of the sample as shown in Figure 2. There are several shrinkage cracks and a clear refinement of the unhydrated grains to the point of mixing with hydration products in components smaller than 1  $\mu$ m. EDS performed on the products between the unhydrated grains showed that the composition had a significant increase in the amount of magnesium and silica in comparison with the reference sample. The main phase continued to be *CAH*<sub>10</sub>, as in the reference sample, but the Si/Ca atomic ratio increased from 0.1 to 1.0, which could point to a temporary mixing of slag as an amorphous phase. This observation is corroborated by the doubling of average Mg content when comparing sample 01 and 02, further, the magnesium quantified in the surface of sample 02 is ten times higher than when millimeters deep with respect to the face that was in contact with molten slag.

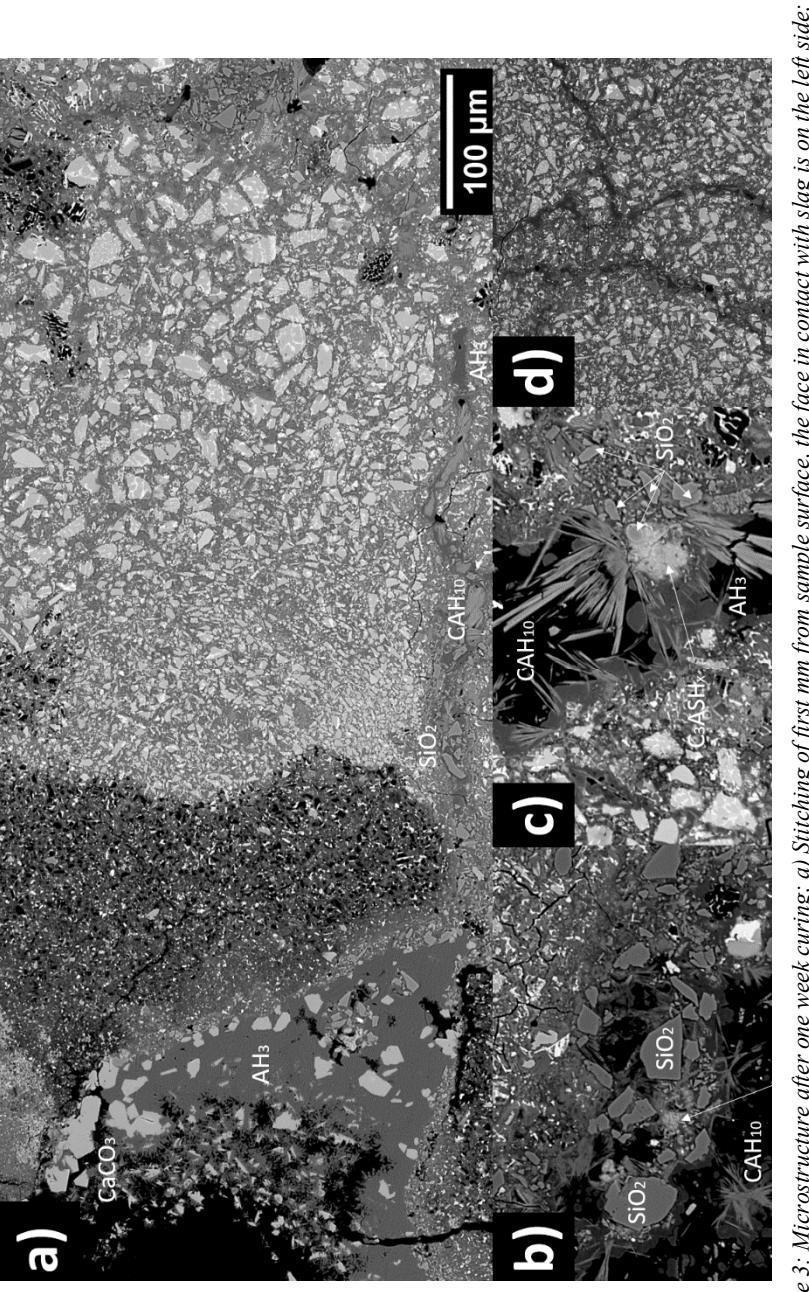
*Figure 3: Microstructure after one week curing; a) Stitching of first mm from sample surface, the face in contact with slag is on the left side; b) Near surface with silica precipitates; c) Cracked zone with CAH\_10 needles; d) Zone with AH\_3-filled microcracks.*

For the sample that went through re-curing, the regions near the surface presented a very complex microstructure, as it can be seen in Figure 3 a), which included the surface coated with a layer of  $CAH_{10}$  embedded in amorphous alumina gel  $(AH_3)$  and  $CaCO_3$  from atmospheric carbonation of the calcium aluminates. Instead of the zone with very fine components, an extremely porous zone was observed, in which most of the unhydrated grains seem to have been completely consumed leaving only  $CAH_{10}$ , then an area in which the CA and  $CA_2$  grains present a smaller granulometry, as in sample 02, and finally a seemingly unaffected area, resembling sample 01. Further, many of the cracks were filled by  $AH_3$  and in smaller volume by  $CAH_{10}$  and  $SiO_2$ , this can be observed at the bottom of Figure 3 a) and in Figure 3 d).

The composition of the hydration products presented increased Mg content, while the amount of Si dropped to values equivalent to the reference sample. The decrease in amount of silicon can be explained by areas in which solid silica precipitations were identified. An example of such areas is shown in Figure 3 b). Inside large cracks and the surface of the sample, freshly formed calcium aluminate decahydrate can be identified by needle morphology as described in [6], which can be seen in Figure 3 c).

No indication of conversion reactions was found, although some particles of  $C_3AH_6$  were observed embedded in  $AH_3$ , those had a very high amount of Si and slight presence of S. Those phases are seen in Figure 3 b) and c). Given their abundance in Si, it is possible that those phases were actually an analogue to Hydrogarnet  $(C_3AS_{3-x}H_{2x})$  or even Gehlenite  $(C_2ASH_8)$  as described in [7].
