Comfort at hospital reception desks

40th AIVC Conference, 8th TightVent Conference, 6th venticool Conference

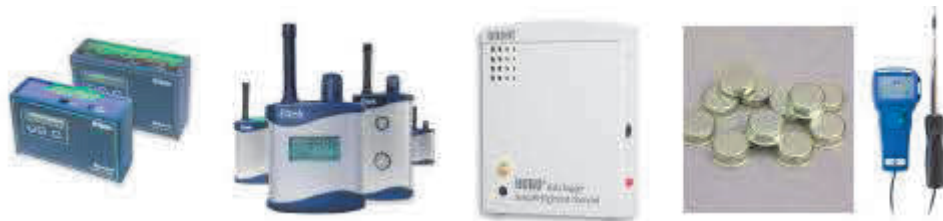
Figure 1: Equipment Eltek Squirrels, Hobo Dataloggers, I-buttons and air velocity meter, images from the producers.

Eltek Squirrels, HOBO dataloggers, I-buttons and EXTECH air velocity meters were used to measure the temperature, the relative humidity the air velocity and the CO₂ concentration, see figure 1. The researcher's nose was used to track and identify any interesting smells at the reception desk and in the surrounding areas. The outdoor temperatures of the nearest airport were taken from the KNMI website. The perceptions of the people from the reception desk were investigated using a questionnaire and additional small talk. The questionnaire consisted of questions about personal characteristics and thermal comfort.

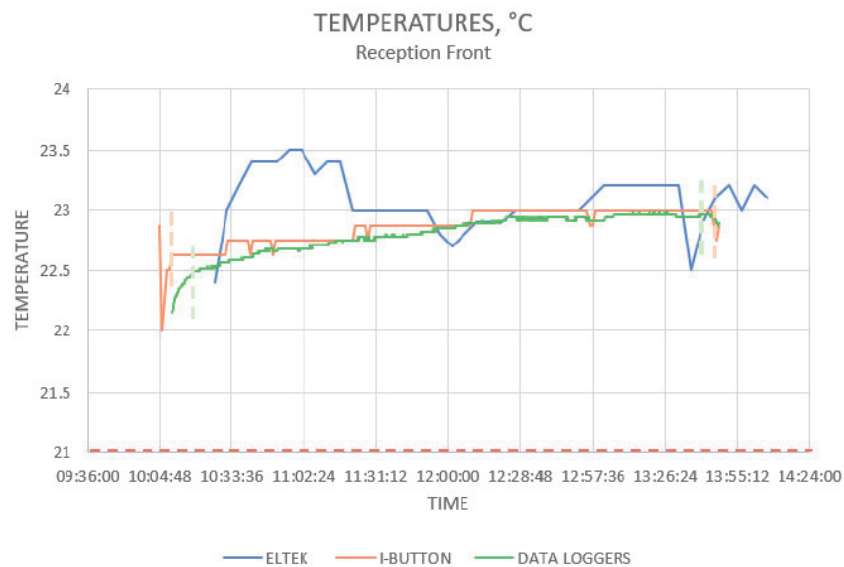
Figure 7: Indoor Temperature at the reception desk in hospital 3.

Hospital 3: The measurements were taken on the 7th of May 2019 between 9.00 and 14:30. The outdoor temperature was between 9.5 and 10.5 °C with a North East wind speed of 18 km/h, see figure 5. The temperature at the reception was again between 22.5 and 23.5 °C measured with Eltek, I-button and Hobo’s, see figure 7. The CO₂ concentration was below 800 ppm and is not further investigated.

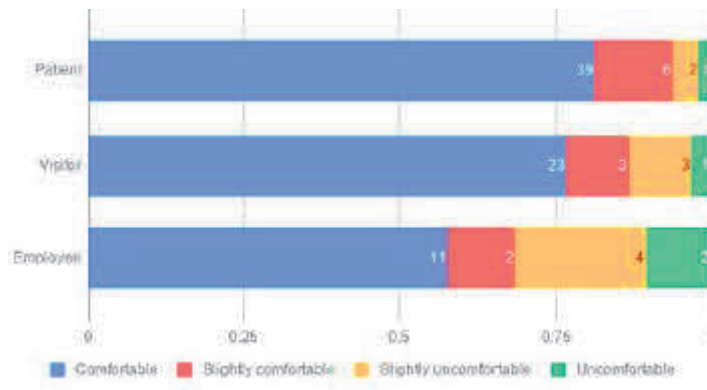
Figure 8: Level of comfort according to patients, visitors and employees in hospital 1.

Hospital 1: 24 employees were surveyed, 60 patients and 36 visitors. 43.8% of the employees were feeling (slightly) cool or cold (where only 12.5% felt slightly warm or hot); and a lot of employees felt draught (68.4%). Those two ways of expressing thermal discomfort are likely to be related. For people that are feeling cool, together with high turbulence intensities – draught can be a serious cause of discomfort, even at locations where no high values are measured for the air velocity.
