Eemdijk full-scale field test programme: sheet pile pullover tests

TProgramme d'essai terrain à taille réelle Eemdijk : essais de déformation et de rupture de murs palplanches

ABSTRACT: Dikes in the Netherlands have traditionally been constructed with soil. Climate change and subsidence requires heightening and or reinforcing of these existing ground dikes. Traditional reinforcements demand additional space, which in some cases conflicts with existing buildings. Applying sheet pile walls in dikes allows for strengthening while minimizing the increase in footprint. However, a validated design approach that complies with relevant regulations lacks. To enable the validation of a proposed design approach, a full-scale field test programme (Eemdijkproef) was performed near the town of Eemdijk, The Netherlands. It consisted of a step wise approach: 1) sheet pile pullover tests, 2) ground dike stability test, 3) sheet pile dike stability test. All tests were loaded until failure occurred. The full-scale pullover tests (POT) consisted of 4 sheet pile configurations. The length of the sheet piles varies between 13 and 16m and the width of the panel varies between 1.8 and 4.2m. Both Z- and

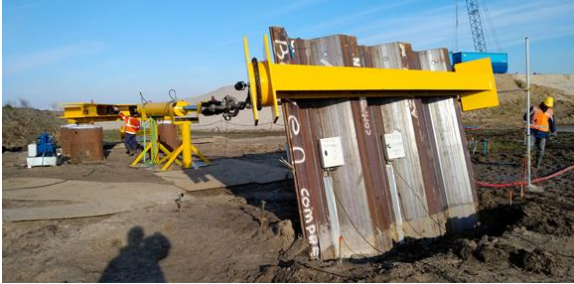
Figure 4. Photo of AZ13-700 during the test

Between the reaction frame and the sheet piles a hydraulic jack is placed 2m above surface level, see Figure 4. This jack can generate a pull-force of 1200kN and has a stroke of 2m. This jack is placed on a sliding table to support the jack and prevent the self-weight of the system to influence the behavior of the sheet pile. The jack is connected to a steel cable to both sides of a waling on the sheet pile. This connection is such that the pull-force is evenly distributed over both sides of the waling and the pull force remains centric on the waling even for large rotations of the sheet pile wall.

The AZ13-700 three double-Z is a relative wide panel in respect to the GU8N triple-U profiles, see Figure 4. Since the wall is wider and has a higher bending moment capacity than the GU8N
