Eemdijk full-scale field test programme: sheet pile pullover tests

TProgramme d'essai terrain à taille réelle Eemdijk : essais de déformation et de rupture de murs palplanches

ABSTRACT: Dikes in the Netherlands have traditionally been constructed with soil. Climate change and subsidence requires heightening and or reinforcing of these existing ground dikes. Traditional reinforcements demand additional space, which in some cases conflicts with existing buildings. Applying sheet pile walls in dikes allows for strengthening while minimizing the increase in footprint. However, a validated design approach that complies with relevant regulations lacks. To enable the validation of a proposed design approach, a full-scale field test programme (Eemdijkproef) was performed near the town of Eemdijk, The Netherlands. It consisted of a step wise approach: 1) sheet pile pullover tests, 2) ground dike stability test, 3) sheet pile dike stability test. All tests were loaded until failure occurred. The full-scale pullover tests (POT) consisted of 4 sheet pile configurations. The length of the sheet piles varies between 13 and 16m and the width of the panel varies between 1.8 and 4.2m. Both Z- and

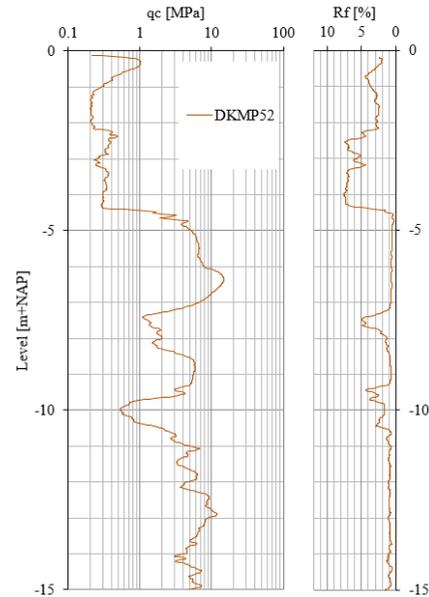
Figure 1. Representative CPT at POT site

The ground conditions at the test site are homogeneous, consisting of peat and clay layers on top of a sand layer. In Figure 1 a representative CPT is presented and Table 1 presents the stratification. The “Eemdijkproef” comprised an extensive field and laboratory testing programme. A more detailed description of the geotechnical conditions is presented in (Lengkeek, 2019b). During

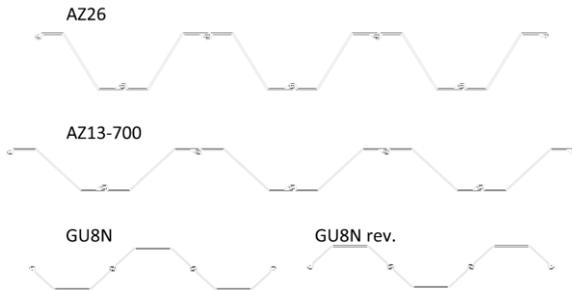
Figure 2. Sheet pile profiles

Four sheet pile configurations are tested in the POT (see figure 2):

- GU8N triple is a class 3 profile according to the (EN 1993-5, 2007) and the same type as used in the FST sheet pile dike. To assess the influence of the loading direction, this profile is also tested in the reversed direction (GU8N-rev).

- AZ26 profile is tested to validate the plastic bending capacity since this profile is a class 2

profile according to the (EN 1993-5, 2007) and therefore is expected to reach the full plastic bending capacity with additional plastic rotation capacity.

- AZ13-700 is a class 3 profile according to the (EN 1993-5, 2007) and is tested for comparison with the AZ26 profile. It is expected to reach the expected elastic bending capacity (plastic resistance in term of Eurocode) but not the full plastic bending capacity.

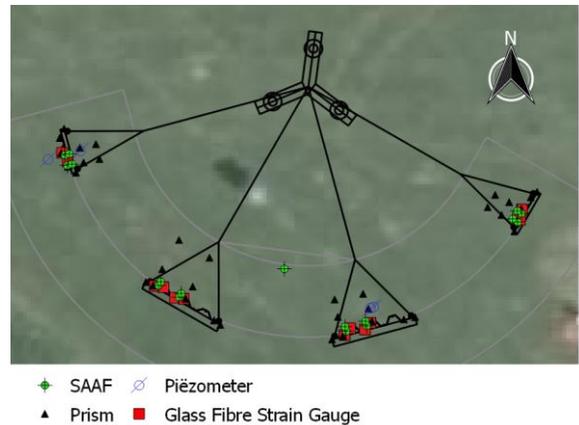
Figure 3. Top view POT site with monitoring instrumentation

The test setup is presented in figure 3. Four sheet pile configurations are placed in a circular formation around a reaction frame. This reaction frame consists of 3 tubular piles interconnected with a steel Y-frame. To prevent any soil interaction between the sheet piles and the reaction frame the sheet piles are installed at a 15m distance of the tubular piles.

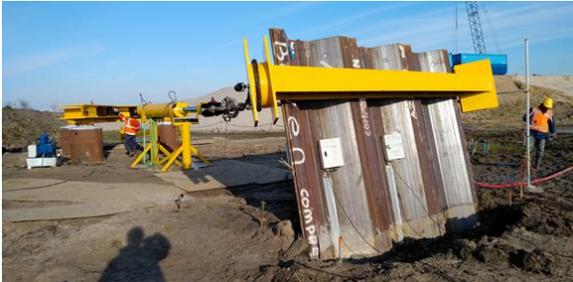
Figure 4. Photo of AZ13-700 during the test

Between the reaction frame and the sheet piles a hydraulic jack is placed 2m above surface level, see Figure 4. This jack can generate a pull-force of 1200kN and has a stroke of 2m. This jack is placed on a sliding table to support the jack and prevent the self-weight of the system to influence the behavior of the sheet pile. The jack is connected to a steel cable to both sides of a waling on the sheet pile. This connection is such that the pull-force is evenly distributed over both sides of the waling and the pull force remains centric on the waling even for large rotations of the sheet pile wall.

The AZ13-700 three double-Z is a relative wide panel in respect to the GU8N triple-U profiles, see Figure 4. Since the wall is wider and has a higher bending moment capacity than the GU8N

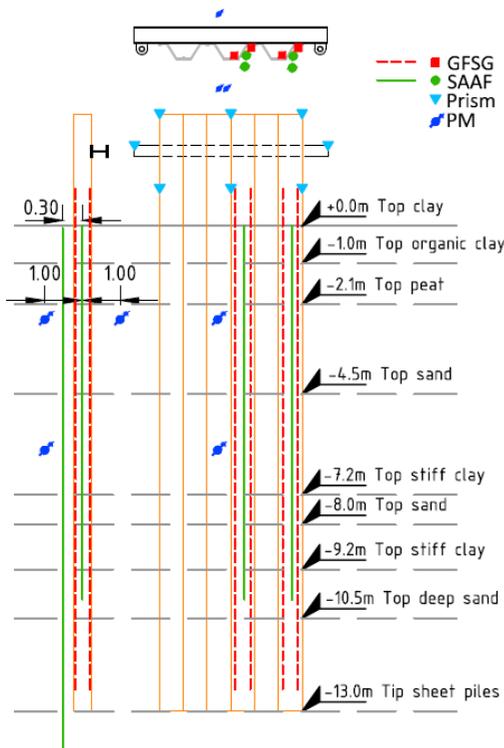
Figure 5. Top, front and side view of instrumented AZ26 sheet pile panel.

To monitor the horizontal displacements of the sheet pile, prisms are placed at three levels on the sheet pile and are monitored with total stations. Two SAAF's (Shape Accel Array Field) are

installed on the sheet pile wall and two SAAF's in the ground at 0.3m in front of the wall center-line to monitor the deflection and horizontal displacements over depth. The total pulling force applied by the hydraulic jack is measured by a force gauge and the stroke of the hydraulic jack is measured by an optical sensor. On the sheet pile wall glass fiber strain gauges (GFSG) are installed.

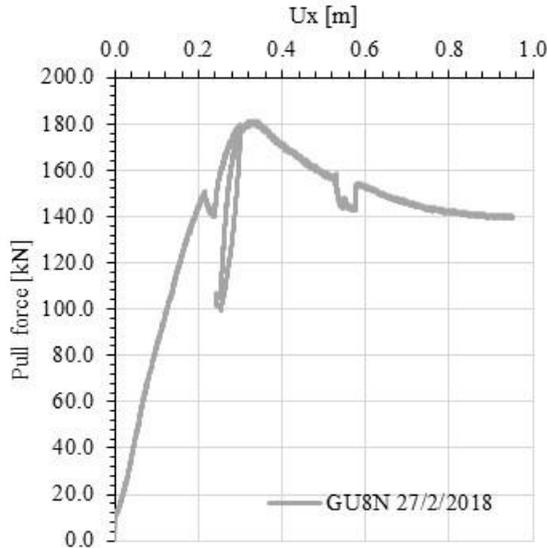
Figure 6. Force-displacement diagram GU8N.
GU8N 2018-02-27 12:47:00

The maximum pulling force reached during this test is 180kN. The fixation level where rotation starts is about -2.0m NAP. Upon reaching 30cm of displacement the SAAF's on the sheet pile wall are removed to prevent any damage due to local buckling of the sheet pile. For this the pull-force is temporary lowered to 100kN. A similar procedure is also followed for the other tests. The obtained force-displacement diagram for the GU8N is shown in figure 6. In figure 7 the horizontal displacements measured by the SAAF and prisms are plotted just before removal of the SAAF. In this figure the SAAF's in front of the wall are also shown with an offset of 1m, in reality they are placed at 0.3m distance of the center-line of the sheet pile wall.

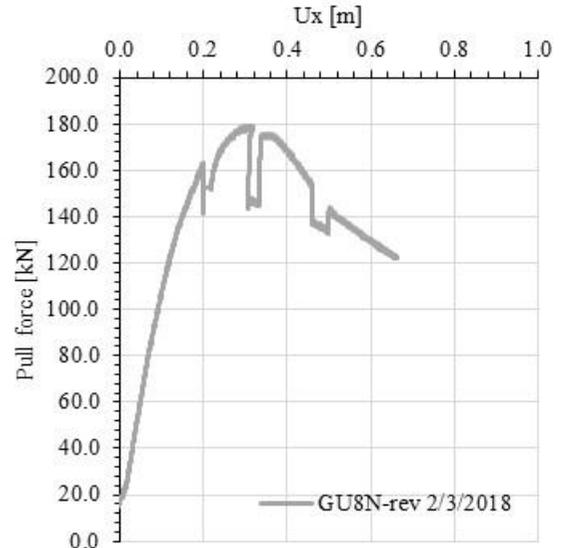
Figure 8. Force-displacement diagram GU8N-rev
GU8Nrev 2018-03-02 13:53:00

Figure 8 shows the maximum pull-force is almost 180kN, which is approximately the same as the GU8N triple-U profile. The reduction in pull-force after reaching the peak is however significantly larger compared with the GU8N triple-U profile. Figure 9 shows the deformations of the GU8N-rev triple-U profile and the layout is similar to figure 7

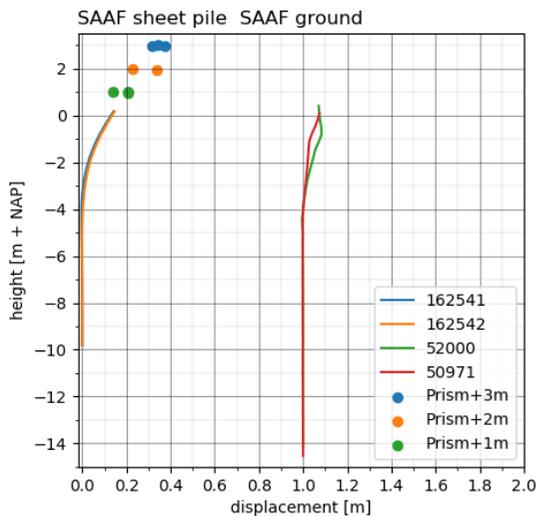
Figure 7. Horizontal displacements over depth of the SAAF and prisms at the GU8N sheet pile.

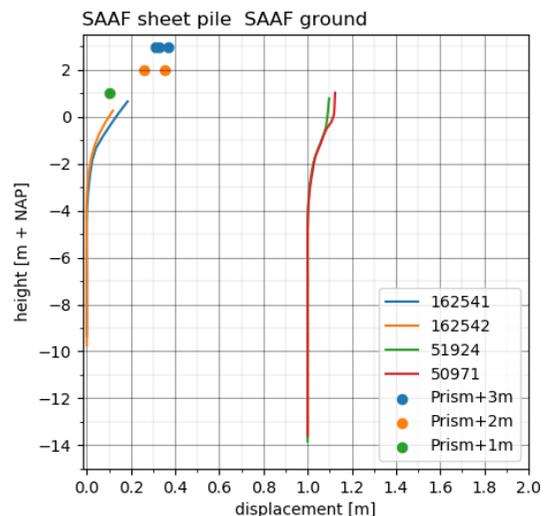
Figure 9. Horizontal displacements over depth of the SAAF and prisms at the GU8N-rev sheet pile.

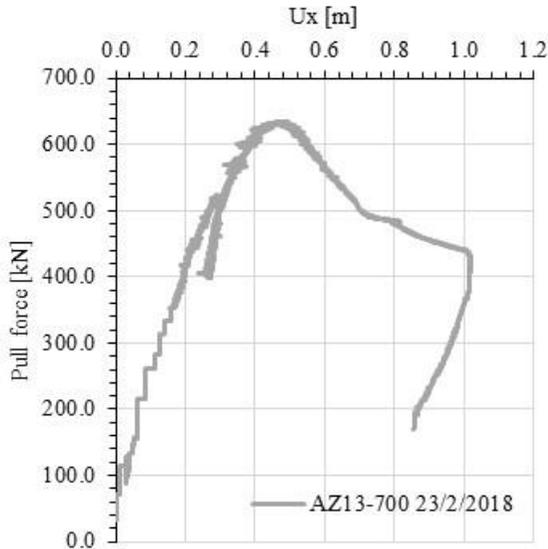
Figure 10. Force-displacement diagram AZ13-700
AZ13-700 2018-02-23 14:04:00

triple-U, the maximum pulling force is also higher at 634kN (figure 10). The AZ13-700 three double-Z profile is stiffer than the GU8N profile. This is also reflected in horizontal displacements (figure 11). The fixation level where rotation starts is about -4.0m NAP due to the higher stiffness.

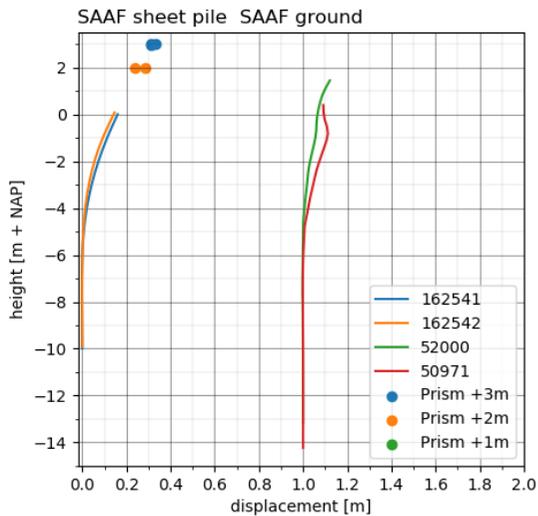
Figure 11. Horizontal displacements over depth of the SAAF and prisms at the AZ13-700 sheet pile

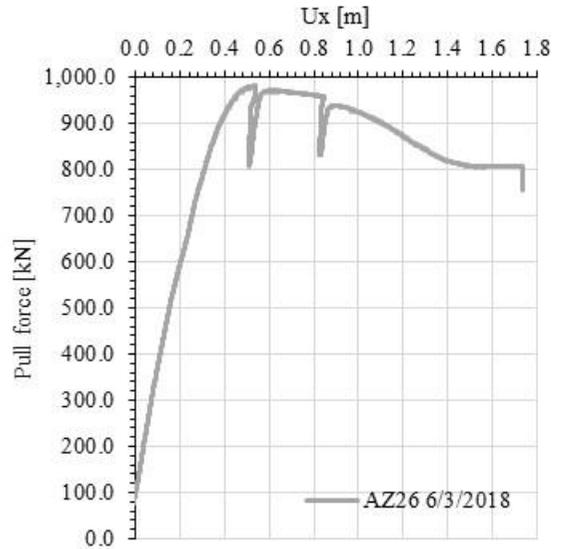
Figure 12. Force-displacement diagram AZ26
AZ26 2018-03-06 12:34:00

The AZ26 three double-Z is the strongest profile that has been tested as part of the pullover test program, a maximum pull-force of 982kN is reached. The fixation level where rotation starts

is about -6.0m NAP due to the high stiffness. The results in figure 12 also show that after reaching the maximum pull-force this profile allows for large additional displacements with little reduction of the pulling force relative to the other tested profiles. This setup of three double heavier profiles represents also the typical configuration

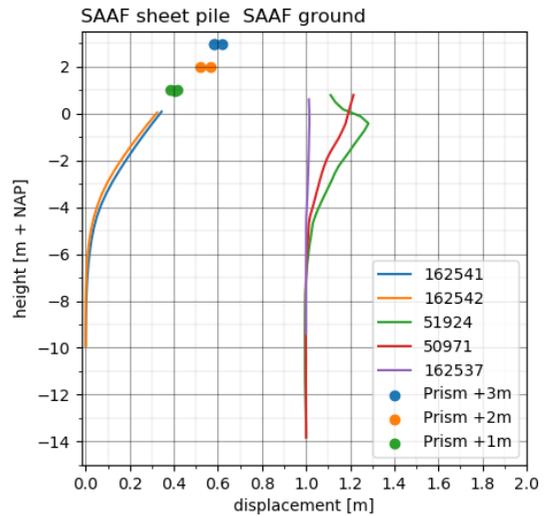
Figure 13. Horizontal displacements over depth of the SAAF and prisms at the AZ26 sheet pile.

Figure 13 shows the deformations of the AZ26 three double-Z-profile. The larger horizontal displacements relate to the deeper point of rotation, compared to the other profiles. In addition, one SAAF is placed at 5m distance of the sheet pile wall to measure the displacements of the soil on a larger distance.

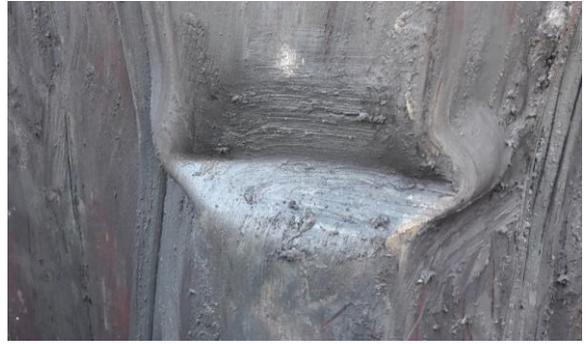
Figure 14. Excavated GU8N-rev with local buckling

After performing the pullover tests the sheet piles have been excavated to investigate the failure mechanism. Figure 14 shows as example the buckled compression flange of the GU8N-rev triple-U.

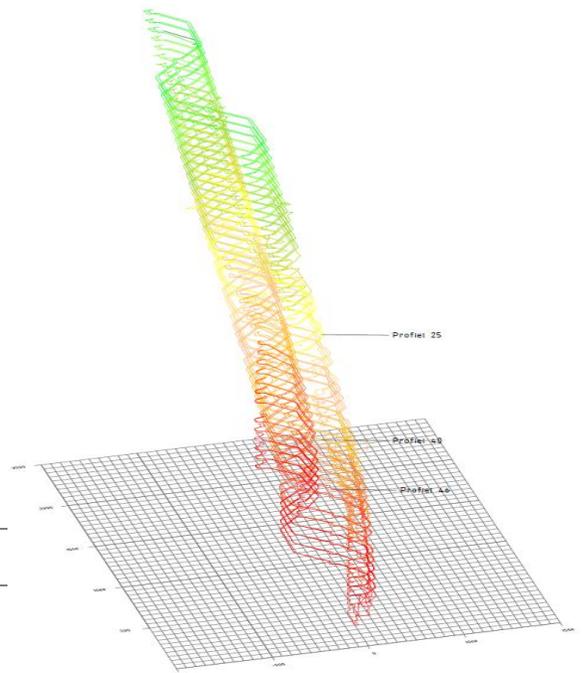
Figure 15. 3D scan of deformed GU8N-rev

In addition to the visual inspection of the excavated sheet piles 3D scans have been made to record the deformed shape of the entire profile, see Figure 15. Based on the 3D-scans it is observed that the buckling and plasticity is limited to approximately 0.5m height. The shape of the rest of the profile did not change significantly.

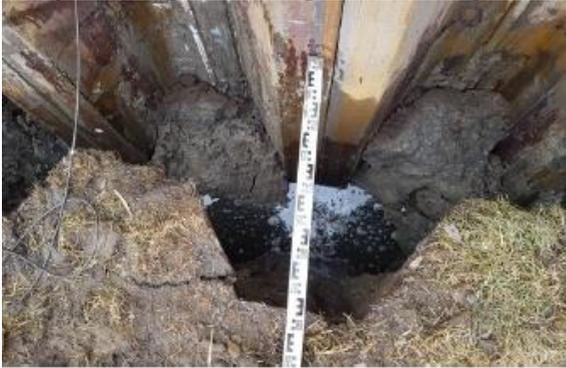
Figure 16. Gapping behind sheet pile wall AZ26

During the pullover test the sheet piles are pulled forward resulting in a gap at the back of the sheet pile wall. Due to the undrained behavior of the cohesive soil the soil remains almost perfectly vertical and the water level in this gap drops significantly below the original water table effectively reducing the loading on the sheet pile.
