Morphodynamic trends of the Ribb River, Ethiopia, prior to dam construction

Mulatu, Chalachew A.; Crosato, Alessandra; Moges, Michael M.; Langendoen, Eddy J.; McClain, Michael

Geosciences (Switzerland)

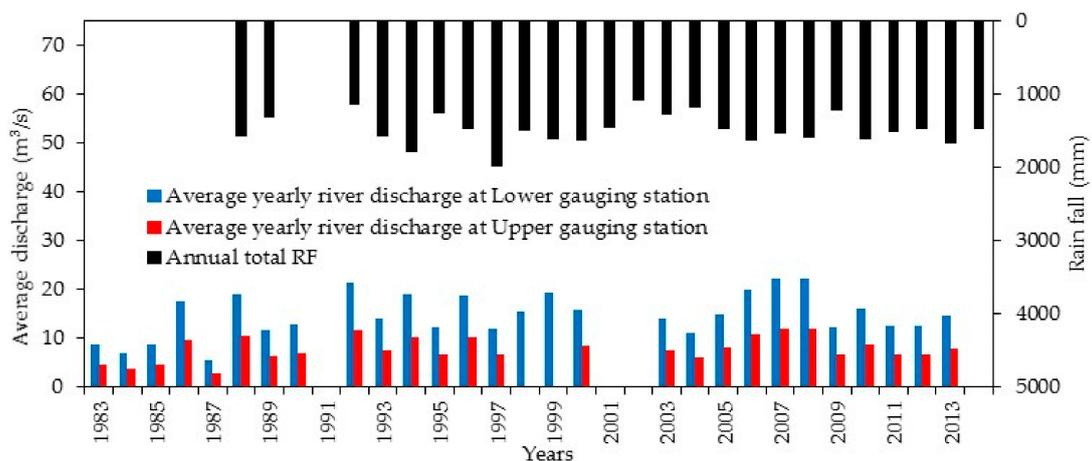
Figure 2. Yearly rainfall from the year 1988 to 2014 and average Ribb River discharges from the year 1983 to 2013 for the Lower and Upper gauging stations. The graph does not show any increasing or decreasing trends. Data source: National Meteorological Agency and Ministry of Water, Irrigation and Energy, Ethiopia.

The average annual maximum temperature in the upper part of the Ribb River basin is 27 °C, while the minimum falls below 0 °C in December (Debre Tabor meteorological station). The temperature increases near Lake Tana, where the average annual maximum and minimum values become 35 and 11 °C, respectively (Addis Zemen meteorological station). The Ribb River flow depends mainly on rainfall. The catchment receives a yearly rainfall of 1300 mm (data from the period 1988–2015), of which 80% occurs between the months of June and September. The annual rainfall at Debre Tabor meteorological station, assumed here representative for the Ribb basin, does not show any increasing or decreasing trends in the last three decades (Figure 2), although there are considerable

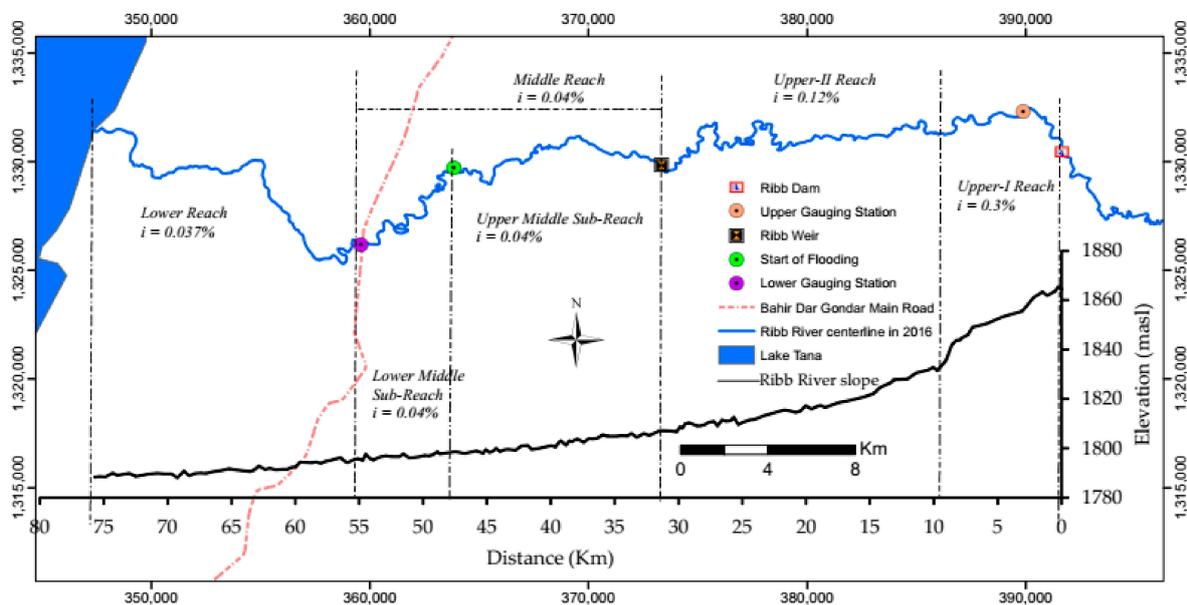
Figure 3. Ribb River study reach, sub-reaches and riverbed profile from the dam site to Lake Tana. The river alignment is derived from Google Earth images of 2016. The slope is obtained from 30 m resolution Digital Elevation Models (DEM) of Advanced Spaceborne Thermal Emission and Reflection Radiometer (ASTER) satellite images of 2014.

The study river reach has a length of 77 km, starting at the Ribb Dam site to Lake Tana. This reach is here sub-divided into four parts: Upper-I, Upper-II, Middle and Lower reaches (Figure 3). The presence of riverbed fixation (rock outcrops and weir), the junction of major tributaries, the longitudinal slope, the channel width and the presence of anthropogenic interventions (sand mining, embankment construction and water extraction) are the basis of this sub-division.

The Middle reach (sub-divided in Upper Middle and Lower Middle) is 25 km long, from the weir site to the Ribb Bridge (Figure 3). The reach is sub-divided based on the existence of embankments for flood protection. The Upper Middle sub-reach is 15 km long and extends from the weir site to the start of the embankment, while the Lower Middle sub-reach forms the remaining 10 km where embankments are present. This part of the reach experiences flooding due to reduced channel conveyance capacity [23]. The Middle reaches have a relatively gentle slope of 0.04% and a sandy bed.

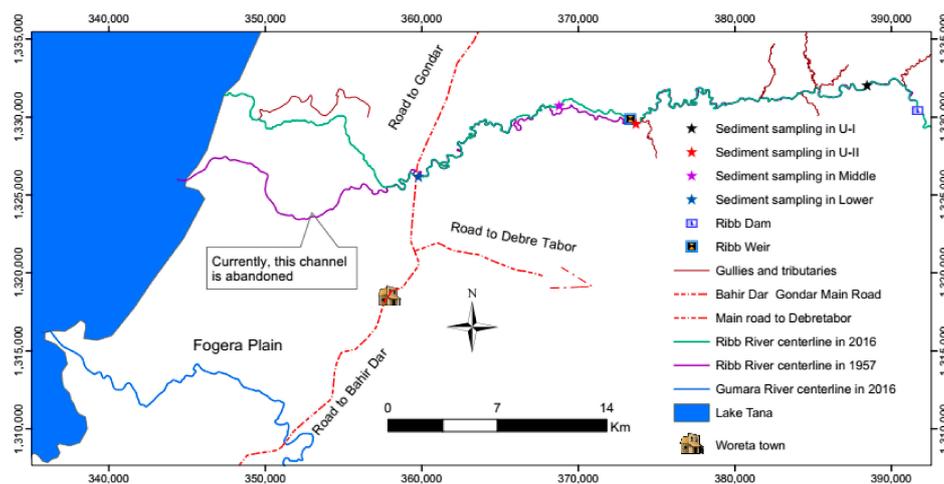
Figure 4. Ribb River alignments in 1957 and 2016 including gullies and tributaries and sediment sampling locations. The area between Lake Tana and the road to Gondar and Bahir Dar is part of the Fogera Plain, which is shared by the Ribb and the Gumara rivers.

The Lower reach is 20 km long, from the Ribb Bridge to Lake Tana. In the past, the river used to bifurcate 4 km downstream of the bridge (Figure 4). Since 2008, the old left channel has been completely silted up and serves as a dry-weather road. During flow peaks, however, the silted channel still conveys a small part of the flow to Lake Tana. Further downstream, the river loses its channel for a distance of 3.5 km (i.e., from 70.2 to 73.7 km from the Ribb Dam). Here, high-flow water spreads over the floodplain until it finds a well-defined channel again near a locality called Boled Gote. Farmers plant maize in the shallow river channel during the dry season, taking advantage of residual moisture (Figure 5). The river banks in the Middle and Lower reaches are made of compacted clay and silt materials.

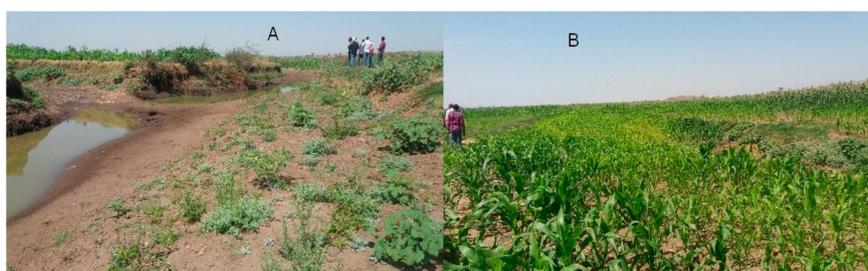
Figure 5. Lower Ribb River reach. (A) the point where the river loses its channel; (B) maize plantation using residual moisture along the river channel downstream of location A.

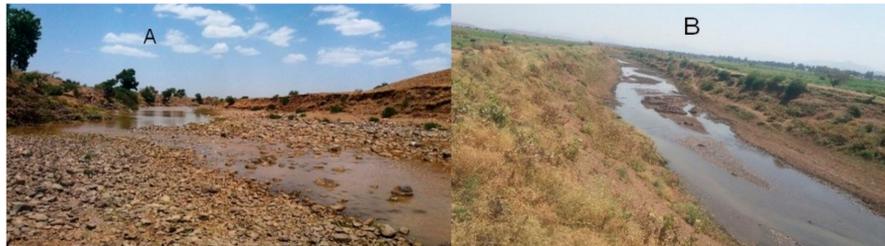
Figure 6. River bed and bank material in the Upper-I (A) and the Lower Middle (B) River reaches (March 2016).

The Ribb River channel has a meandering planform with sporadic central bars in the Upper-I reach where the channel is wider. Point bars inside river bends and alternate bars are observed in the Upper-II, Middle and Lower River reaches. Figure 6 shows the riverbed and banks in the Upper-I reach and Lower Middle sub-reach.

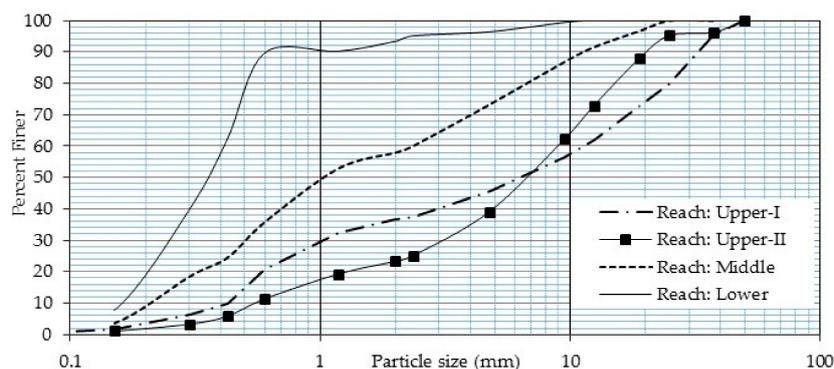
Figure 7. Grain size distribution of Ribb River bed material downstream of the Ribb Dam site, upstream and downstream of the weir site and upstream of the Ribb Bridge, at Universal Transverse Mercator (UTM) coordinates 37P 0388475, 1332080, 1872 m a.s.l.; 37P 0373692, 1329576, 1819 m a.s.l.; 37P 0368803, 1330762, 1804 m a.s.l. and 37P 0359808, 1326196, 1795 m a.s.l., respectively (Samples were collected in March 2016).

The granulometric curves of the bed material (Figure 7) show that the Ribb River sediment becomes finer in the downstream direction [13,24].

The riverbed near the dam site is dominated by a mixture of gravel (65%) and sand (35%). The bed material gradually changes to sand near the weir site (60% sand and 40% gravel). Further downstream, the riverbed is composed of 90% sand. The median grain size, D_{50} , is 7 mm in the Upper I and Upper II reaches and decreases to 0.65 mm in the Middle (the Upper and the Lower) reaches and 0.35 mm in the Lower reaches. Historical data on sediment grain size are lacking and this does not allow for assessing their temporal evolution.

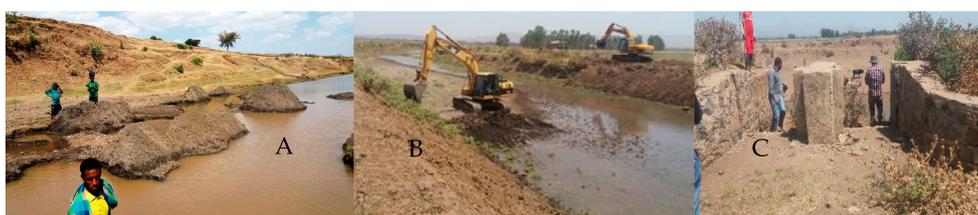
Figure 8. (A) excavated sand accumulation by sand miners in the Middle River reach; (B) river channel enlargement and deepening to increase flow conveyance. The contractor used the material for embankment construction at the Lower reach; (C) flood outlet structure to the farmlands as low height weir (April 2016).

The Ribb River has been subject to long years of sand mining (Figure 8A) and water extraction for irrigation during the dry season (Figure 9A). The prolonged sand mining activity in the Middle and Lower River reaches has clearly affected the natural riverbed topography. Sand miners extract sand from bar tops during low flow conditions, altering the shape and height of sand bars, as well as the sediment balance of the river. This activity has steadily increased in the last 30 years.

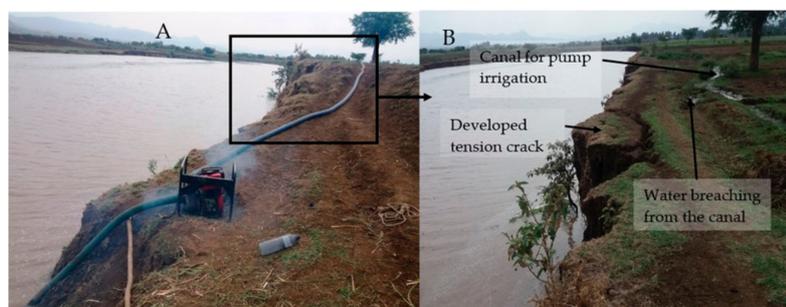
Figure 9. (A) water extraction with a diesel pump for irrigation; (B) irrigation canal to transport extracted water, which has been breached, and adjacent failing banks. The photos were taken immediately upstream of the under-construction Ribb weir in April 2017.

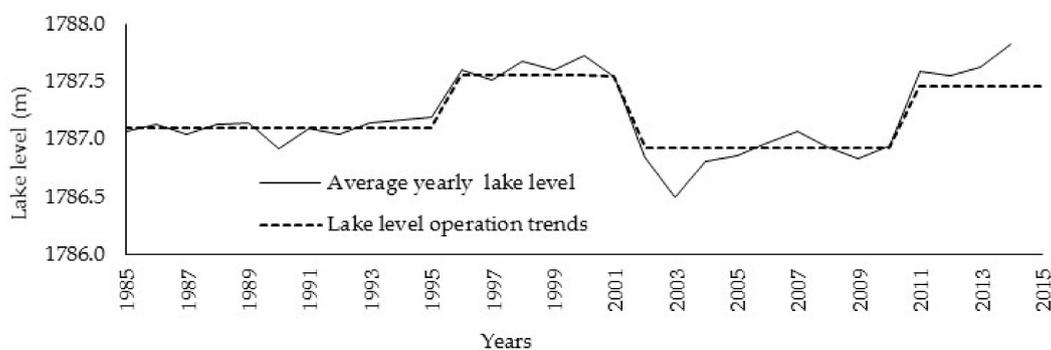
Figure 10. Mean annual Lake Tana level since 1985 (data source: Ministry of Water, Irrigation and Energy, Ethiopia).

The Ribb River debouches in Lake Tana, which had a regulated level for hydropower production since 1995. It shows three distinct operation periods: (1) a rise by 45 cm in the period 1995–2001, (2) a drop by 53 cm in the period 2001–2010, and (3) a rise by 62 cm in the period 2010–2015 (Figure 10). Increased flooding and the recent channel avulsion of 2008 have been often attributed to past lake level regulation.

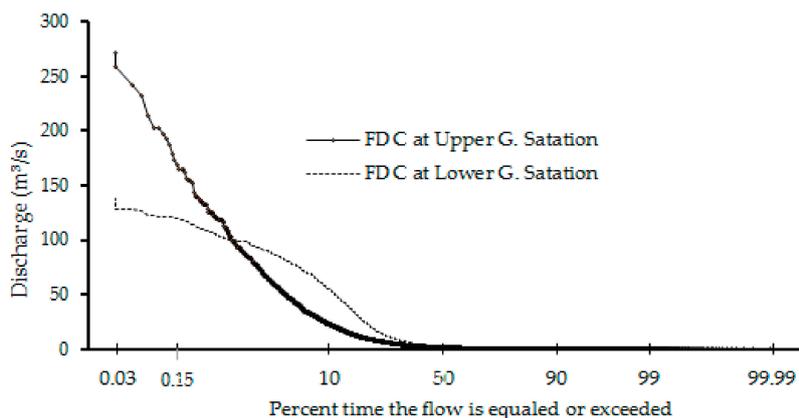
Figure 11. Flow duration curves at the Lower and Upper gauging stations (data source: Ministry of Water, Irrigation and Energy).

The FDCs derived for the gauging stations are shown in Figure 11. It is evident that the peak discharge at the Upper gauging station is substantially greater than the one at the Lower gauging station. This is likely due to overbank flow reducing the discharge exceeding the bankfull by as much as 71% at the Lower gauging station [21].

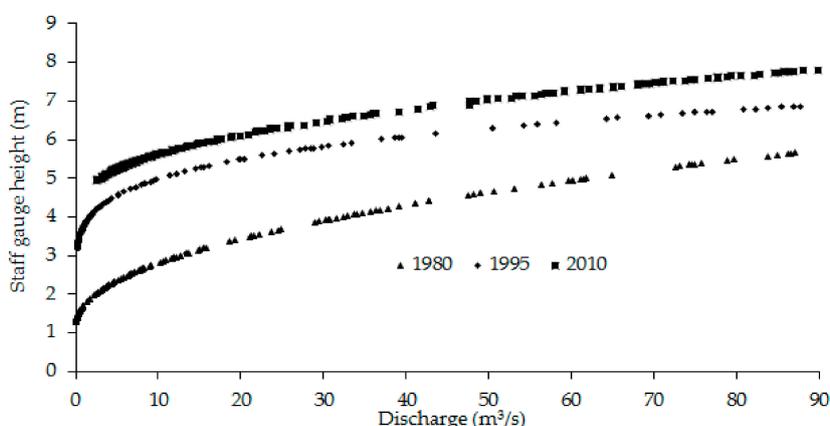
Figure 12. Ribb River staff level at the Lower gauging station with corresponding discharges (Data source: Ministry of Water, Irrigation and Energy, Ethiopia).

The time-series of daily water levels at the Lower gauging station shows that the riverbed rose by 2.2 m ($14.7 \text{ cm}/\text{year}$) and 0.7 m ($4.4 \text{ cm}/\text{year}$) between 1980 and 1995 and between 1995 and 2010, respectively, which is 2.9 m in 30 years (1980 to 2010) (Figure 12). Similarly, the nearby Gumara River bed rose by 2.91 m ($6.3 \text{ cm}/\text{year}$) between 1963 and 2009 [18]. The adjacent Megech River to the north has similarly experienced sedimentation of the old channel downstream of a bifurcation since 1998 [23]. This means that sedimentation is observed in practically all rivers debouching in the Lake Tana from the Fogera plain.

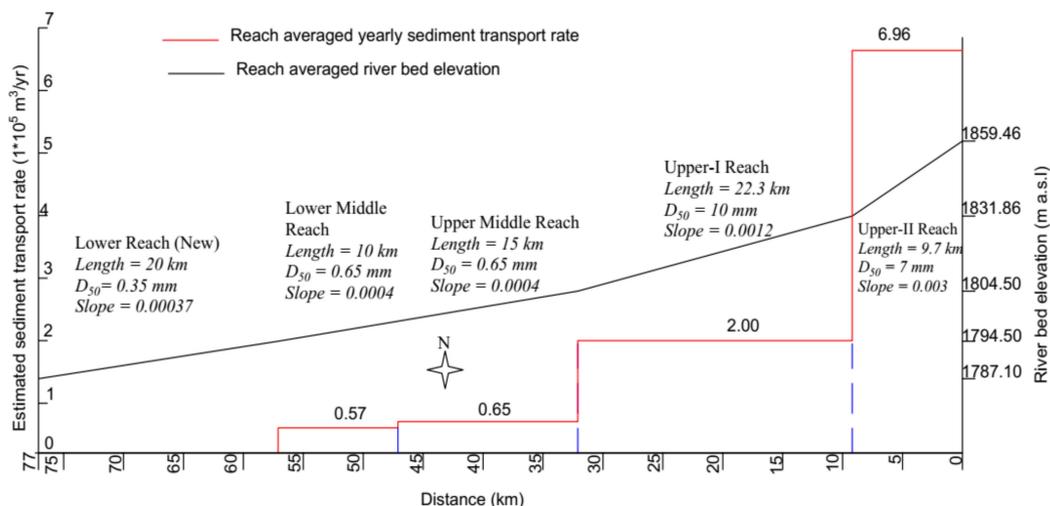
Figure 13. Sedimentation trend along the Ribb River based on estimated sediment transport rates. Distance of 0 km corresponds for dam site while 77 km is Lake Tana.

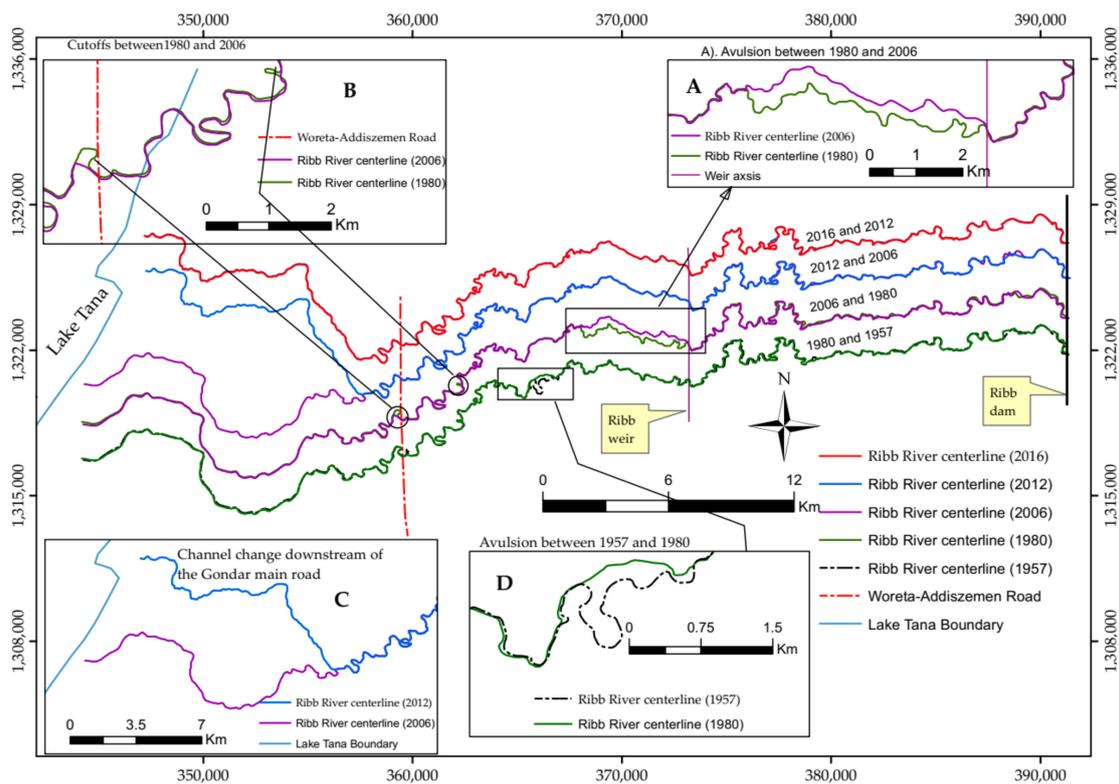
Figure 14. Successive Ribb River centerlines. (A) avulsion developed between the years 1980 and 2006; (B) cut-off developed between the years 1980 and 2006; (C) complete channel change between the years 2006 and 2012; (D) cut-off developed between the years 1957 and 1980.

The river reach-scale characteristics in 1957, 1980, 2006, 2012 and 2016 are presented in Table 2, where negative values for sinuosity changes indicate length reduction. The river planform changes caused by bank retreat, cut-off formation, channel avulsion, and complete channel blockage between 1957 and 2016 are shown in Figure 14.

The analysis of aerial photographs and satellite images shows that the study reach of the Ribb River reduced its length from 81 to 77 km since 1957. In the Upper-I and Upper-II reaches, the river has experienced only little planform changes, with -4.08% and 11.28% sinuosity changes resulting in 0.2 km length reduction and 1.5 km length increment between 1957 and 2016, respectively. The rocky nature of the channel bed and banks in the Upper-I reach controls channel shape and width. The Middle reach reduced in length by 2.4 km, resulting in a sinuosity reduction of 16.9%. This was due to a channel avulsion event (Figure 14A) and a cut-off (Figure 14B), which occurred in the period 1980–2006. Another cut-off event (Figure 14D) occurred in the period 1957–1980. The small avulsion in Figure 14A reduced

the channel length from 7.4 to 6.3 km and the sinuosity from 1.41 to 1.20, while the cut-off in Figure 14D reduced the river channel length from 3.0 to 1.4 km and the local sinuosity from 2.51 to 1.11. Generally, channel cut-offs and avulsions immediately increase the energy slope and the bed shear stress and may coarsen the riverbed materials [42]. However, in the absence of further changes, the channel tends to restore its characteristics (slope, width, etc.) as before the shortening, with channel incision as a result. Embankments have been built in the Lower Middle sub-reach to reduce flooding. These embankments have also drastically reduced local channel migration. In the Lower reach, the channel experienced sedimentation, which resulted in complete river channel blockage starting 4 km downstream of the bridge in 2008 followed by channel avulsion (Figure 14C). The length of the new river channel is 2.6 km larger than that of the old river reach, but has similar sinuosity (Table 2).

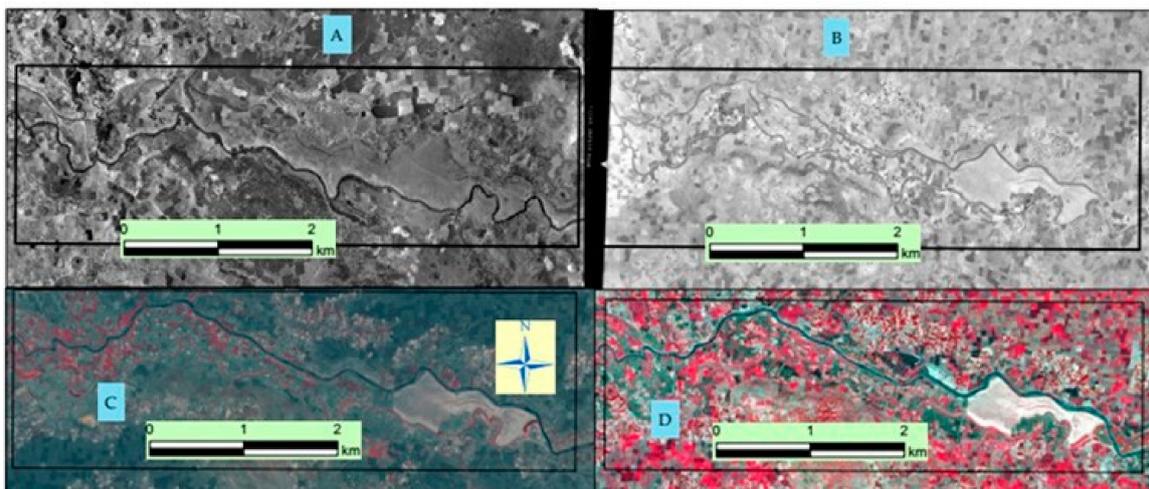
Figure 15. Aerial photographs and SPOT satellite images of the Middle river section downstream of the weir. (A,B) aerial photograph and river pattern of the year 1957 and 1980, respectively, and (C,D) SPOT satellite image and river pattern of the year 2006 and 2012, respectively.

The temporal river planform changes occurred in the Middle reach in the period between 1980 and 2006 are shown using the aerial photographs 1957 and 1980 and the SPOT satellite images 2006 and 2016 (Figure 15).
