Cathodic protection of steel in concrete – experience and overview of 30 years application

Abstract. This paper presents an overview of 30 years' experience with cathodic protection of steel in concrete in The Netherlands. Principles and practical aspects of CP and its design and installation are presented. Three phases have passed from the late 1980s until present: pioneering, development and maturity. In the first period CP was mainly applied to precast elements corroding due to mixed-in chlorides. The parties involved worked together to draw up a Technical Guideline. In the second period, application to bridges came up, including post-tensioned structures, which was then innovative. Furthermore, galvanic anode systems were introduced. In the third period, CP became a fully accepted method of securing durability and safety. Renewed collaboration led to a database that allowed analysis of various aspects of CP system working life, including shortcomings in early systems. Major successes and lessons learned will be presented. Technical and non-technical developments are highlighted and some recent innovative CP components and systems are discussed.

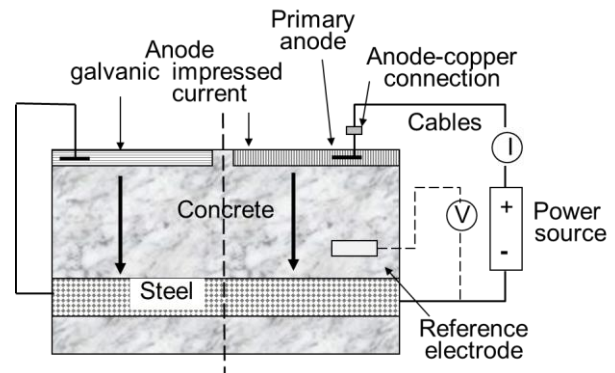
Fig. 1. Main components of galvanic (left) and impressed current (right) CP systems.

Two basic types of CP systems exist: impressed current CP (ICCP) and galvanic or sacrificial CP (GCP). The main components for both are illustrated in Figure 1.

With ICCP a low voltage DC power source causes the current to flow. The anode consists of a material that is not or only slowly consumed, such as activated titanium (whose surface is covered with noble metal oxides, Mixed Metal Oxide or MMO) or a conductive coating. Activated titanium has the shape of a mesh embedded in a cementitious overlay installed on the concrete surface; or of strips in boreholes in the cross section or in slots cut in the concrete surface; holes and slots are filled with cementitious grout. Conductive coatings are carbon filled polymers applied to the concrete surface, usually covered with a top coat. Primary anodes are metal wires used to feed the current into the actual anode material; they should be separated closely enough to avoid large potential drops in the metallic circuit. Cementitious overlays and conductive coatings should be durably bonded to the concrete surface to ensure electrical contact. Obtaining good bond requires adequate surface preparation; proper application and curing are critical. Power source and anode are metallically connected by isolated copper cables and anode-cable connections. Cable cross sections should be large enough to limit potential drops. Cables need to be redundant in order to avoid system failure due to cable interruptions (e.g. by vandalism); at least two cables should feed both anodes and cathodes, with their connections as far apart as possible within a zone. Power sources are fed from the grid or by solar or wind energy, backed up by batteries.

In GCP systems the power stems from the electrochemical potential difference between the anode material and the steel. Corrosion of the sacrificial material, usually zinc, provides the current according to

A GCP system can be built up of zinc sheet with an appropriate activator and a conductive adhesive on the concrete surface; or by embedding zinc probes with an activator inside cavities or boreholes in the cross section. Activators are needed to keep the zinc corroding; they are proprietary formulations based on alkalinity, complexing agents or halides. Zinc anodes are connected to the reinforcement by metallic wires.

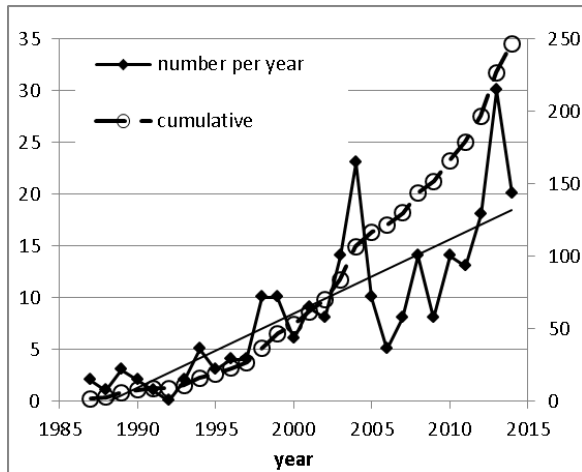
Fig.2. Number of CP systems installed in The Netherlands per year (left Y-axis), cumulative number (right Y-axis) and trend line for number per year.

In early 2015 the database on CP systems was updated. An overview is presented here. By the end of 2014, a total of 230 structures had CP with some multiple systems installed, counting a total of 250 CP systems. Figure 2 presents annual and cumulative numbers. They comprised 105 buildings, 97 bridges and 44 other structures. From the total, 103 had conductive coating anodes, 57 titanium and 58 galvanic anodes (29 had
