# Cathodic protection of steel in concrete – experience and overview of 30 years application

**Abstract.** This paper presents an overview of 30 years' experience with cathodic protection of steel in concrete in The Netherlands. Principles and practical aspects of CP and its design and installation are presented. Three phases have passed from the late 1980s until present: pioneering, development and maturity. In the first period CP was mainly applied to precast elements corroding due to mixed-in chlorides. The parties involved worked together to draw up a Technical Guideline. In the second period, application to bridges came up, including post-tensioned structures, which was then innovative. Furthermore, galvanic anode systems were introduced. In the third period, CP became a fully accepted method of securing durability and safety. Renewed collaboration led to a database that allowed analysis of various aspects of CP system working life, including shortcomings in early systems. Major successes and lessons learned will be presented. Technical and non-technical developments are highlighted and some recent innovative CP components and systems are discussed.

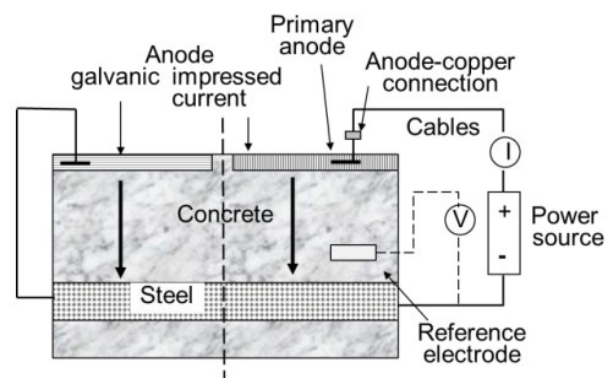
**Fig. 1.** Main components of galvanic (left) and impressed current (right) CP systems.

Two basic types of CP systems exist: impressed current CP (ICCP) and galvanic or sacrificial CP (GCP). The main components for both are illustrated in Figure 1. With ICCP a low voltage DC power source causes the current to flow. The anode consists of a material that is not or only slowly consumed, such as activated titanium (whose surface is covered with noble metal oxides, Mixed Metal Oxide or MMO) or a conductive coating. Activated titanium has the shape of a mesh embedded in a cementitious overlay installed on the concrete surface; or of strips in boreholes in the cross section or in slots cut in the concrete surface; holes and slots are filled with cementitious grout. Conductive coatings are carbon filled polymers applied to the concrete surface, usually covered with a top coat. Primary anodes are metal wires used to feed the current into the actual anode material; they should be separated closely enough to avoid large potential drops in the metallic circuit. Cementitious overlays and conductive coatings should be durably bonded to the concrete surface to ensure electrical contact. Obtaining good bond requires adequate surface preparation; proper application and curing are critical. Power source and anode are metallically connected by isolated copper cables and anode-cable connections. Cable cross sections should be large enough to limit potential drops. Cables need to be redundant in order to avoid system failure due to cable interruptions (e.g. by vandalism); at least two cables should feed both anodes and cathodes, with their connections as far apart as possible within a zone. Power sources are fed from the grid or by solar or wind energy, backed up by batteries.

In GCP systems the power stems from the electrochemical potential difference between the anode material and the steel. Corrosion of the sacrificial material, usually zinc, provides the current according to

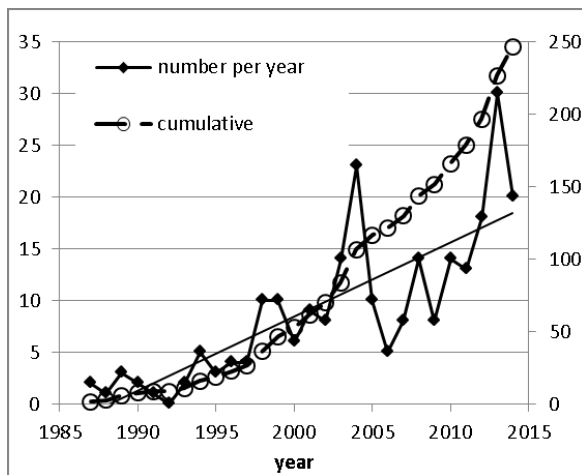
**Fig.2.** Number of CP systems installed in The Netherlands per year (left Y-axis), cumulative number (right Y-axis) and trend line for number per year.

total of 230 structures had CP with some multiple systems installed, counting a total of 250 CP systems. Figure 2 presents annual and cumulative numbers. They comprised 105 buildings, 97 bridges and 44 other structures. From the total, 103 had conductive coating anodes, 57 titanium and 58 galvanic anodes (29 had other anodes or two types). Owners were The Ministry of Infrastructure (65 systems), lower governments (41) housing companies (48), private collective building owners (24) and other owners (69). Increasing numbers of projects involved protecting corroding bridge abutments, preventive applications and systems with ground bed anodes; some are illustrated in more detail below.
