Cathodic protection of steel in concrete – experience and overview of 30 years application

Rob Polder^{1,2,*}, Willy Peelen³

Abstract. This paper presents an overview of 30 years' experience with cathodic protection of steel in concrete in The Netherlands. Principles and practical aspects of CP and its design and installation are presented. Three phases have passed from the late 1980s until present: pioneering, development and maturity. In the first period CP was mainly applied to precast elements corroding due to mixed-in chlorides. The parties involved worked together to draw up a Technical Guideline. In the second period, application to bridges came up, including post-tensioned structures, which was then innovative. Furthermore, galvanic anode systems were introduced. In the third period, CP became a fully accepted method of securing durability and safety. Renewed collaboration led to a database that allowed analysis of various aspects of CP system working life, including shortcomings in early systems. Major successes and lessons learned will be presented. Technical and non-technical developments are highlighted and some recent innovative CP components and systems are discusse

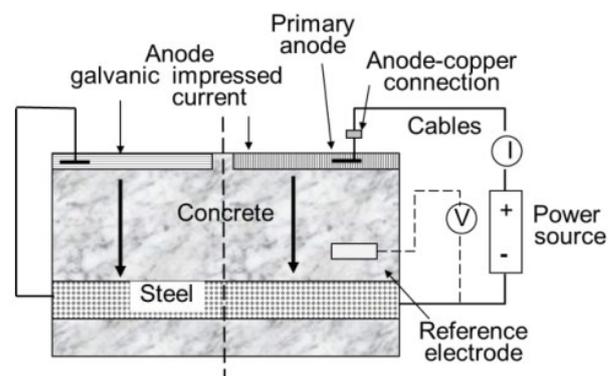
Fig. 1. Main components of galvanic (left) and impressed current (right) CP systems.

Two basic types of CP systems exist: impressed current CP (ICCP) and galvanic or sacrificial CP (GCP). The main components for both are illustrated in Figure 1. With ICCP a low voltage DC power source causes the current to flow. The anode consists of a material that is not or only slowly consumed, such as activated titanium (whose surface is covered with noble metal oxides, Mixed Metal Oxide or MMO) or a conductive coating. Activated titanium has the shape of a mesh embedded in a cementitious overlay installed on the concrete surface; or of strips in boreholes in the cross section or in slots cut in the concrete surface; holes and slots are filled with cementitious grout. Conductive coatings are carbon filled polymers applied to the concrete surface, usually covered with a top coat. Primary anodes are metal wires used to feed the current into the actual anode material; they should be separated closely enough to avoid large potential drops in the metallic circuit. Cementitious overlays and conductive coatings should be durably bonded to the concrete surface to ensure electrical contact. Obtaining good bond requires adequate surface preparation; proper application and curing are critical. Power source and anode are metallically connected by isolated copper cables and anode-cable connections. Cable cross sections should be large enough to limit potential drops. Cables need to be redundant in order to avoid system failure due to cable interruptions (e.g. by vandalism); at least two cables should feed both anodes and cathodes, with their connections as far apart as possible within a zone. Power sources are fed from the grid or by solar or wind energy, backed up by batteries.

In GCP systems the power stems from the electrochemical potential difference between the anode material and the steel. Corrosion of the sacrificial material, usually zinc, provides the current according to
