Journal of Flood Risk Management

# A pragmatic, performance-based approach to levee safety assessments

## Abstract

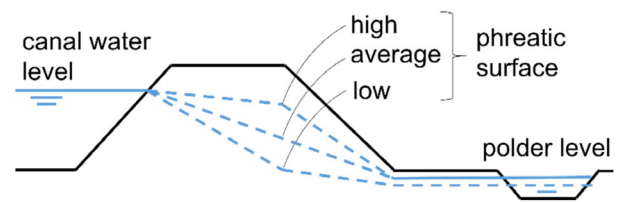
**FIGURE 1** Schematic representation of possible phreatic surface levels (high, average, and low)

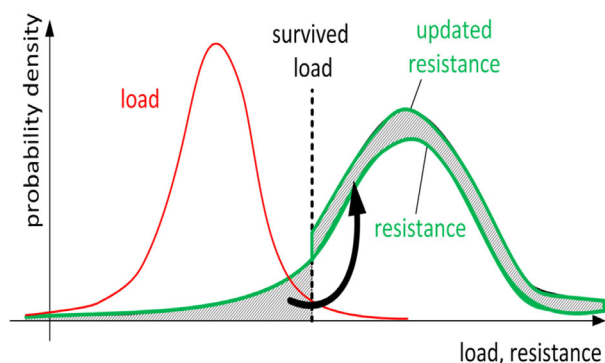
**FIGURE 2** The concept of “reliability updating,” where the probability density under the survived load is redistributed over the probability density above the survived load (Schweckendiek, 2014)

In which  $P(F|\epsilon)$  is the probability of failure, given observation  $\epsilon$ . This is illustrated in Figure 2: the failure probability is determined by the probability density of the load (in red) and the probability density of the resistance (in green). When the levee resistance is constant in time, a survived load (at dashed vertical black line) serves as evidence that the probability of failure for that load (and smaller loads) equals zero. The probability density under that load is then redistributed over the probability density above that survived load, reducing the levee’s overall failure probability.

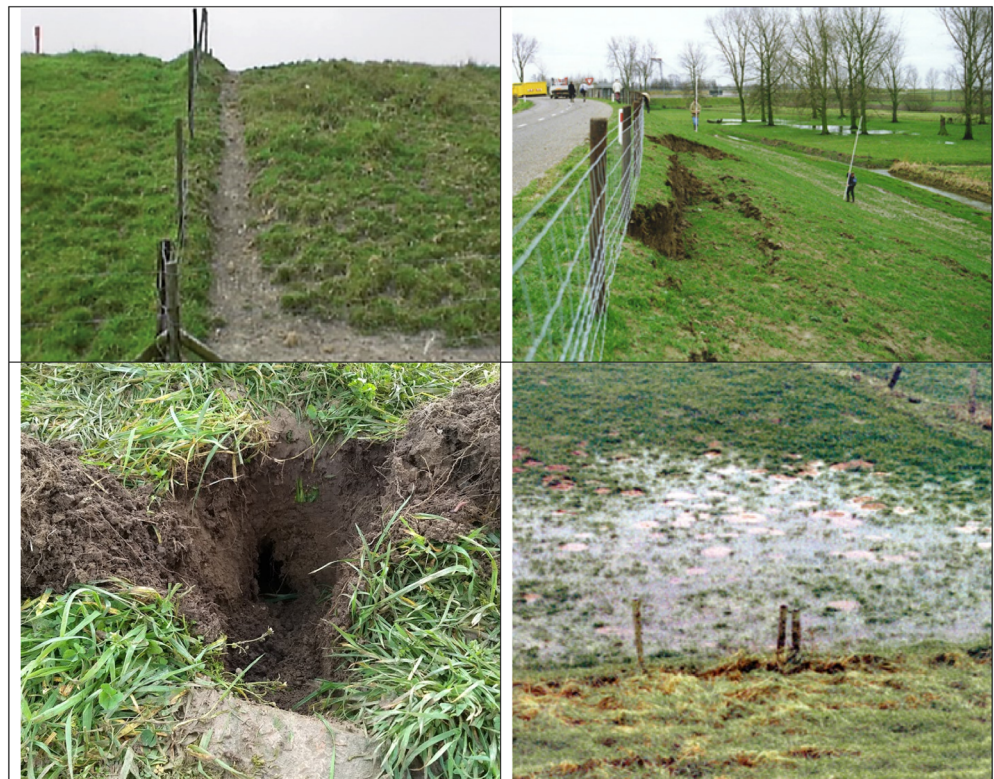
**FIGURE 3** Examples of performance indicators. Local subsidence due to trampling by livestock (upper left; picture from STOWA, 2018), severe subsidence (upper right; picture from STOWA, 2018), animal burrowing (lower left; picture taken by S.J.H. Rikkert, 2020), and wet spots at the levee toe (lower right; picture from STOWA, 2018)

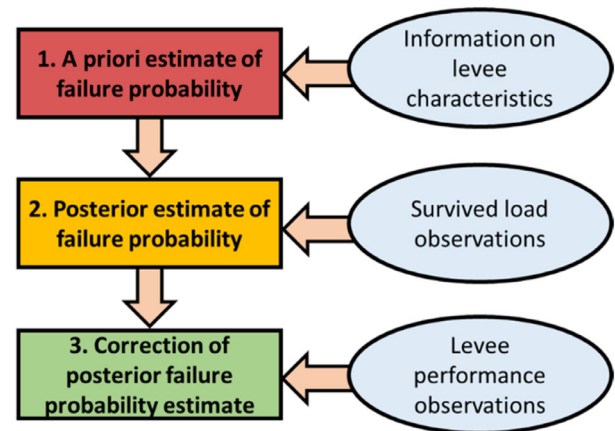
**FIGURE 4** Schematization of the proposed method to estimate the failure probability, utilizing information on levee performance under critical conditions and levee inspection results

Figure 4 shows a schematization of the proposed approach. The first step of this method is to estimate the failure probability, based on levee specific load and strength parameters. In the two following steps, this estimation is improved by including observed levee behavior.

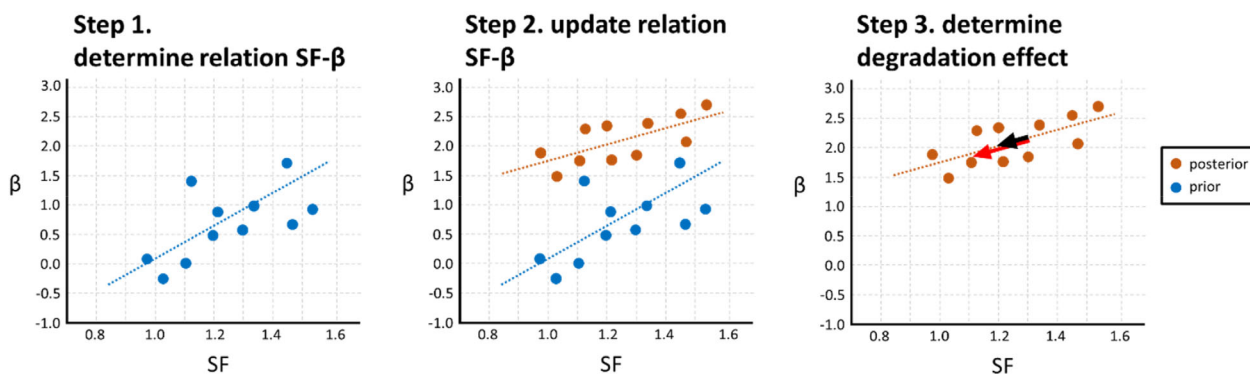
**FIGURE 5** The approach explained through three steps. Step 1: Relation between safety factor SF and reliability index  $\beta$  for one levee type, based on probabilistic stability assessments. Step 2: Updating the prior relation between safety factor SF and reliability index  $\beta$  for one levee type, based on observations of survived hydraulic loads, with the prior relation in blue and the relation after updating in orange. Step 3: The arrows indicates how different degrees of degradation (black: light degradation; red: severe degradation) affect the stability factor, and hence the reliability index, of one levee type is influenced by levee degradation. The arrows are indicative, and effects on the stability factor depend on levee characteristics and degradation type

2. Observations of performance of the levee under various loading conditions can be included, using the approach described in Section 2.2.1 on reliability updating. The initial relation found in step 1 can be improved, by fitting a line through the points after reliability updating, as is shown in (see step 2 in Figure 5).

3. The final step is to correct the posterior failure probability by including results of levee inspections in the form of levee performance indicators, in addition to the survived loads from the previous step. These levee performance indicators contain information about the actual condition of the levee, and they influence the stability factor, and hence the probability of failure. Ideally, the same approach as in step 2 would be used here: including the effects of a certain performance observation, based on Bayes theorem. However, in this study a more pragmatic approach was used to limit the processing time of the study. Besides, discretization of the load and resistance in reliability updating makes it difficult to take into account gradual degradation. Therefore, we assumed that the effect of an observation (e.g., animal burrows) on the stability factor can be expressed as a reduction factor that is dependent of the levee type, the performance indicator and the level of severeness (see step 3 in Figure 5).

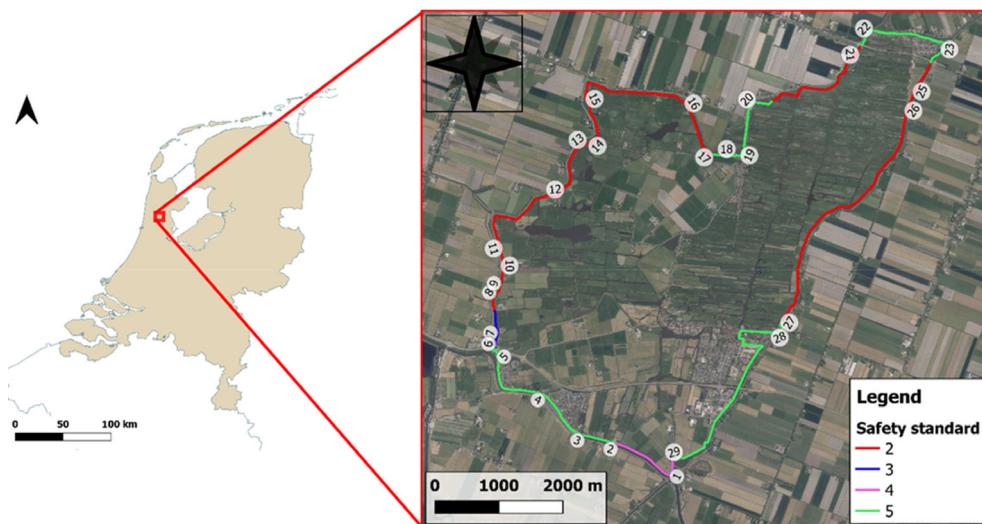
**FIGURE 6** Left: Map of the Netherlands, with the location of the Eilandspolder. Right: Overview of levees protecting the Eilandspolder, the distinction into separate, numbered, levee sections, and their assigned flood protection standard

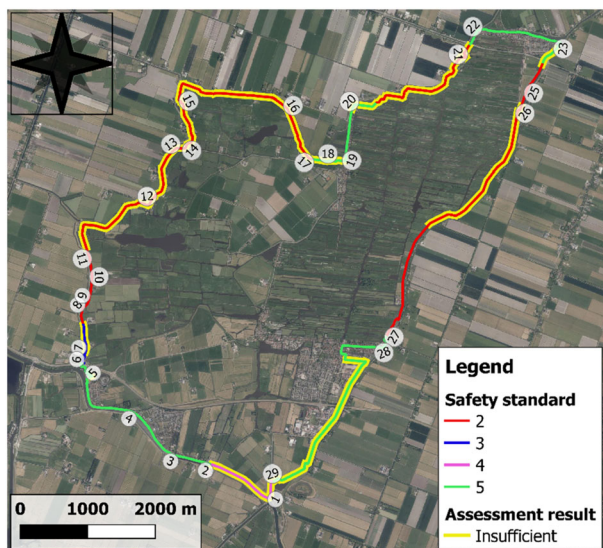
**FIGURE 7** Overview of levees that do not meet the required safety standard for the failure mechanism macro-instability

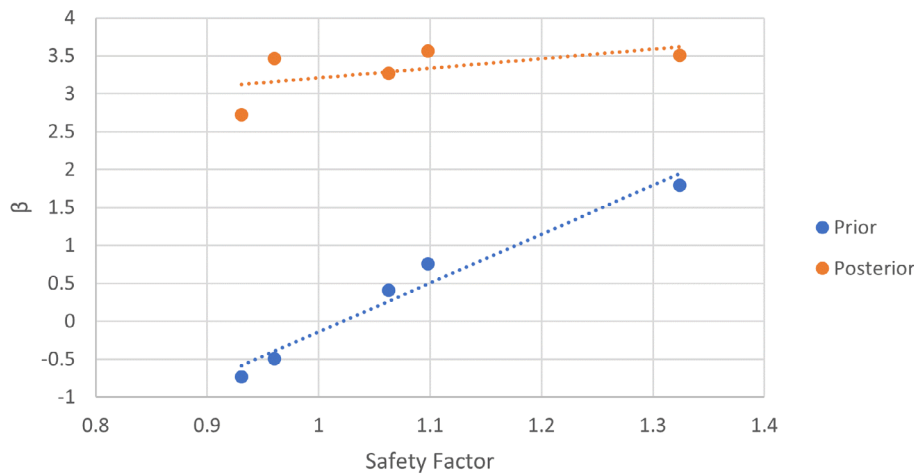
**FIGURE 8** Results of probabilistic stability assessment for a-priori (blue) calculations and after reliability updating (orange)

Figure 8 shows the results of the stability analysis before and after reliability updating. As the figure shows, including observations of survived loads result significantly increase the estimated reliability index. The new Safety Factor and reliability index were found by assuming a failure probability of 0 during the survived load combinations.

The relation between  $\beta$  and SF after reliability updating shows a different, milder, slope than before updating, as can be seen in Figure 8. A possible explanation for this change in slope is that reliability updating might have a larger effect on stability assessments that resulted in low safety factors (low values for  $\beta$ ), than on high safety factors, especially if the lower safety factors are caused by high uncertainties. Observations of survived loads will then result in a large uncertainty decrease and, consecutively, in higher reliability indices. If uncertainties are smaller, reliability updating is expected to have a smaller effect, resulting in a decreased slope.

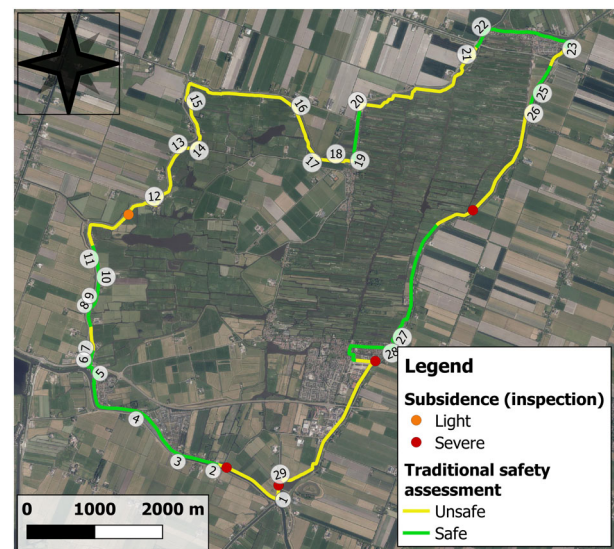
**FIGURE 9** Map showing the subsidence observations from the levee inspection. Light subsidence is observed in section 4.5, and severe subsidence is observed in section 1 (on 2 locations), 8.2, and 9.2

Figure 9 shows the severity of levee subsidence per location, observed during levee inspections over a course of about 2 years (2016–2018). The figure only includes observations of levees that were unsafe according to the semi-probabilistic safety assessment. A distinction is made based on the degree of severity of subsidence:
