# Measuring Plasticity with Orientation Contrast Microscopy in Aluminium 6061-T4

**Abstract:** Orientation contrast microscopy (i.e., electron backscattered diffraction, EBSD) was employed to monitor the plastic strain in loaded tensile samples of aluminium alloy Al6061 in T4 condition. The kernel average misorientation (KAM) is known to be an appropriate parameter in orientation contrast microscopy which has the potential to characterise the plastic strain by monitoring the local misorientations. This technique was applied here to gauge the extent of the plastic zone around a fatigue crack. To establish the magnitude of strain (which can be identified by the KAM parameter), a series of tensile samples were strained in the range of 1% to 25%. KAM maps were compared, and the average misorientations were related to the tensile strain values. The KAM distribution functions for all the strained samples were derived from a large scanned area. In addition, Vickers microhardness tests were conducted for these series of samples. This allowed the comparison of the mesoscopic plastic strain measured by Vickers microhardness with the micro plastic strain locally obtained by KAM. Noise was ob

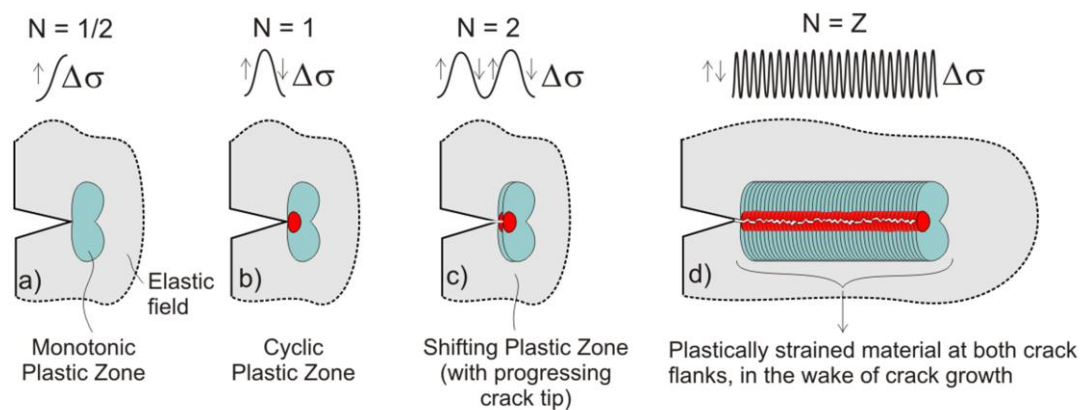
**Figure 1.** A schematic view of the formation of a plastic zone at the tip of a progressing fatigue crack with (a) Formation of a monotonic plastic zone at the moment of reaching the maximum nominal stress level (for the first time after crack initiation); (b) Formation of the cyclic plastic zone after unloading of step (a); (c) Shifting of the position of the plastic zone, along with the progressing crack tip; (d) Resulting areas of plastic deformation in the wake of crack growth, being the remnants of former plastic zones, in the earlier stage of crack growth.

A schematic view of the formation of a plastic zone at the tip of a progressing fatigue crack showing the formation of the MPZ and CPZ is demonstrated in Figure 1a–d. As the crack grows, the plastic zone forms a wake of plastically strained material along both flanks of the crack (cf. Figure 1d).

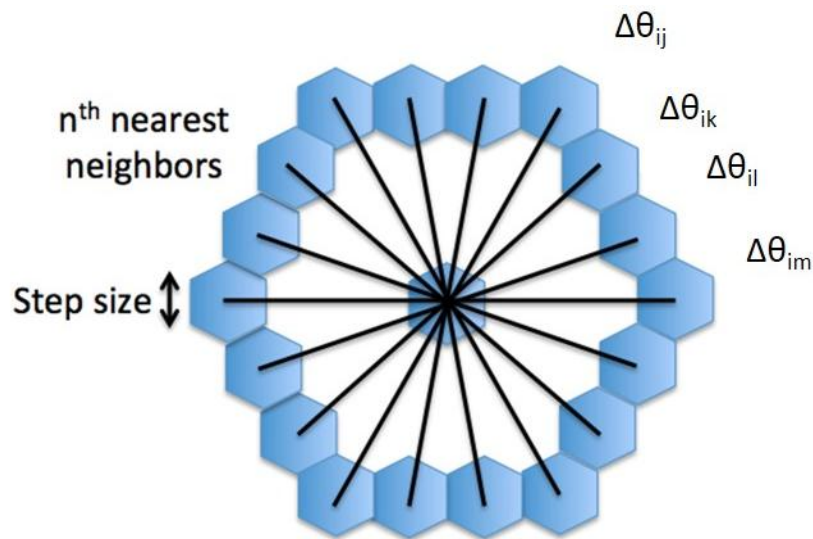
**Figure 2.** Kernel average misorientation (KAM) parameter used to characterize the accumulated plastic strain by monitoring the local orientation gradients [15].

For metallographic purposes, conventional mechanical polishing up to 0.25  $\mu\text{m}$  was applied with OPS (oxide polishing suspension), followed by electropolishing with A2 Struers<sup>®</sup> electrolyte (Maassluis, The Netherlands, 2011) with a voltage of 39 V and a flow rate of 9 for 15 s. Orientation contrast scans were carried out in a selected region around the crack tip with an EDAX-TSL<sup>®</sup> EBSD tool (EDAX Inc., Draper, UT, USA, 2012) attached to an FEI Quanta 450<sup>TM</sup> field emission gun (FEG)-SEM. Several grids with step sizes ranging from 0.3 to 2.0  $\mu\text{m}$  were applied. The kernel average misorientation (KAM) parameter was considered as a measure of local orientation gradient. This parameter is calculated by considering for each pixel the average misorientation with the Nth neighbouring pixels (neighbouring pixels for which the misorientation exceeds  $5^\circ$  are not included in the average). Only the perimeter points of the kernel are included in the procedure (cf. Figure 2). The misorientation cut-off  $\theta_c$  was set to  $5^\circ$ , as it is assumed that misorientations of more than  $5^\circ$  originate from grain boundaries, and were not induced by (micro-)plasticity around the crack tip.

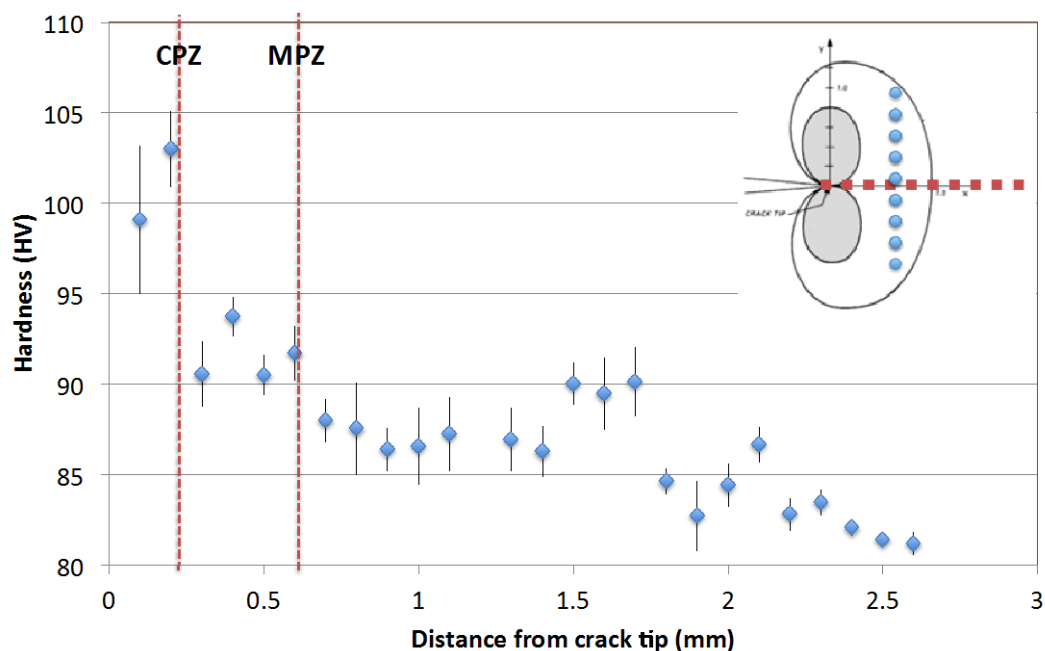
**Figure 3.** Vickers Hardness (Hv) values along a line in the extension of the crack tip. Each data point is the average of ten data points along a line that is perpendicular to the crack tip (cf. insert). CPZ: cyclic plastic zone; MPZ: monotonic plastic zone.

Figure 3 presents the hardness data along a line that extends along the crack tip. Each data point is the average of 10 data points along a line that is perpendicular to the crack tip (cf. insert in Figure 3). Based on these data, the plastic zone size was determined visually by two drops in Hv values, indicated by the vertical lines in Figure 3. It must be noted that  $H_v = 85 \pm 2$  is the hardness of the unstrained or base material. Vickers microhardness measurements indicate an MPZ and CPZ size of  $\sim 0.6$  mm and  $\sim 0.2$  mm, respectively (cf. Figure 3).

Vickers microhardness measurements indicate the MPZ and CPZ size of ~0.6 mm and ~0.2 mm, respectively (cf. Figure 3). These values are in reasonable agreement with the theoretical estimated values of MPZ and CPZ size of 0.53 mm and 0.13 mm, respectively, as derived from Equation (1) with  $K_{max} = 5.62 \text{ MPa } \sqrt{m}$  and  $C = 1.17$  [3], whereby  $CPZ = (1/4) * MPZ$  [4].

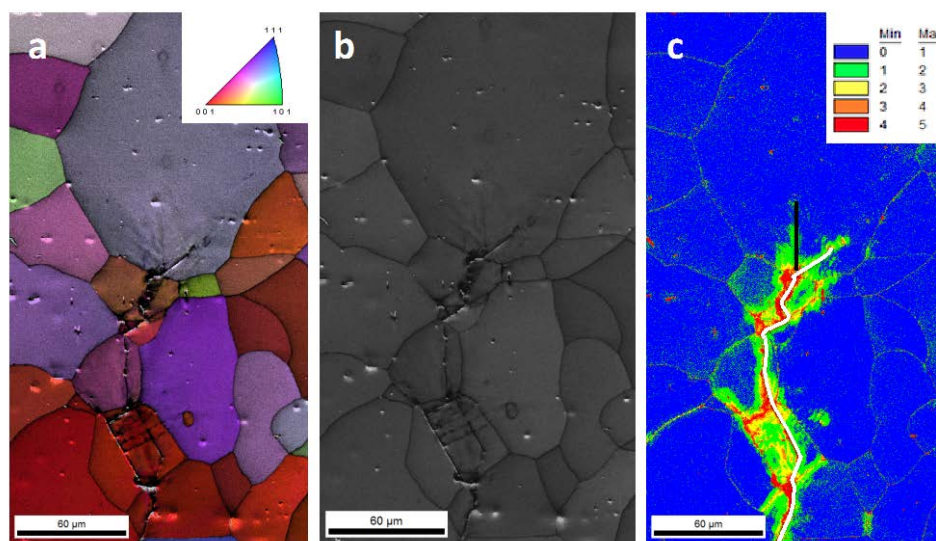
**Figure 4.** Electron backscattered diffraction (EBSD) scan of the crack tip region: (a) Inverse pole figure map; (b) Image quality map; and (c) KAM map (colour legend in degrees).

Figure 4 shows the orientation contrast scan of the crack tip area. In the inverse pole figure map of Figure 4a, it can be observed that the crack is predominantly of a transgranular nature. The scan also shows that there are many particles in the microstructure, which is normal for this type of aluminium grade alloyed with Si and Mg. It appears that the crack path morphology is affected by these particles. A similar phenomenon was observed in a previous study of cast iron with the graphite particles embedded in a pearlitic metal matrix during thermo-mechanical fatigue (TMF) testing [16]. Similar to the cast iron case, in the current material under investigation, the crack deviates towards the particles that exhibit a characteristic stress field. The tip of the crack splits in two branches; the one on the right-hand side (marked in white in Figure 4c) is more pronounced, whereas the one on the left-hand side (marked in black in Figure 4c) is less developed but appears to exhibit some deformation lines perpendicular to the crack path (cf. image quality (IQ) map of Figure 4b). However, it seems that this branch of the crack was stopped by a particle in its front.

As pointed out in the introduction, the kernel average misorientation approach has the potential to characterize the accumulated plastic strain by monitoring the local orientation gradients, of which it is well known that they bear a connection with the density of geometrically necessary dislocations (GNDs). As can be seen in the KAM map of the crack (cf. Figure 4c), there is a small trace of a plastically deformed zone in the immediate vicinity of the crack, with a size of approximately 30 µm. However, a textbook-type elliptic plastic zone at the crack tip cannot be discerned, even though the hardness data indicated a size of ~0.2 mm for the CPZ. It is interesting to note that the KAM map (cf. Figure 4c) shows a plastic wake, which is left behind by the propagating fatigue crack as would be expected from continuum fracture mechanics. This is due to the accumulation of plastic deformation by the progressing crack.

The misorientation corresponding to the plastic zone at the crack tip—as revealed by the KAM parameter—is shown in Figure 4c. This map suggests a plastic wake size of less than  $30\ \mu\text{m}$ , which is much smaller than the size obtained from the hardness measurements and theoretical calculations as mentioned above. Therefore, this can suggest that the magnitude of strain in the plastic zone is not high enough to be gauged with EBSD. Hence, the following experiment was performed to determine if the noise dominates the misorientation maps for strain levels below a critical threshold.

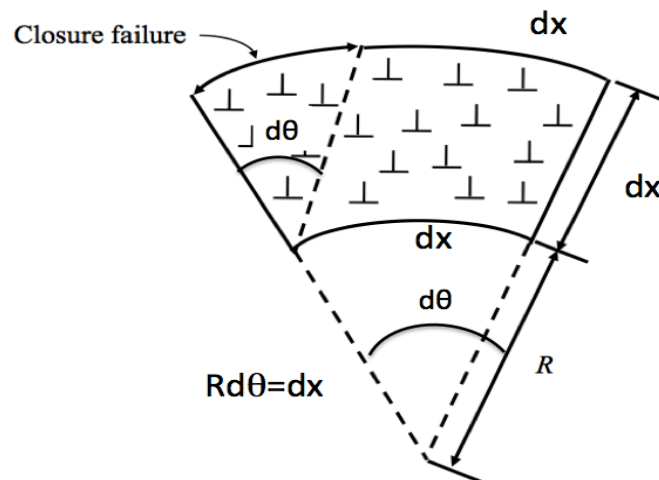
**Figure 5.** Schematic representation of a one-dimension lattice curvature, inducing a shear strain  $d\theta$  [7].

The Nye tensor connects the density of GNDs to the lattice curvature tensor. In a simplified one-dimensional (scalar) representation assuming only parallel edge dislocations of the same sign, this tensor relation can be expressed as (cf. Figure 5) [7]:

whereby  $\kappa$  is the lattice curvature  $d\theta/dx$ ,  $\rho$  the density of GNDs, and  $b$  the Burgers vector. On the simplified lattice geometry of Figure 5, it can be seen that the curvature  $\kappa = 1/R = d\theta/dx$ . In a discrete representation, the local  $d\theta/dx$  value can be approximated as  $\Delta\theta/\Delta x$ , whereby  $\Delta\theta$  is the local average misorientation as quantified by the KAM parameter in an EBSD measurement and  $\Delta x$  is the distance over which the misorientation is evaluated.

Figure 5 equally shows that the shear strain  $\tan(d\theta) \approx d\theta$  is approximately equal to the local lattice misorientation  $d\theta$  in the approximation of very small (shear) strains. If it is assumed that the angular resolution limit of EBSD is approximately equal to  $1.0^\circ$  (0.0174 rad), then this corresponds to a plastic shear detection limit of  $\sim 1.7\%$ .

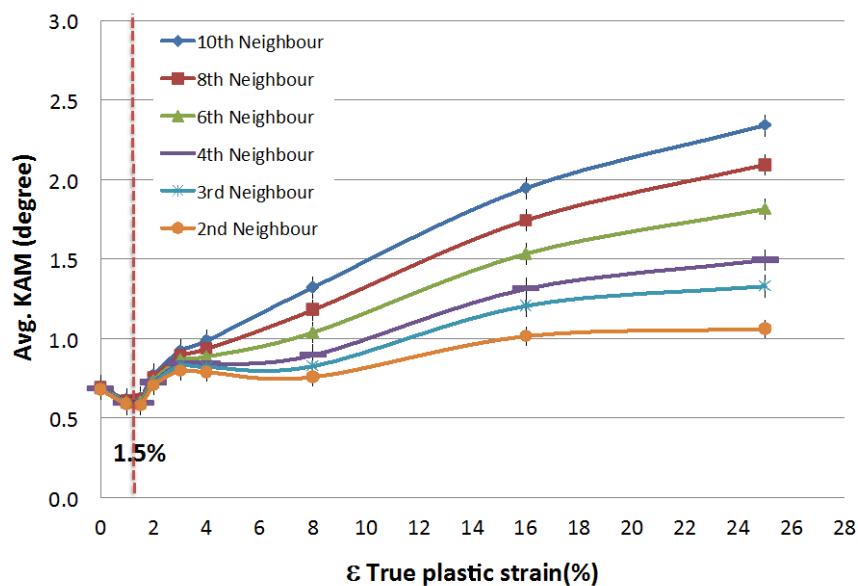
**Figure 6.** Average KAM parameter vs. true strain observed in tensile experiments. The KAM parameter was evaluated for different values of nearest neighbours.

A plastic strain was applied to a tensile test sample of the same aluminium alloy with tensile strains ranging from 1% to 25% at fracture. Orientation contrast maps were measured with a step size of  $0.3\ \mu\text{m}$  on each of the tensile samples in four different locations (scanned area  $200 \times 300\ \mu\text{m}^2$ ), and the scan average KAM value was extracted for each scan; thereafter, the average value and the standard deviation was determined for the set of four scans. The procedure was repeated for different values of nearest neighbours: 2nd, 3rd, 4th, 6th, 8th, and 10th nearest neighbours were considered. The dependence of the KAM value on the tensile plastic strain is shown in Figure 6.

According to the theoretical expectation, it was confirmed that no specific tendency could be observed up to a plastic strain level of  $\sim 1.5\%$ , indicating that the accumulated plastic strain at the crack tip is less than the detectable limit. For plastic strains exceeding the critical value of  $\sim 1.5\%$ , noise no longer determines the average KAM value, and there is an ascending correspondence between the KAM value and the plastic strain, which was also observed by Kamaya et al. [13].
