Optimizing the open payment boundary

Exploration and evaluation of a design strategy for reducing the incidence of missed check-outs when travelling

This study was conducted by the Expertise Centre E-ticketing in Public Transport

June 2017

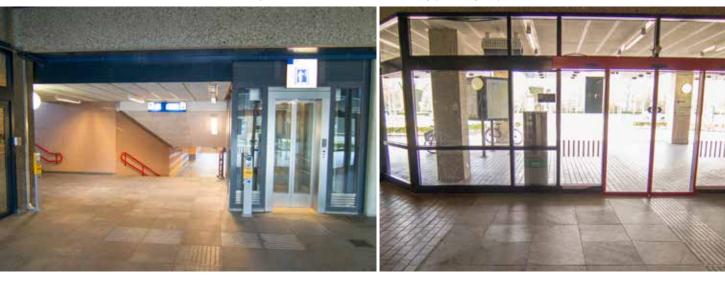
Figure 11: Another lift with OV-chipkaart posts on both sides of the door. In the photo on the right, the OV-chipkaart posts are located just around the corner. The stamp-card machine and the ticket vending machine are clearly visible.

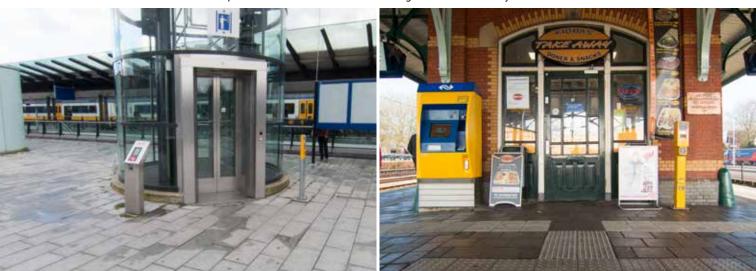
Figure 12: Examples of situations in which OV-chipkaart posts are located amidst other facilities and are thus not clearly visible.

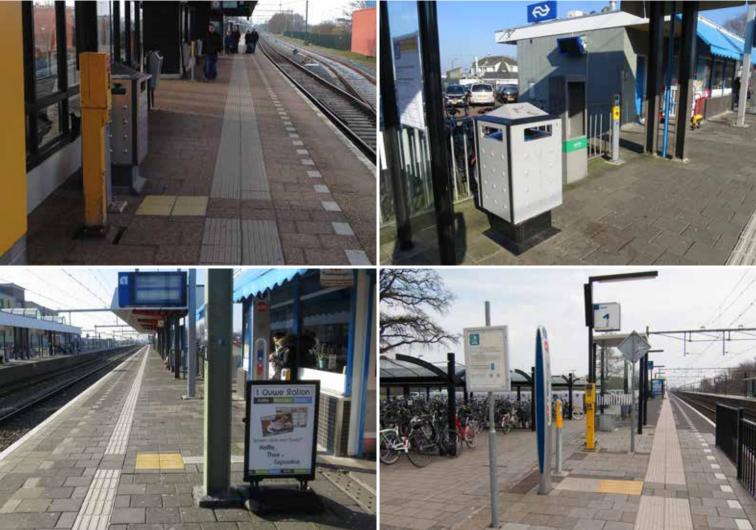
Many objects are located at stations and on platforms, including information panels, waste bins, information and emergency call boxes, stamp-card readers and billboards. It is no coincidence that they are often very close to the access points. Because OV-chipkaart posts are smaller than other objects, they are less noticeable. In some cases, they might not be visible at all (see Figure 12).

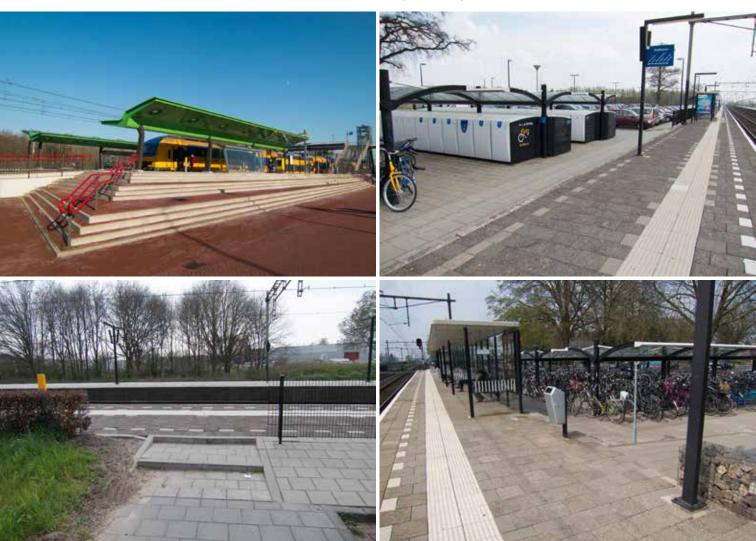
Figure 15: From left to right: No colour; with a 'cigar band' and floor markings; yellow top and in a row; transfer cube with three OV-chipkaart posts of different public transport operators.

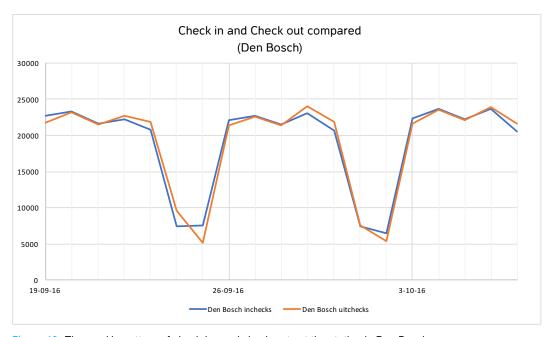
Figure 19: The weekly pattern of check-ins and check-outs at the station in Den Bosch.

Comparison of check-ins and check-outs reveals clear differences, particularly in the weekend (see Figure 19). On Saturday, there are more check-outs than there are check-ins. The pattern is reversed on Sunday. This pattern could reflect people visiting the city for a weekend, although it might also be due to the student population in a city.

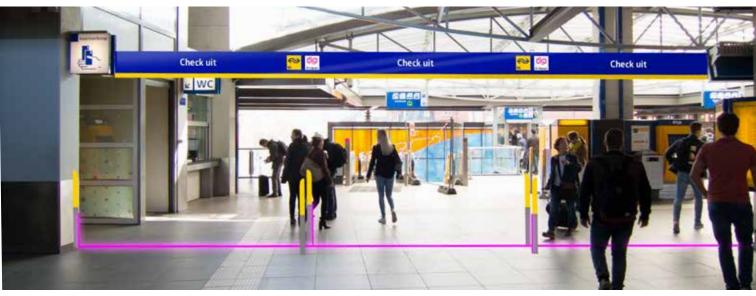
Figure 26: Photo montage of the Den Bosch station hall with the initial proposal.

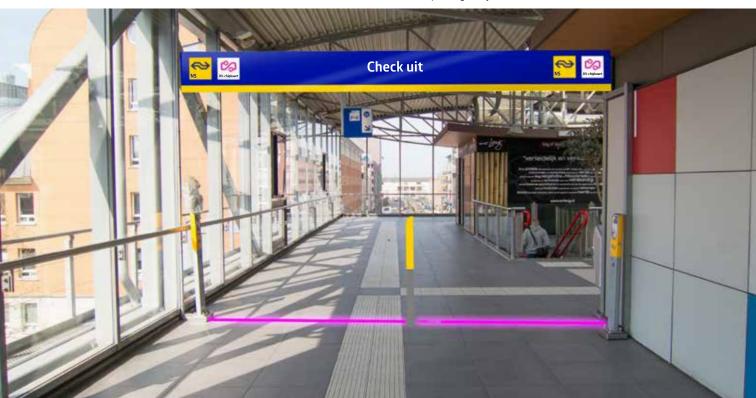
Figure 27: Photo montage of an access point on the rear side of the station in Den Bosch with the initial proposal; another OV-chipkaart post has been added in order to restrict the width of the passageway.

The initial proposal (based on the design developed by Niermeijer, 2013) was based on enhancing visibility through the addition of frontal surface. One requirement from the stakeholders was that it should be installed higher than 2.5 metres. The first design assumes a portal across the entire width of an access point, above all OV-chipkaart posts. The appearance is heavily derived from existing portals above a row of gates at a station where multiple public transport operators stop. An illuminated line incorporated into the floor combines with the portal to connect the OV-chipkaart posts, thereby visually reinforcing the boundary (see Figure 25). Another choice was made to have the card reader for the OV-chipkaart emit light in order to make it more noticeable and obvious where the OV-chipkaart should be held. Figure 26 and Figure 27 are photo montages of the existing situation with the proposal for the payment boundary.

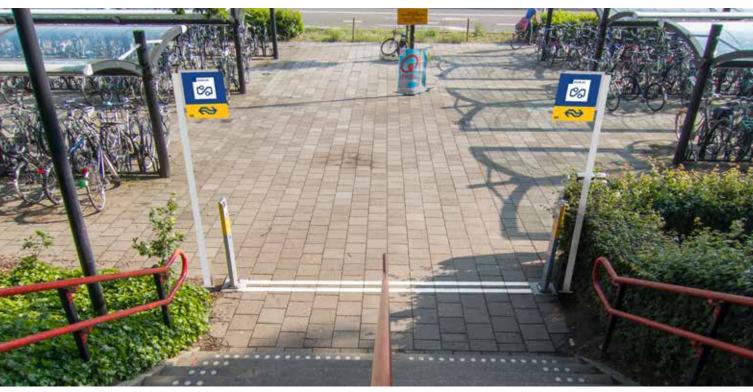
Figure 29: Photo montage of the Den Bosch station hall with the revised proposal.

The revised design assumes separate signs above all OV-chipkaart posts or groups of OV-chipkaart posts (see Figure 28). The illuminated line is replaced by lighting fixtures in the signs that project a line on the floor. The light is quite visible, due to a light-reflecting line on the floor (see Figure 29 and Figure 30). The format of the sign is not as well suited to displaying two icons (public transport operator and OV-chipkaart) next to each other. The choice was made to have the sign have two colours, so that it will still correspond to the portal visually. It also bears a strong resemblance to the top of the AVM at gate lines (see Figure 31 on p. 58). The logo of the public transport operator now appears in the border. The addition of the public transport operator's colour increases the contrast with the surroundings and provides clear coherence between the sign and the OV-chipkaart post.

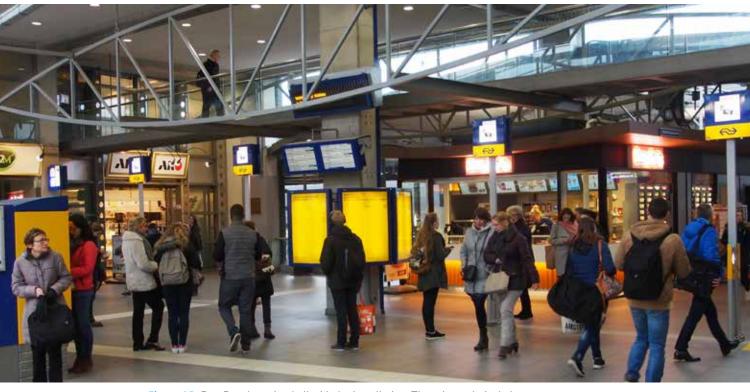
Figure 35: Den Bosch station hall with the installation. There is a relatively large amount of distraction: illuminated elements and other signs.

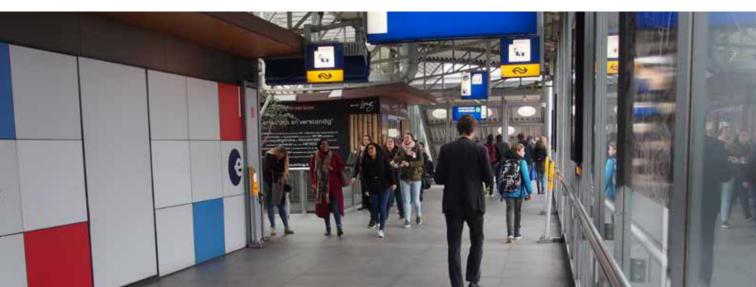
Figure 36: Rear side of Den Bosch station. On one side, the sign could not be hung above the OV-chipkaart post, due to limited height. Moreover, this sign is one-sided.

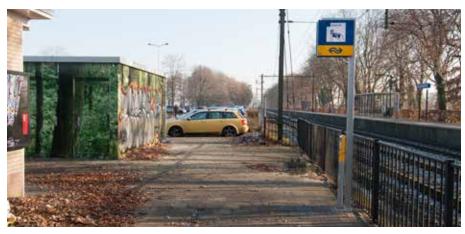
Figure 37: The access point from and to the car park.

At Veenendaal-De Klomp station, five signs were positioned at the three access points, each with one lighting fixture. All of the OV-chipkaart posts (five in all) were equipped with an illuminated card reader. At this station, there is more contrast with the surroundings than is the case at Den Bosch station (see Figure 37 and Figure 38). The illuminated elements are also more visible in the dark (see Figure 40).

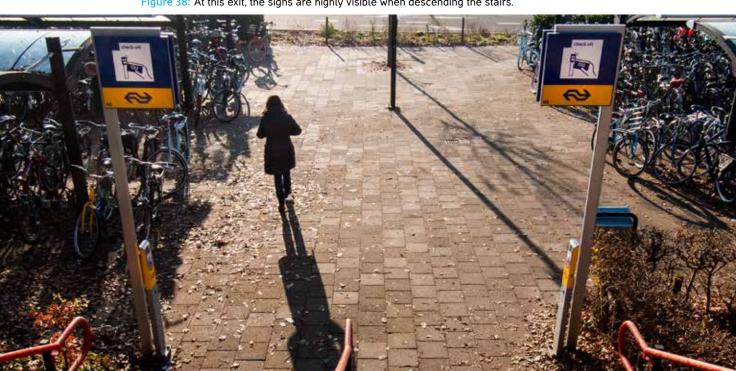
Figure 38: At this exit, the signs are highly visible when descending the stairs.

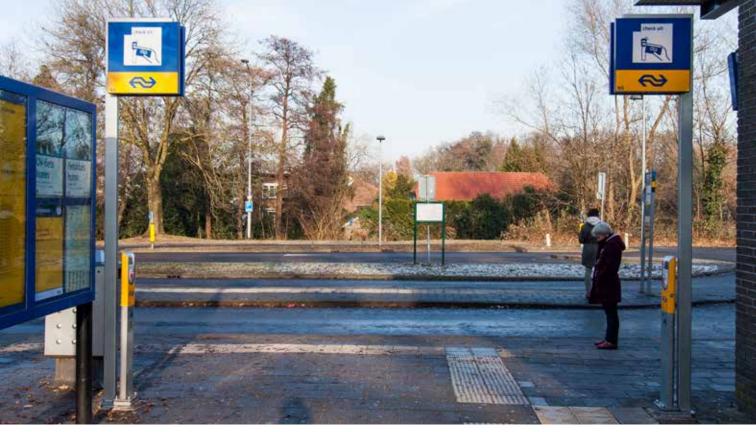
Figure 39: The installation on the side of the bus stops.

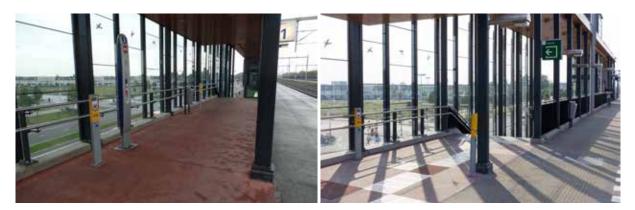
Figure 44: An example (Utrecht Terwijde) from before and after the modification: on both platforms, one OV-chipkaart post was positioned closer to the access point.

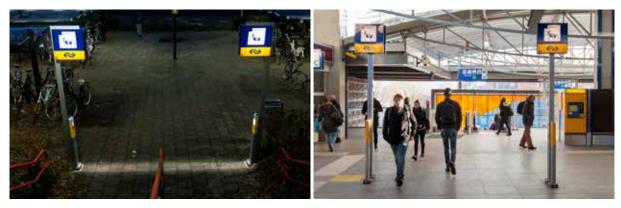
Figure 45: Veenendaal-De Klomp and Den Bosch stations with the test installation.

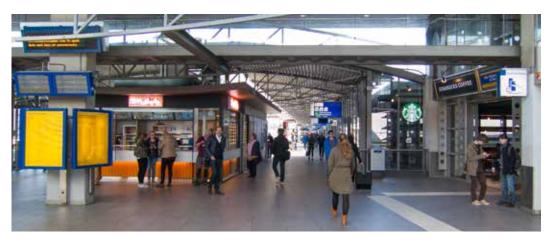
The presence of other signs or facilities in the vicinity of the payment boundary can reduce the visual contrast of the check-out-zone (see Figure 47). Conversely, the absence of other facilities can increase the contrast with the payment boundary. The modification of the surroundings was not part of this study. The design of an access point with a payment boundary calls for an integral approach that also considers all other facilities in the immediate surroundings of the OV-chipkaart posts.

Figure 47: Visual distraction in the hall of Den Bosch station.

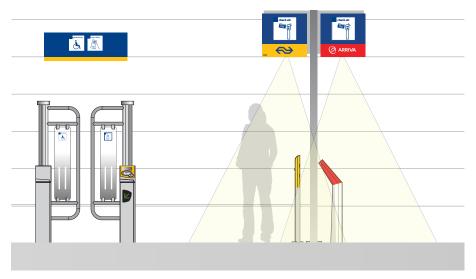
Figure 49: The sign used in the trial corresponds to the portal that is used above the row of gates. In addition, the coloured border makes it possible to make clear distinctions between various public transport operators.
