Cathodic protection of steel in concrete – experience and overview of 30 years application

Abstract. This paper presents an overview of 30 years' experience with cathodic protection of steel in concrete in The Netherlands. Principles and practical aspects of CP and its design and installation are presented. Three phases have passed from the late 1980s until present: pioneering, development and maturity. In the first period CP was mainly applied to precast elements corroding due to mixed-in chlorides. The parties involved worked together to draw up a Technical Guideline. In the second period, application to bridges came up, including post-tensioned structures, which was then innovative. Furthermore, galvanic anode systems were introduced. In the third period, CP became a fully accepted method of securing durability and safety. Renewed collaboration led to a database that allowed analysis of various aspects of CP system working life, including shortcomings in early systems. Major successes and lessons learned will be presented. Technical and non-technical developments are highlighted and some recent innovative CP components and systems are discussed.

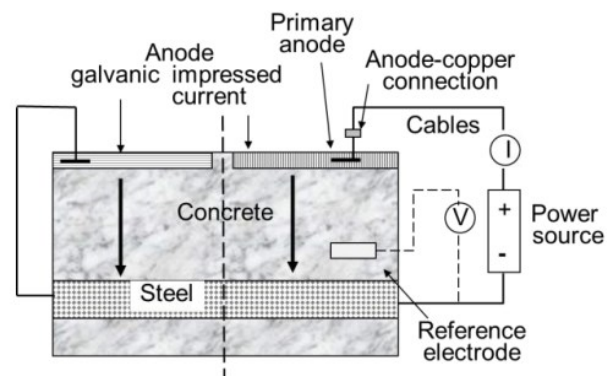
Fig. 1. Main components of galvanic (left) and impressed current (right) CP systems.

Two basic types of CP systems exist: impressed current CP (ICCP) and galvanic or sacrificial CP (GCP). The main components for both are illustrated in Figure 1. With ICCP a low voltage DC power source causes the current to flow. The anode consists of a material that is not or only slowly consumed, such as activated titanium (whose surface is covered with noble metal oxides, Mixed Metal Oxide or MMO) or a conductive coating. Activated titanium has the shape of a mesh embedded in a cementitious overlay installed on the concrete surface; or of strips in boreholes in the cross section or in slots cut in the concrete surface; holes and slots are filled with cementitious grout. Conductive coatings are carbon filled polymers applied to the concrete surface, usually covered with a top coat. Primary anodes are metal wires used to feed the current into the actual anode material; they should be separated closely enough to avoid large potential drops in the metallic circuit. Cementitious overlays and conductive coatings should be durably bonded to the concrete surface to ensure electrical contact. Obtaining good bond requires adequate surface preparation; proper application and curing are critical. Power source and anode are metallicly connected by isolated copper cables and anode-cable connections. Cable cross sections should be large enough to limit potential drops. Cables need to be redundant in order to avoid system failure due to cable interruptions (e.g. by vandalism); at least two cables should feed both anodes and cathodes, with their connections as far apart as possible within a zone. Power sources are fed from the grid or by solar or wind energy, backed up by batteries.
