## Strain-Hardening Cementitious Composite (SHCC) For Durable Concrete Repair

Lukovic, Mladena; Ye, Guang; Schlangen, E.; van Breugel, Klaas

Proceedings of the Konferencija Savremena Građevinska Praksa 2019

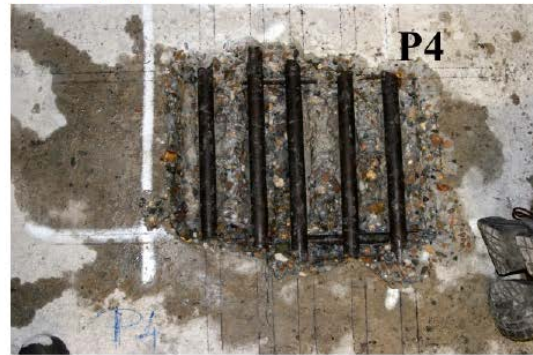
(a) Patch 1 (P1)

(b) Patch 2 (P2)

(c) Patch 3 (P3)

(d) Patch 4 (P4)

Figure 18: Four patches prior to casting of the repair material.

Before the application of the repair material, patches with dimensions of 500 x 500 mm<sup>2</sup> and the depth of around 110 mm were prepared in the tunnel (Figure 18).

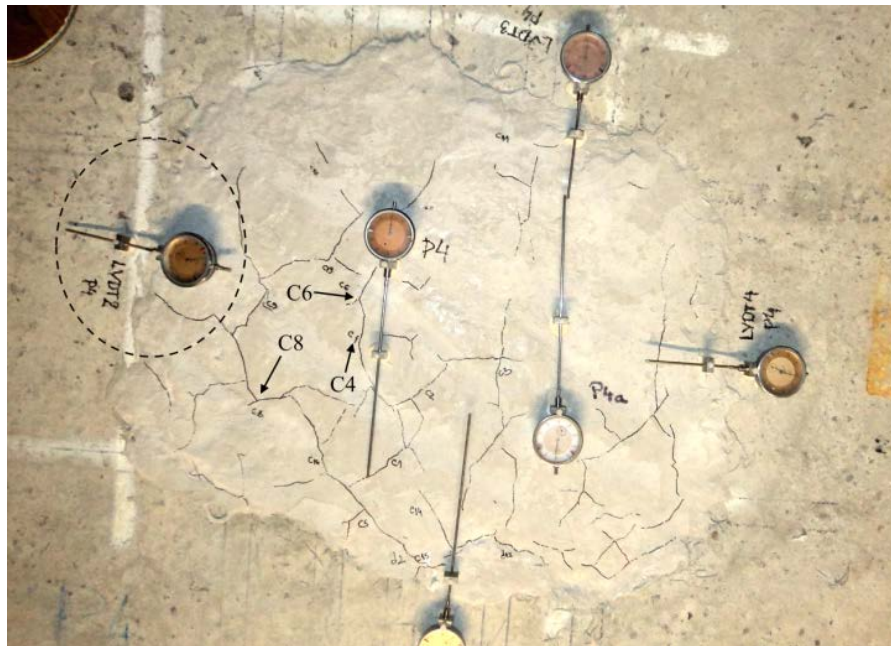
Figure 19: Shrinkage induced cracks in SHCC patch repair and magnified cracks (bottom).

Hydro-jetting was applied for roughening of the concrete substrate. The substrate was water saturated (with a dried surface) in all patches. Besides SHCC (Figure 19), four other repair materials were applied as repair materials. One of these mixtures was regular concrete. As one of the main factors limiting the use of SHCC in practice is its high cost due to high cement content, two new mixtures incorporating coarse aggregates (up to 16 mm size) within the regular SHCC mixture are developed. This resulted in the design of cheaper and commercially more attractive fibre reinforced mixtures. Flexural tests on notched samples showed that both mixtures exhibited deflection hardening behaviour.

In all the patches no delamination occurred, and small shrinkage cracks (smaller than 100  $\mu$ m) are observed

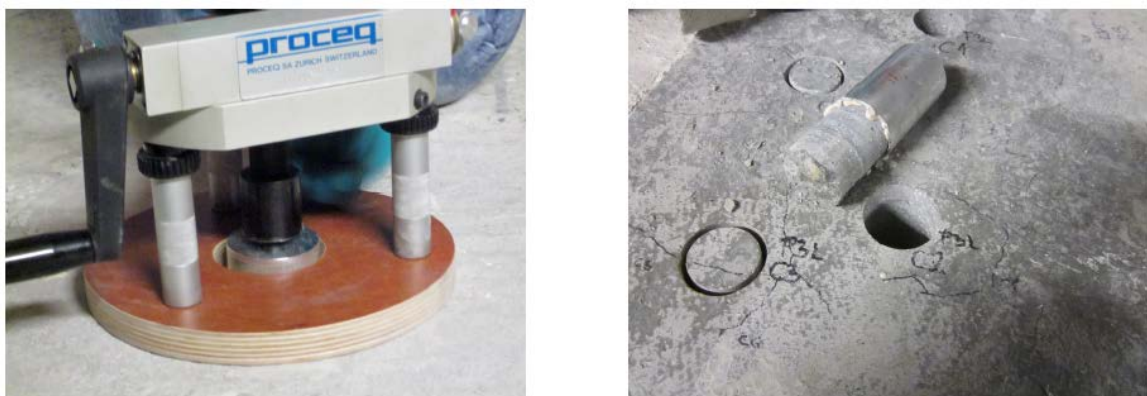
Figure 20: a) Pull-off test set-up and b) Typical failure mode in the substrate

Pull-off tests (Figure 20) indicated that, in general, good bond is achieved between the tested repair materials and the concrete substrate, and that in most of the tests, the concrete substrate was the weakest link in the system.
